# *Adopt a Road*

Bradford Conservation Commission

Spring 2020 Report

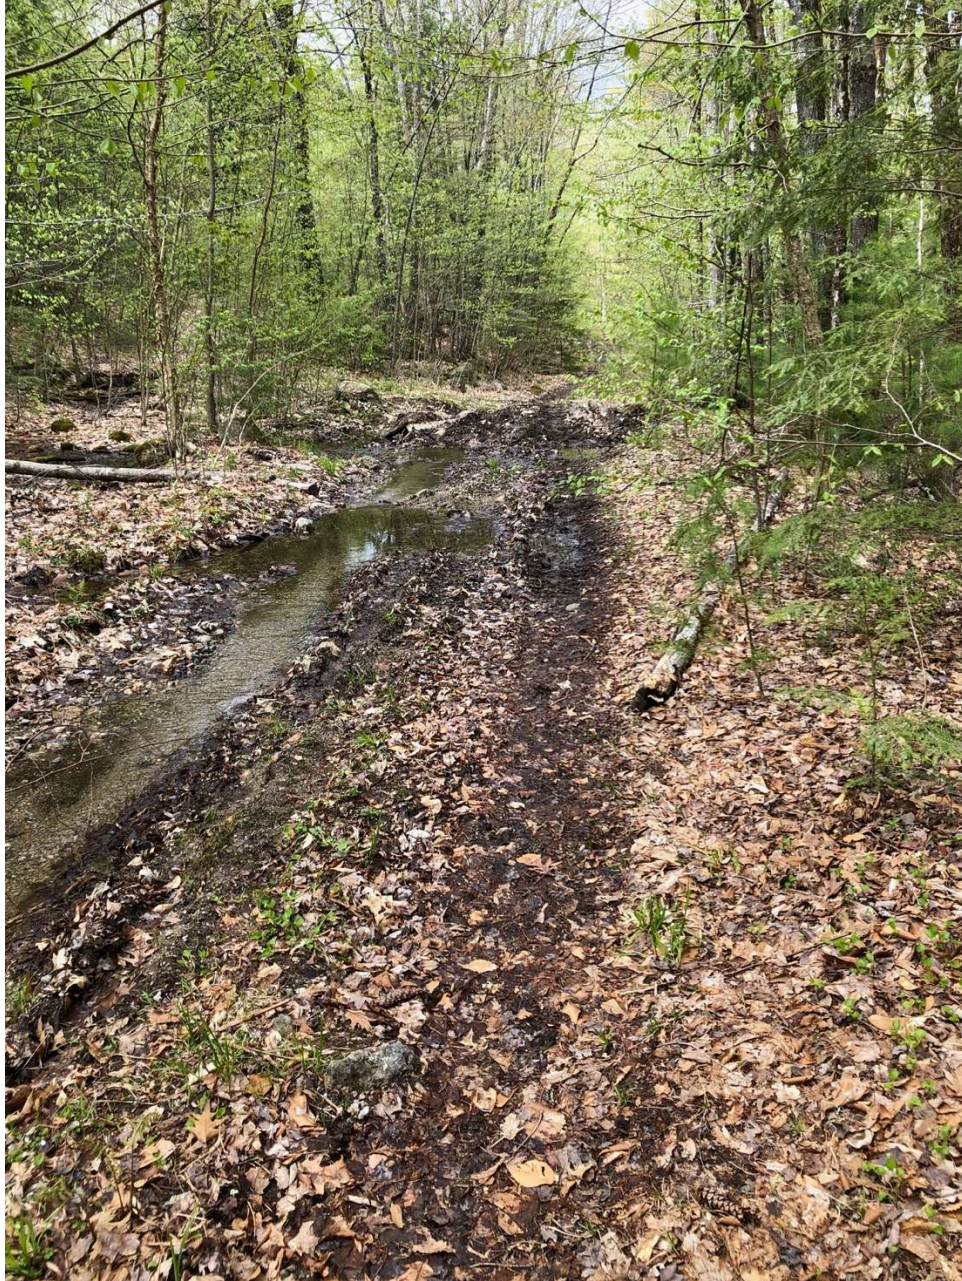
Erosion: Modest amount of erosion as the road surface and surrounding land are relatively flat. However, there are numerous mud puddles.

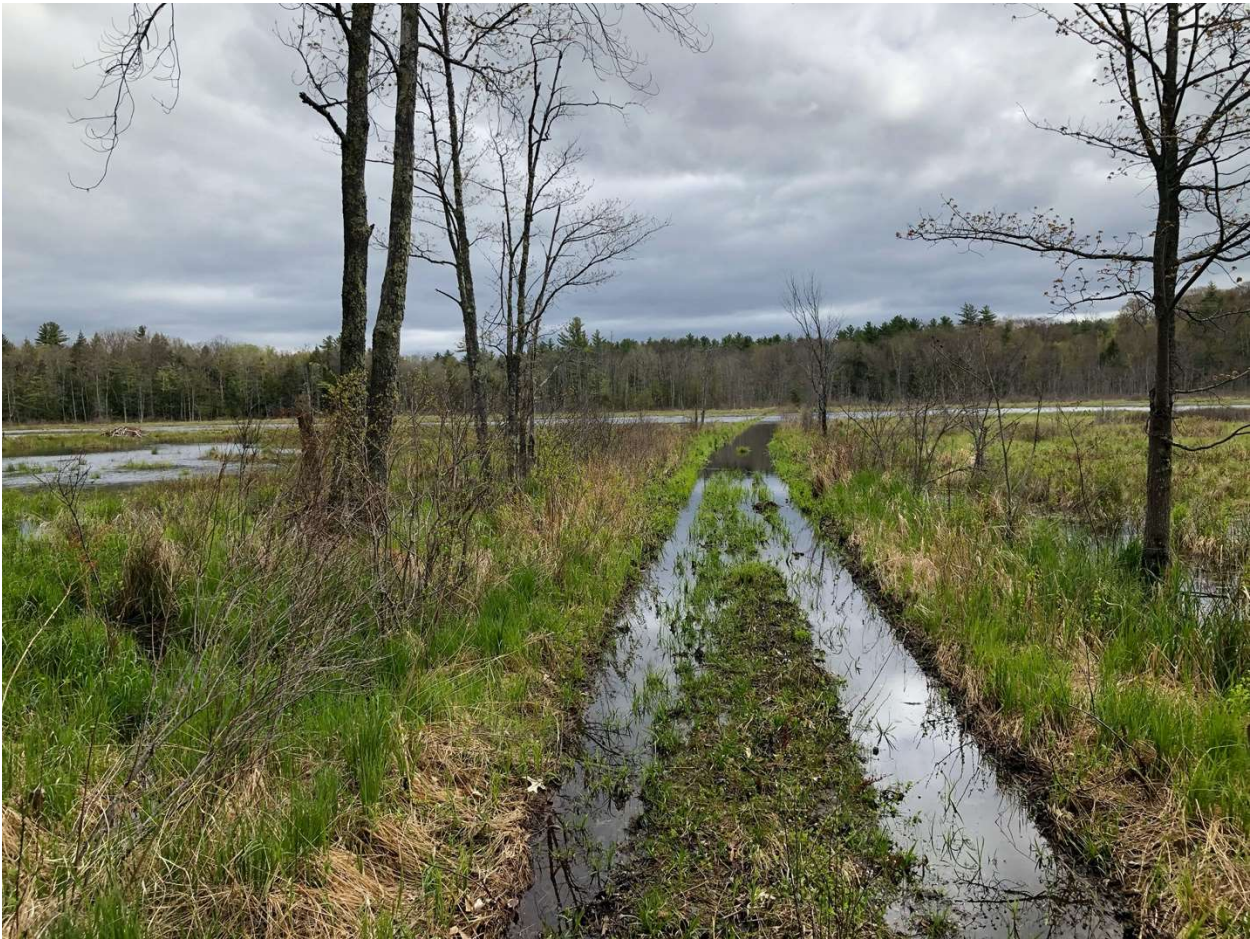
0.25	Up until this point, road is in Good condition with placement of crushed rock. A small building is encountered on the left side of the road and appears occupied. Numerous junk piles and cars/trucks along-side of the road.
0.75	Road surface is Fair to Good, reasonably flat, but with significant mud puddles. One culvert juts up from the road surface.
1.0	Road continues to be in Fair to Good condition, but ends in water at approximately 1 mile (see pic).

Obstructions: Standing water in some areas of the road.

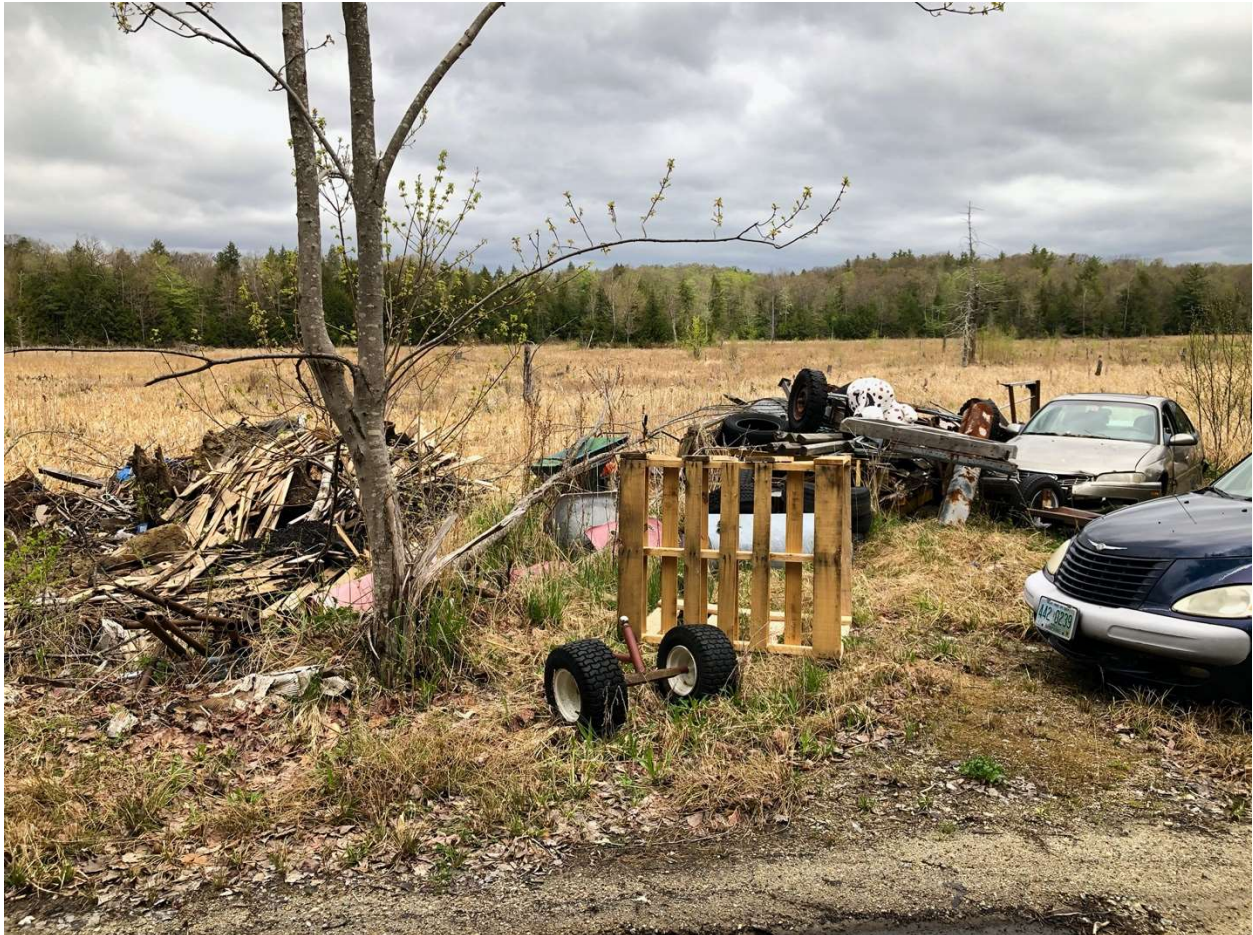
Trash/Dumping: The junk and trash piles looked the similar to the report of Fall 2019. One pile may be somewhat lower than before.

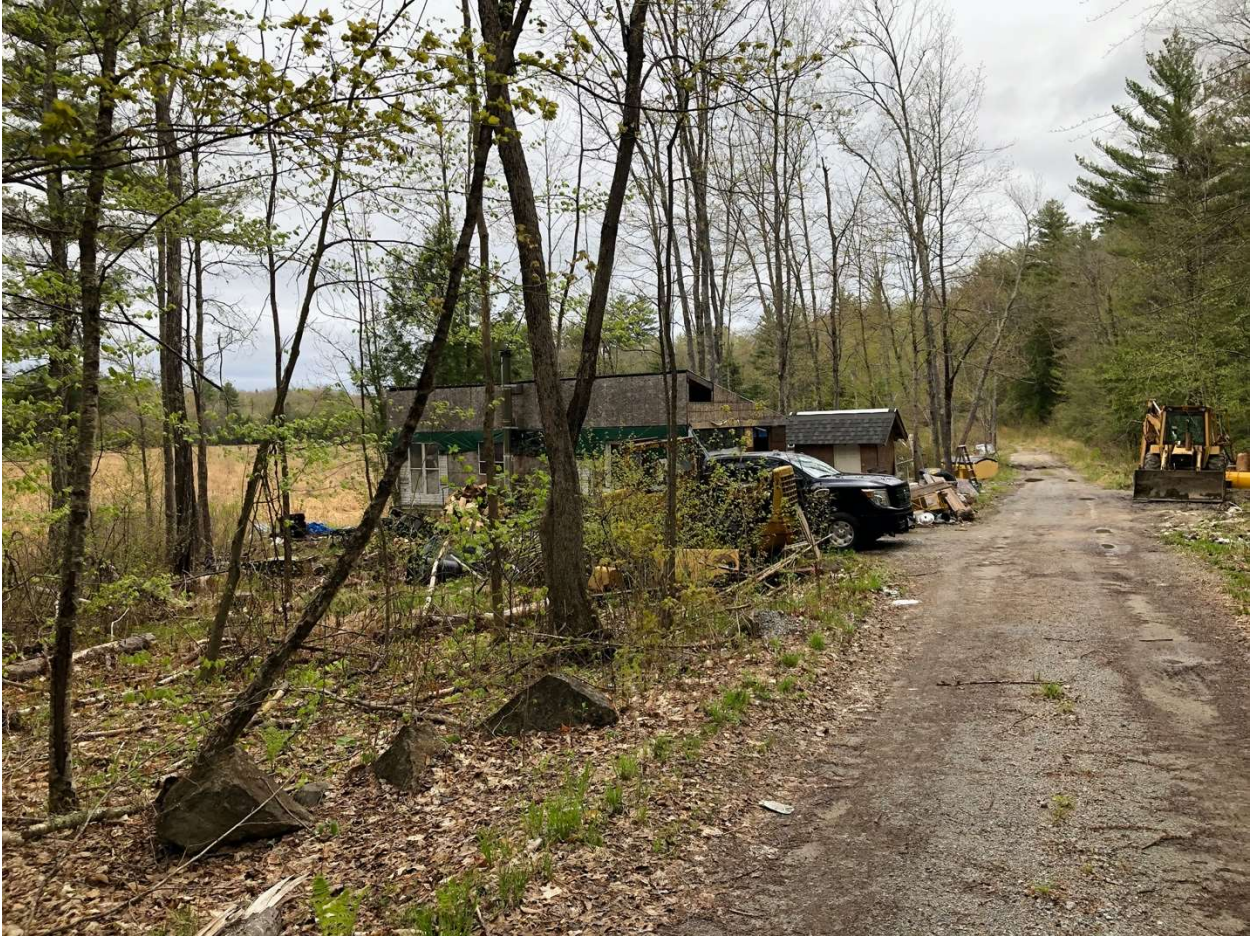
Other Conditions: There appears to be an occupied camp under development at 260 Adler Plains Road (map9, lot 15).

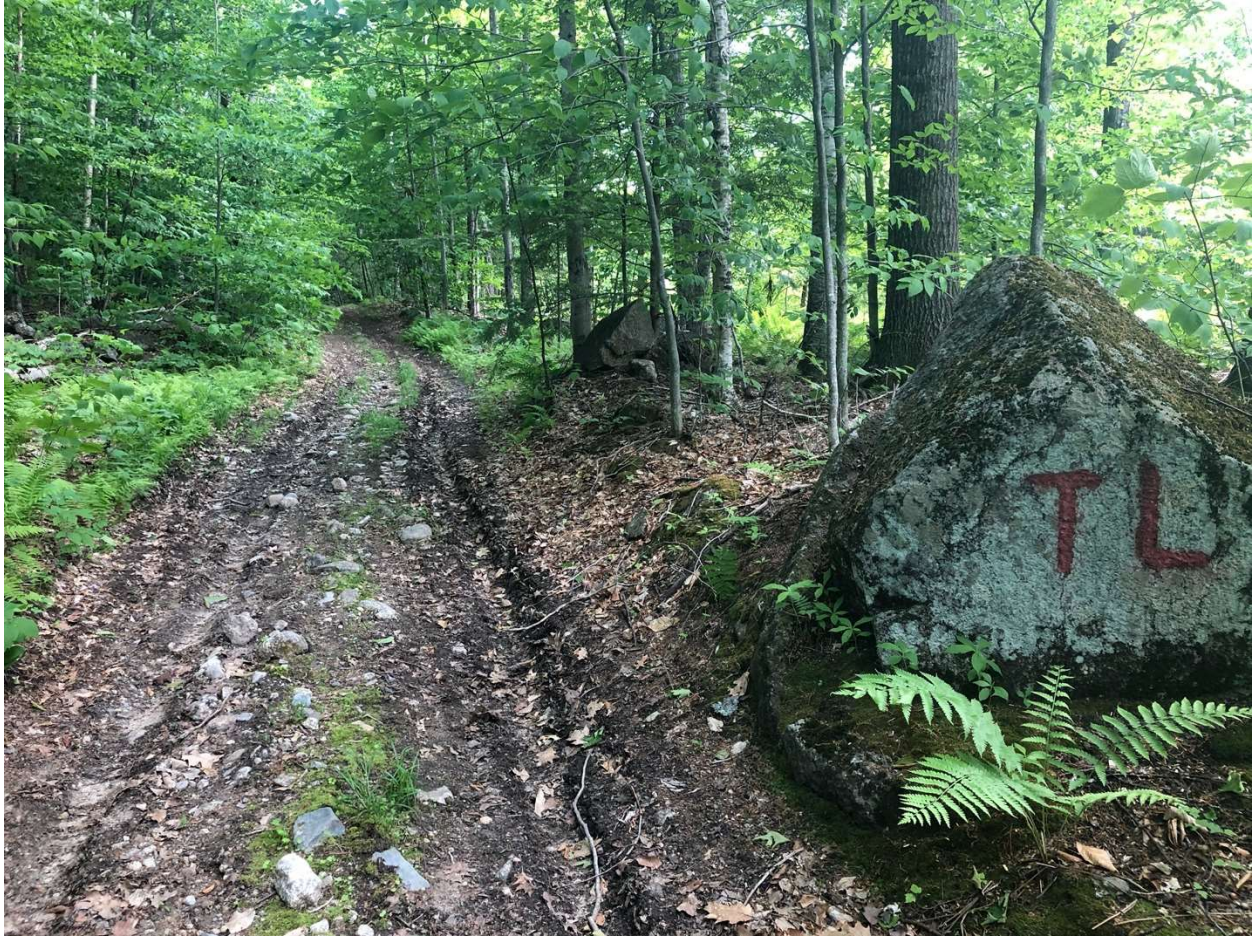
Erosion: Mud/pot holes with some large rocks noted on the Bradford Class VI section.

Motorized/Non-motorized Activities: Some motorized tracks noted in the mud.

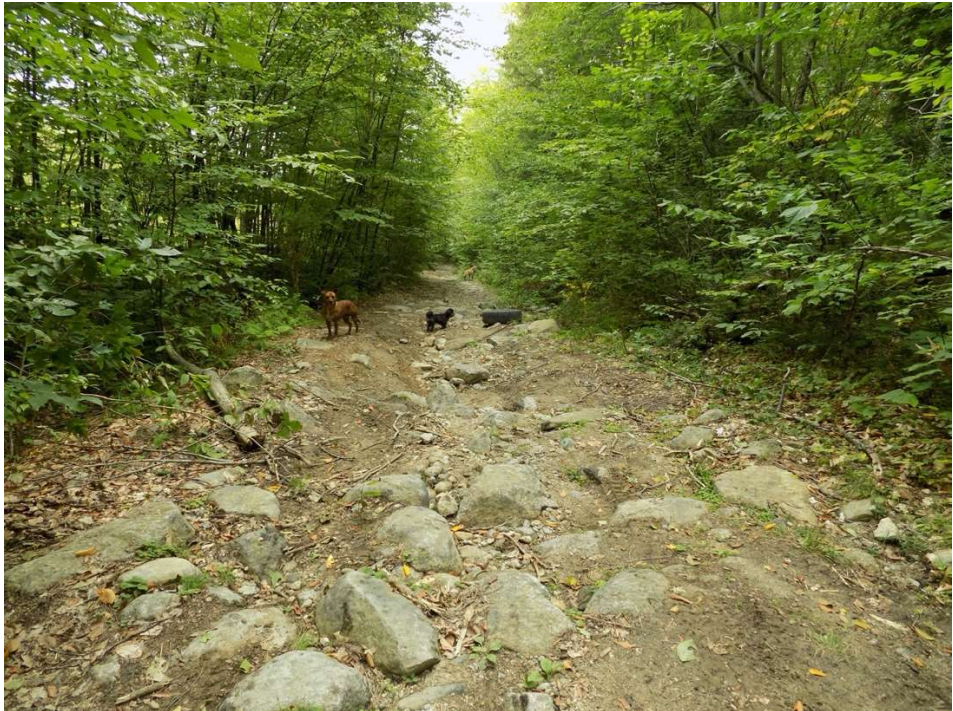
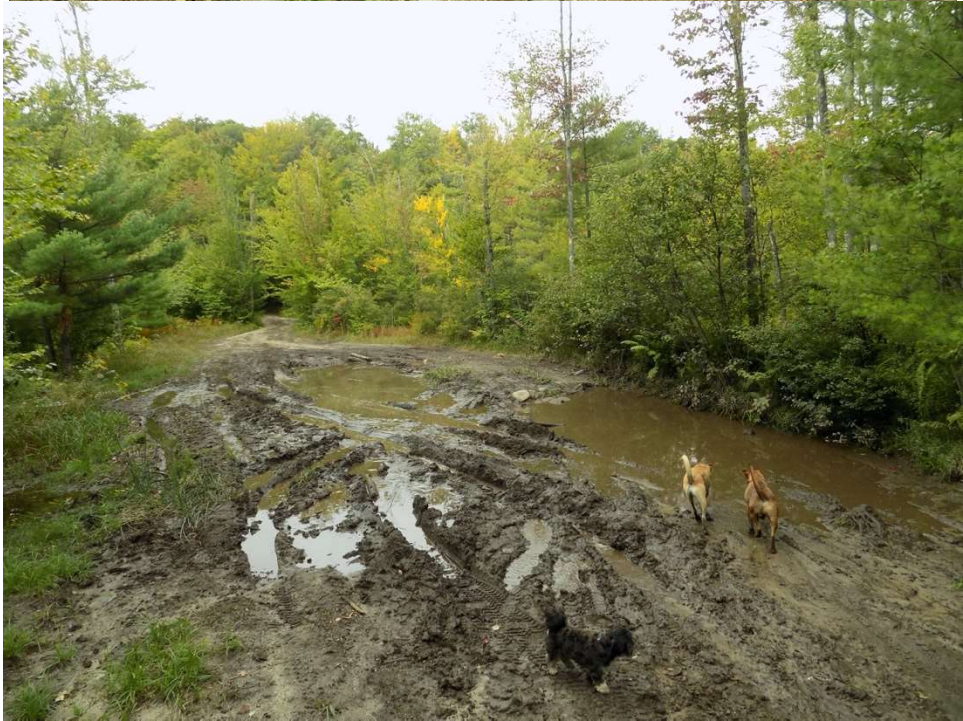
Erosion: Significant erosion from beginning to Hillsborough town line. Some sections essentially impassable except by articulated suspension.

Obstructions: One low lying area has roughly 6 inches to 2 feet of muddy water, perhaps 50ft by 30ft (see picture).

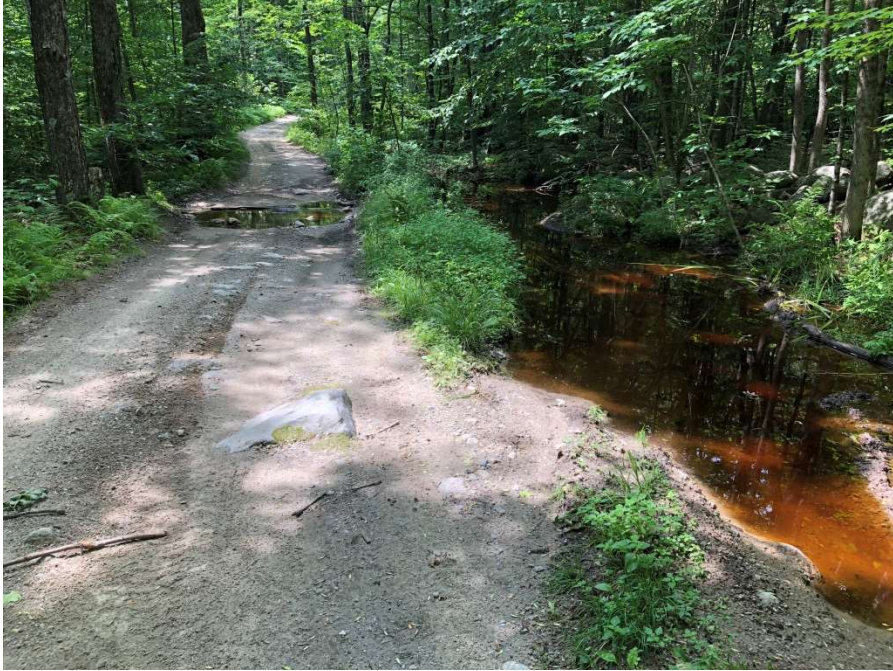
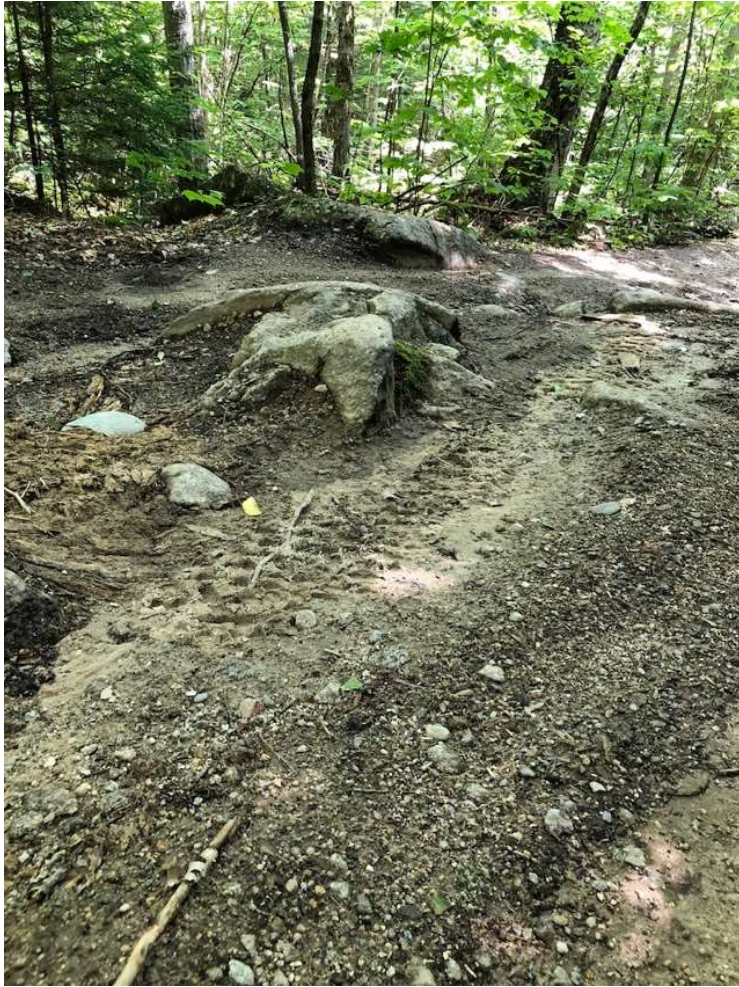
Erosion: Section closest to Rowe Mountain Road has significant erosion. Rip-rap placed on Liberty Hill end makes road a bit more stable. Erosion appears to be somewhat greater than seen on previous observations.

Recreational Vehicle Trail Signage: One "snowmobile?" sign pointing to Henniker located at junction with Rowe Mountain Road. Trail sign needs to be labeled "Snowmobile".

Motorized/Non-motorized Activities: Old off-road embankment damaged as noted above. No activity directly observed.

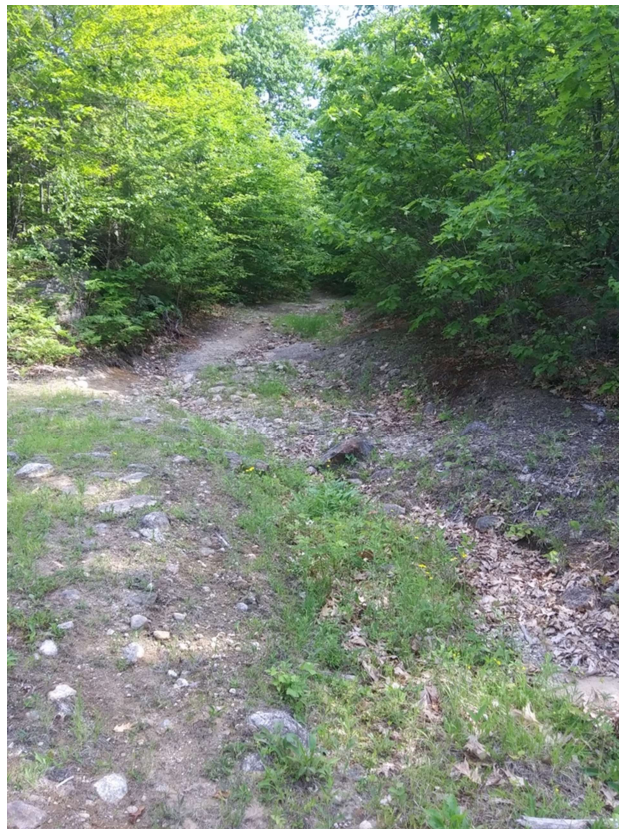
Erosion: No further erosion. Conditions extremely dry. Most of road is completely dry. One stream still lightly flowing where road is now the stream bed. Overall, the road is in Fair condition with a few areas in Poor repair.

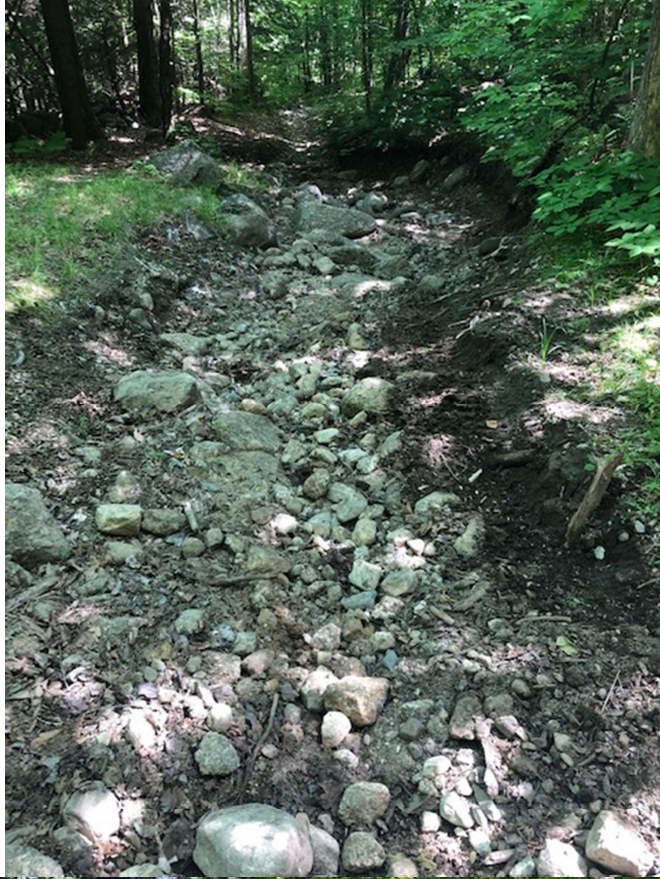
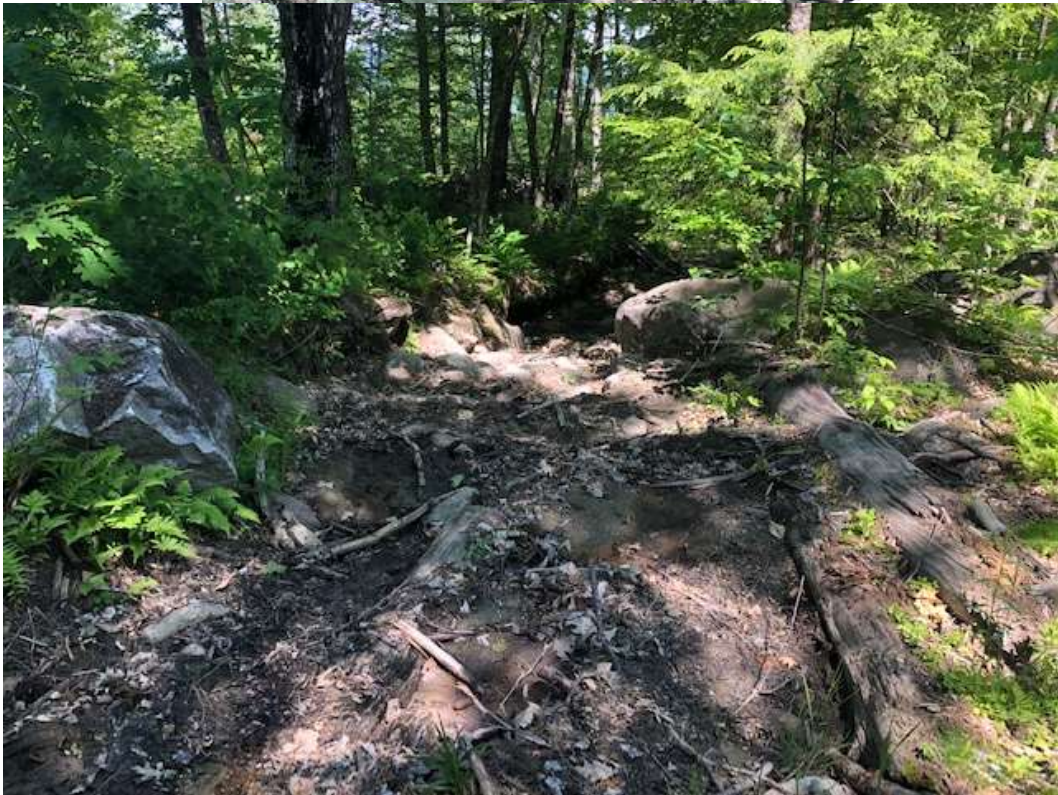
Erosion: Water bars on the initial section appear to be a bit deeper than previously noted and functioning well. Also, one end of the pipe on the East end of Dunfield Road is above ground and doing no good at all.

Obstructions: Extensive and significant erosion on the Eastern section makes road essentially unpassable.

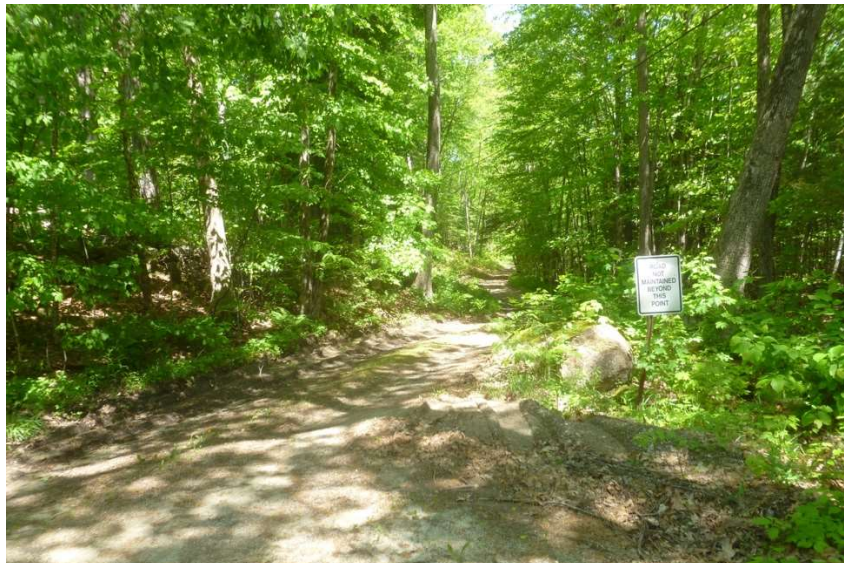
Erosion: Yes, in multiple places. Overall, the road is "GOOD" with the exception of some significant mud holes.

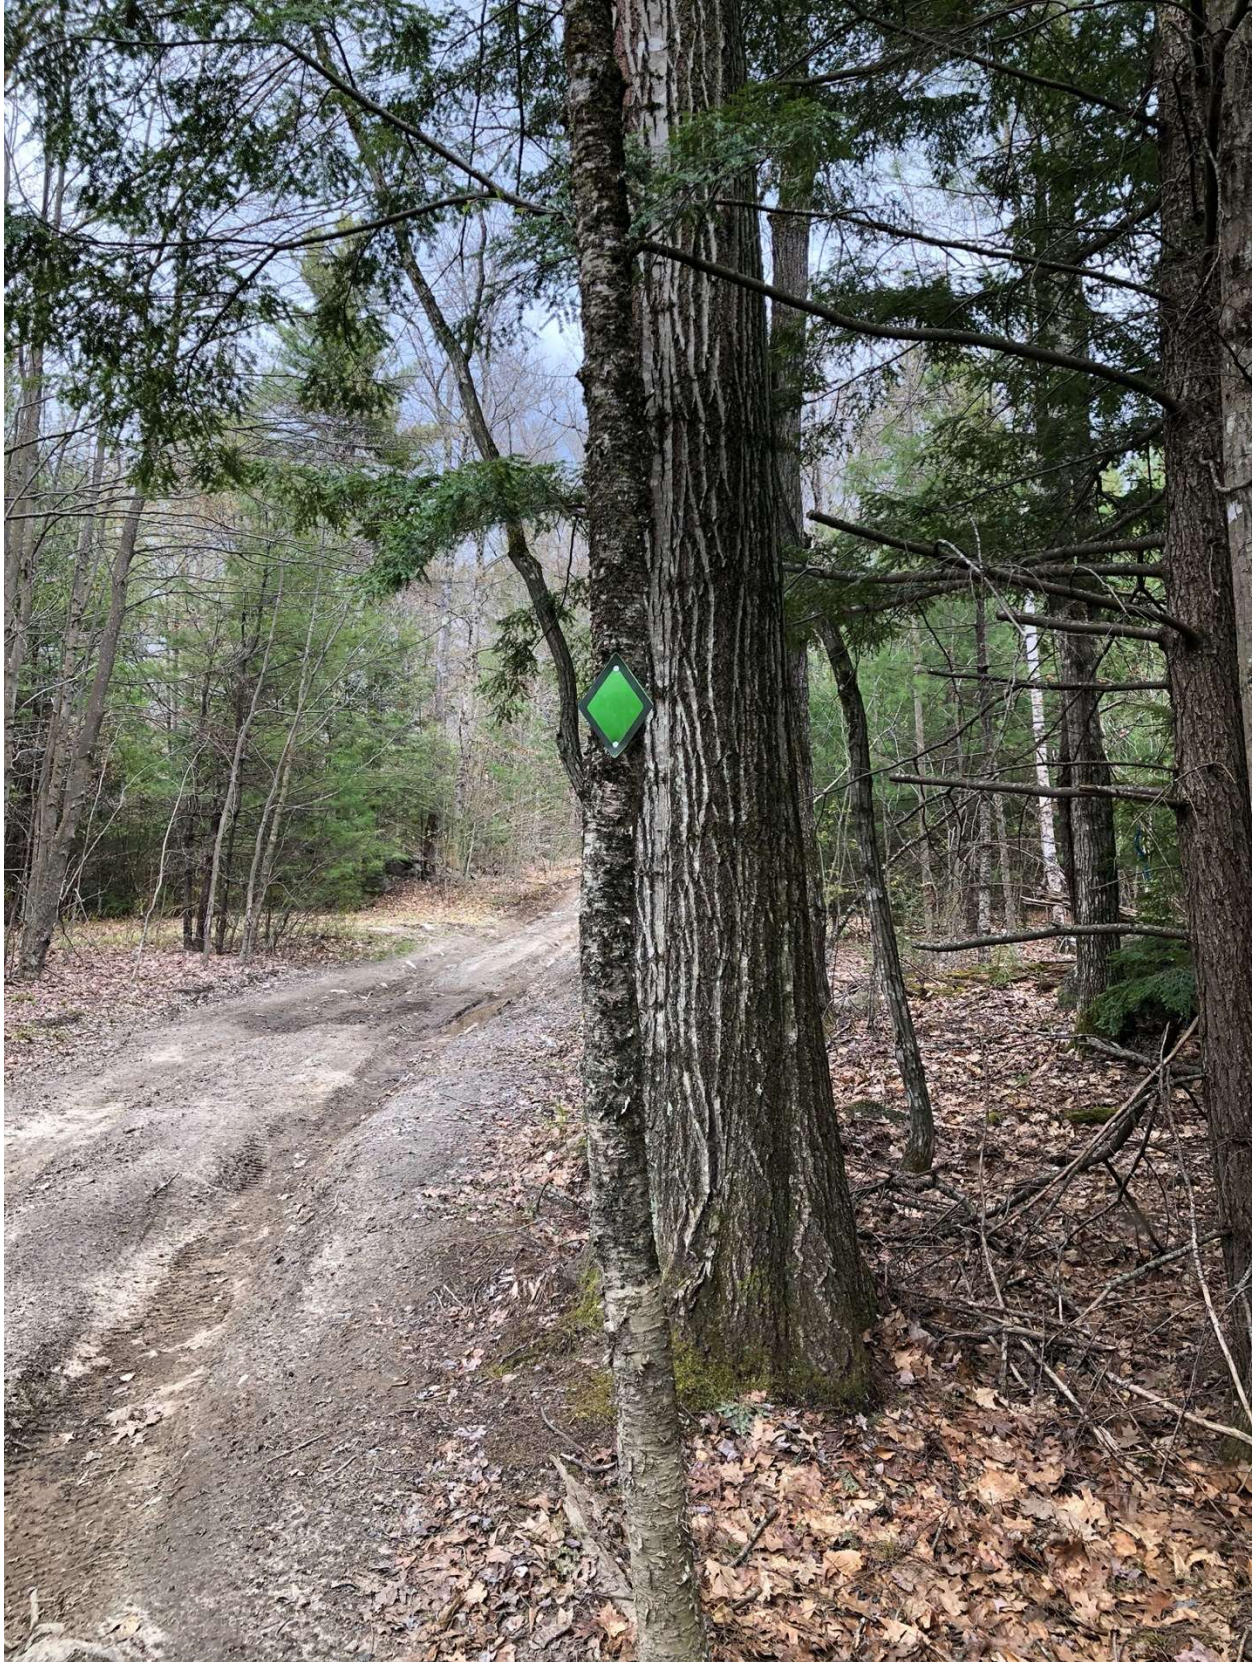
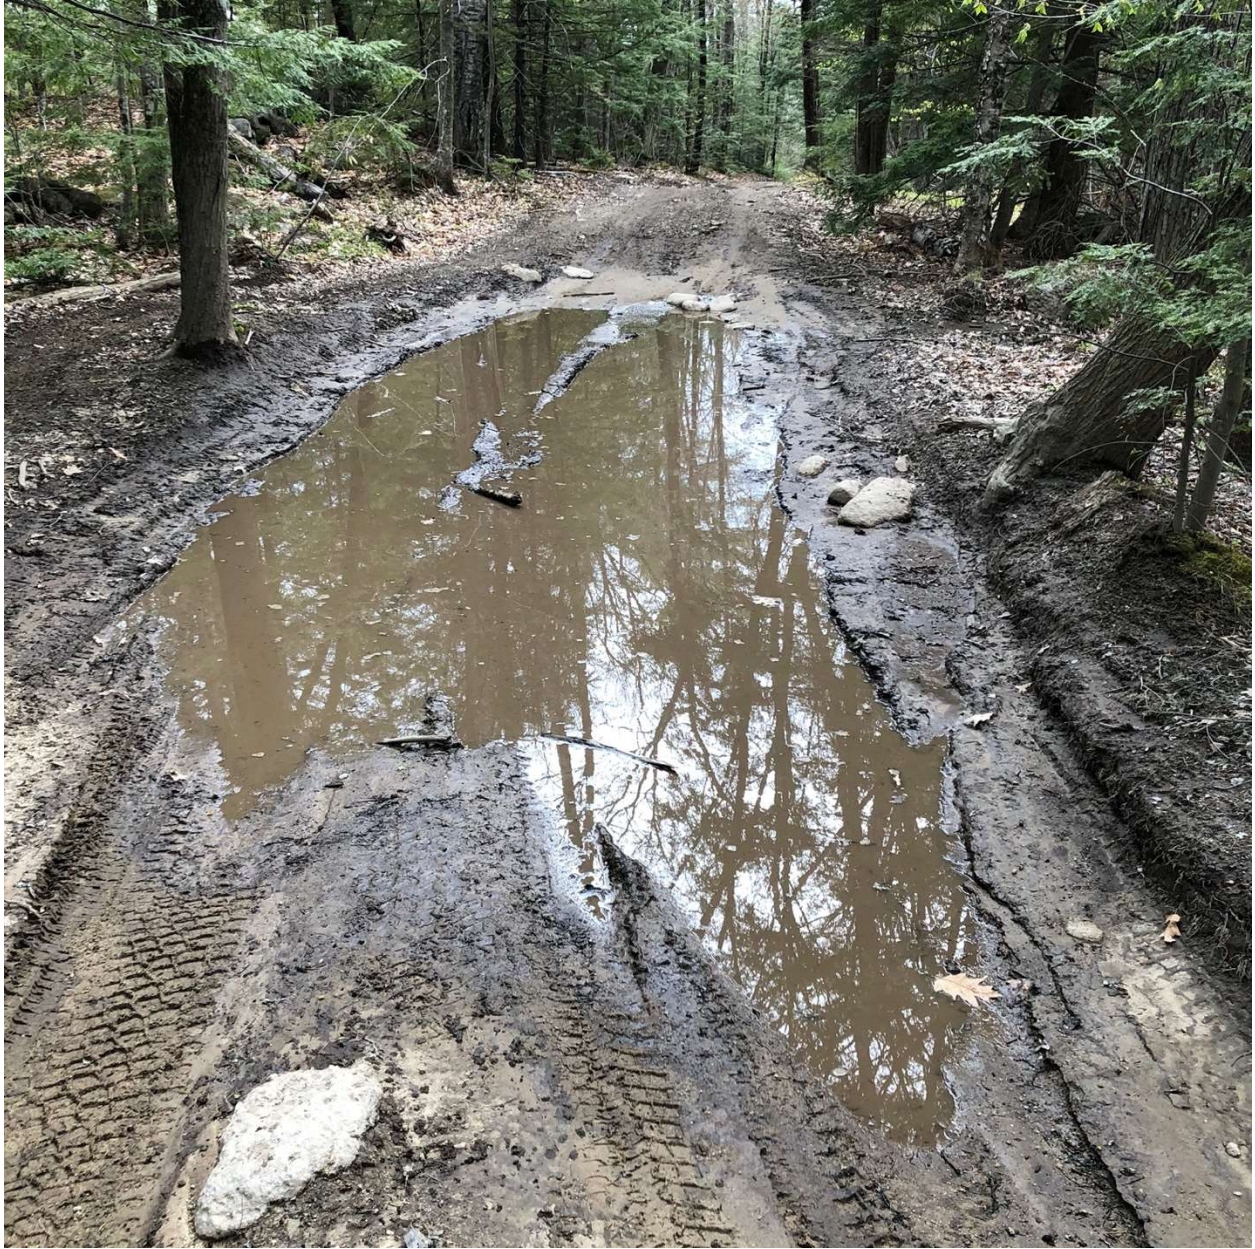
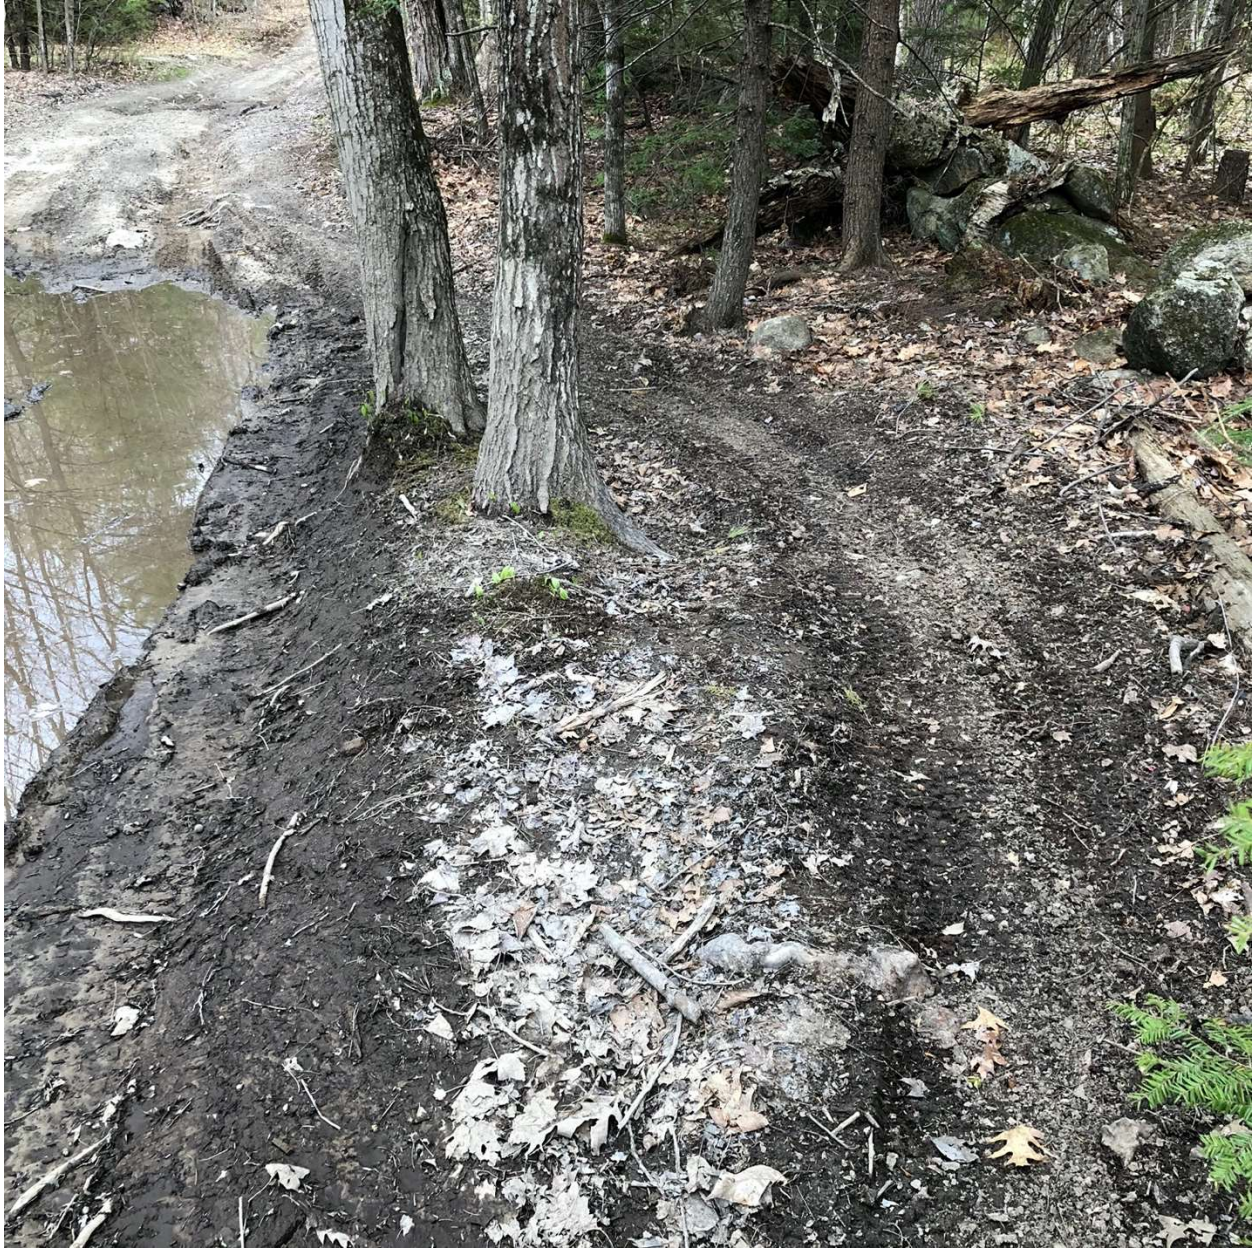
Erosion: Section closest to Henniker has significant erosion. Multiple large mud puddles encountered with vehicle tracks extending the road on both sides (see picture 2). Crushed rock placed on Bradford end makes road a more stable.

Recreational Vehicle Trail Signage: There are "No ATVs/Dirt Bikes" signs placed at the junction of Day Pond Road and Liberty Road. End of ATV trail sign previously installed at the Bradford/Henniker town line is again missing. Will contact Jennifer McCourt at the Contoocook Valley ATV Club regarding a replacement. Also, noted was a green diamond shaped sign (see picture 1) which appears to be new, located about 50 feet on the Bradford side of the town line.

Motorized/Non-motorized Activities: Embankment damaged as noted above. No ATV activity directly observed at this time, however, mud bike tracks were seen in several locations (see picture 3).

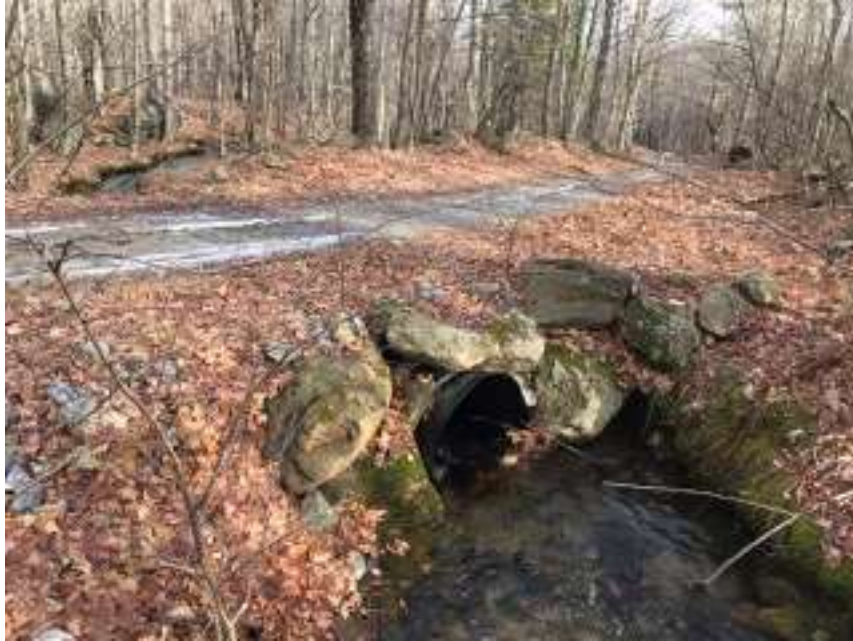
3' culvert at top of first hill – Mile 0.6

Mile 0.4 to 0.6 - The road crosses the brook and climbs a steep hill to another stream crossing. This section of road has washed out and subsequently rebuilt by abutters at least three times in the last thirty years, to provide access for forest management. It is currently in "GOOD" condition — the three-foot culvert now at the top is holding, but water bars on the hill are starting to fill and some erosion has started.

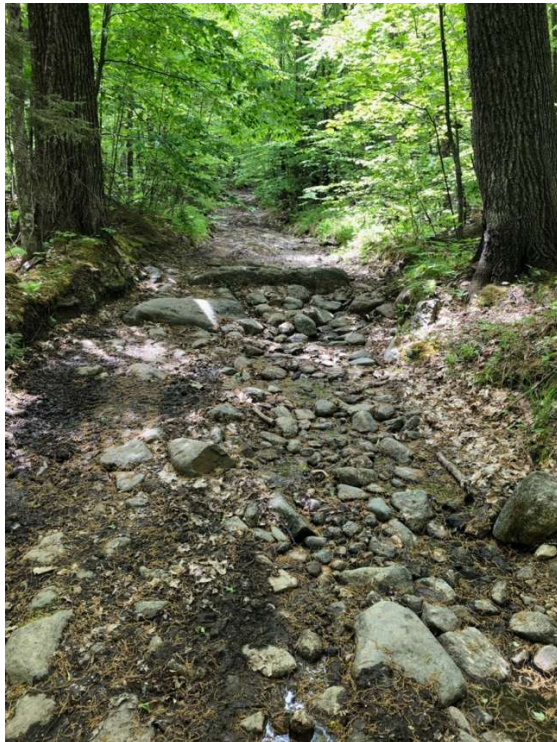
Looking west from Mile 0.9 (after Butler camp)

Mile 0.9 to 1.2 - From the Butler driveway to the Washington town line, the road is in "POOR" condition. The roadway has become a stream bed flowing for much of the year, and it has eroded to boulders, rocks and cobbles.

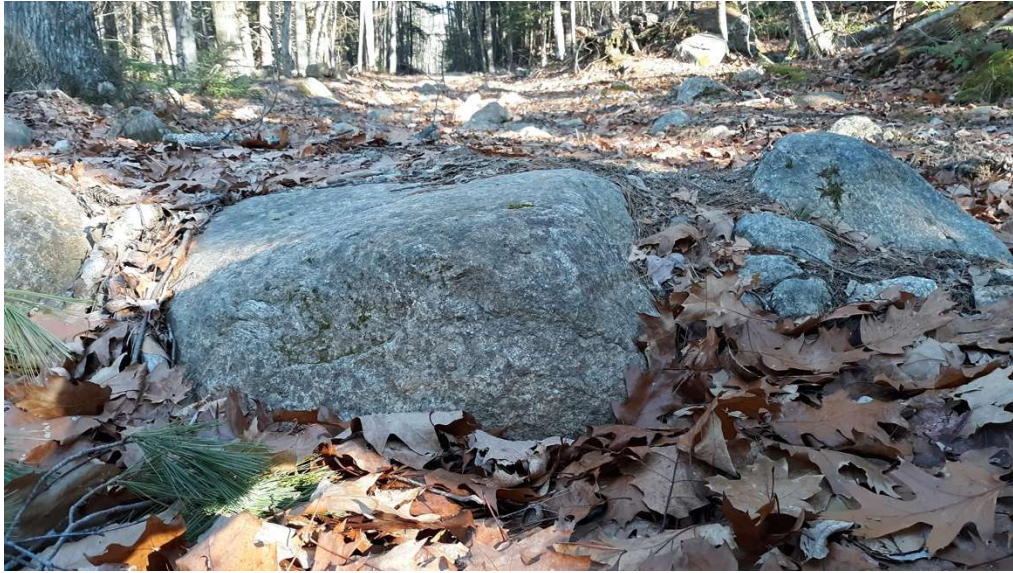
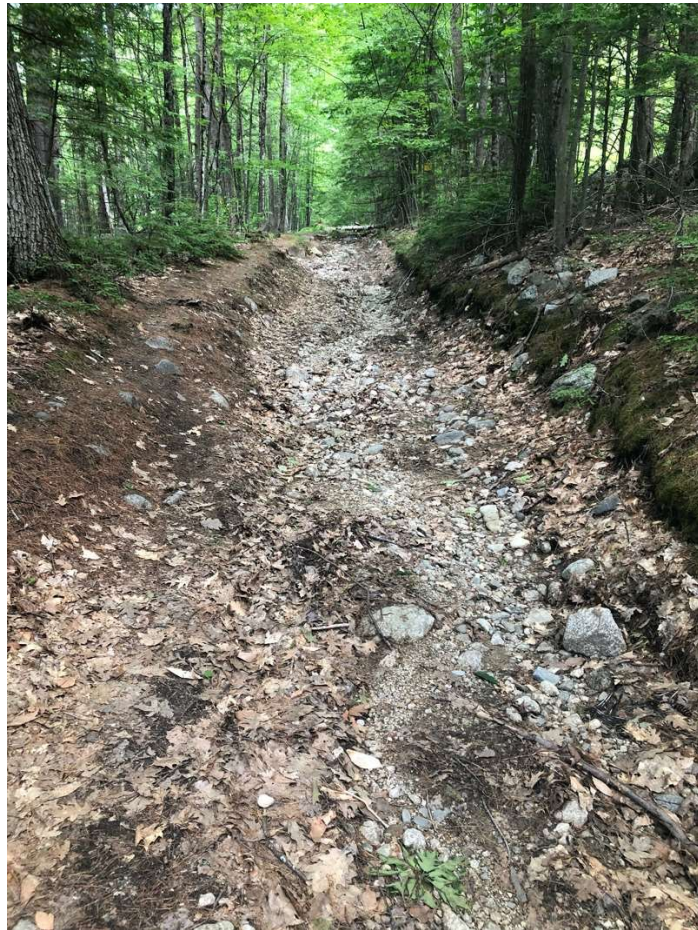
- The first 100 yards is in Good condition with evidence of crushed rock being added in recent years (probably associated with logging operations).
- As one goes further up the road the road becomes washed out with large rocks. Further up still there are several water beds that have cut across the roadway making it pretty well impassable. Most of this road is Fair with several short areas bordering on Poor.

Erosion: As noted above, this road is heavily eroded with portions appearing to serve seasonally as a creek bed.

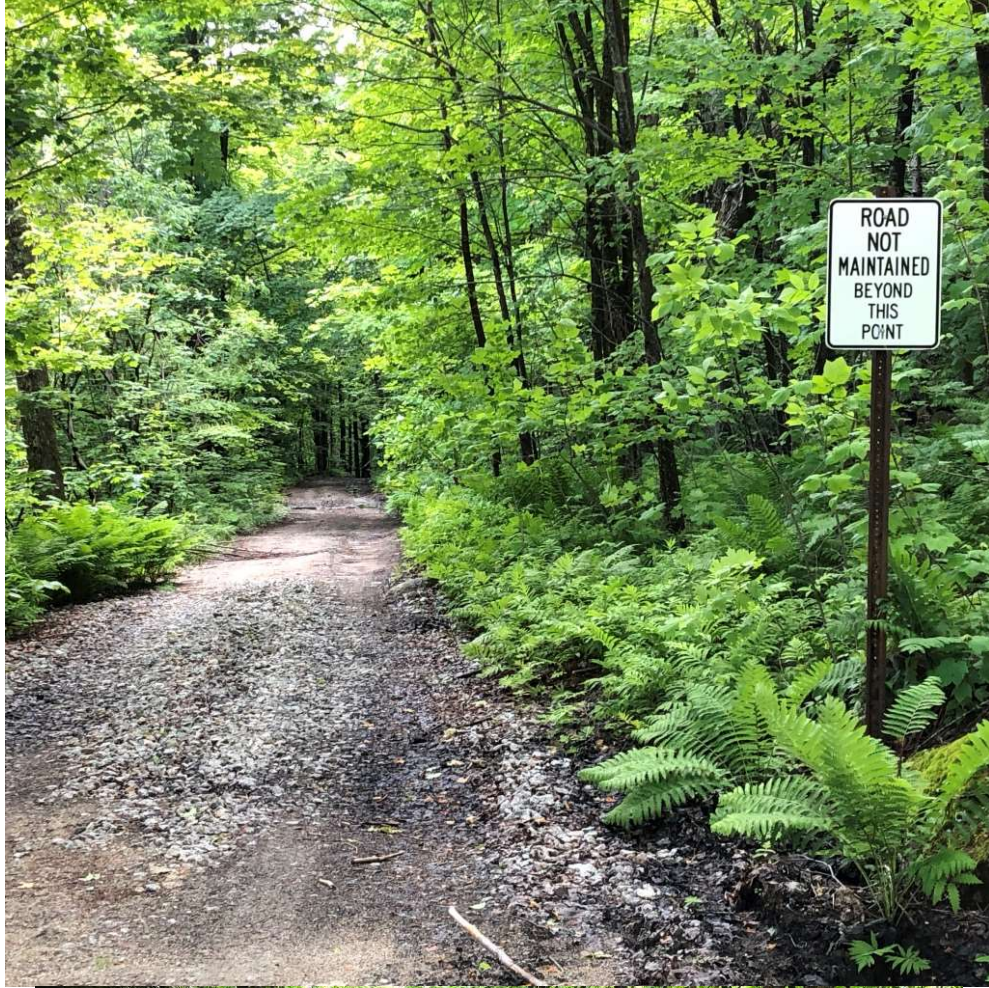
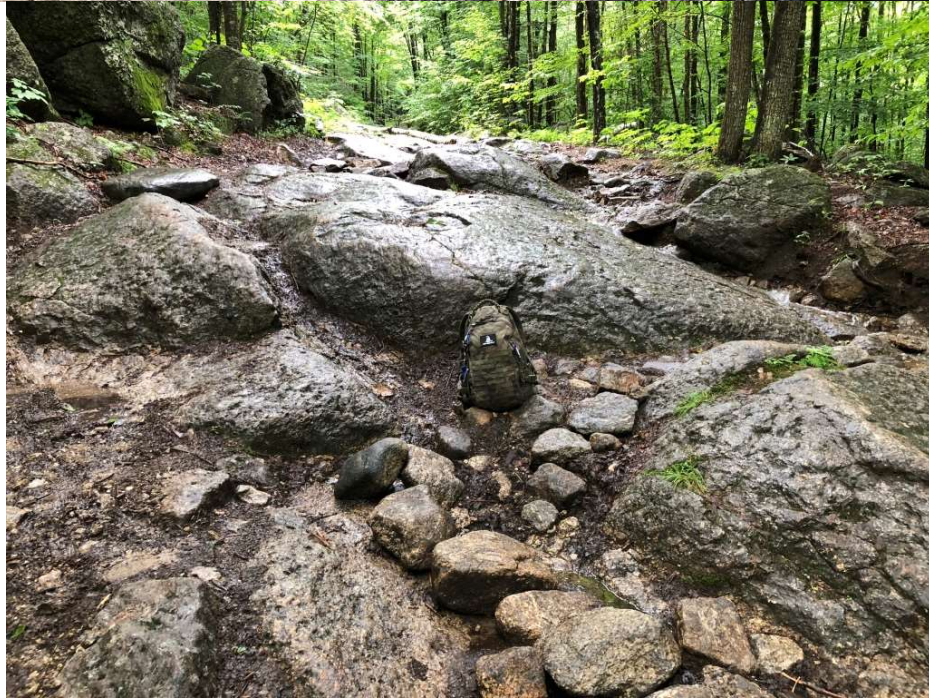
- 0.65 Snowmobile detour to the left (Northside).
- 0.75 Road conditions deteriorate substantially. Gentle downslope with significant rock outcropping, ledge and general erosion. Road condition is "POOR". See pictures.

Erosion: Entire road suffers from erosion, however, the section from 0.75 to 0.94 is extremely eroded. Rocks/ledge drops of 1-2 feet are frequent in this section.
