# *Adopt a Road*

Bradford Conservation Commission

Fall 2020 Report

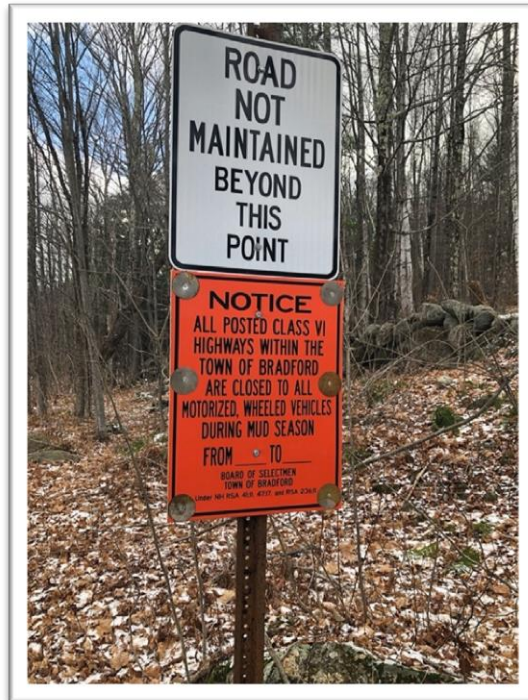
- The Select Board has decided to enforce an ordinance directing closure of Class VI roads during the Spring mud season. Signs to that effect are now being installed (see cover picture).
- Increased ATV, 4X4 and mud bike traffic is reported on a number of roads with damage reported on Carter Hill and Pierce Roads.
- Purrington Road is now monitored and included on the Class VI road map.

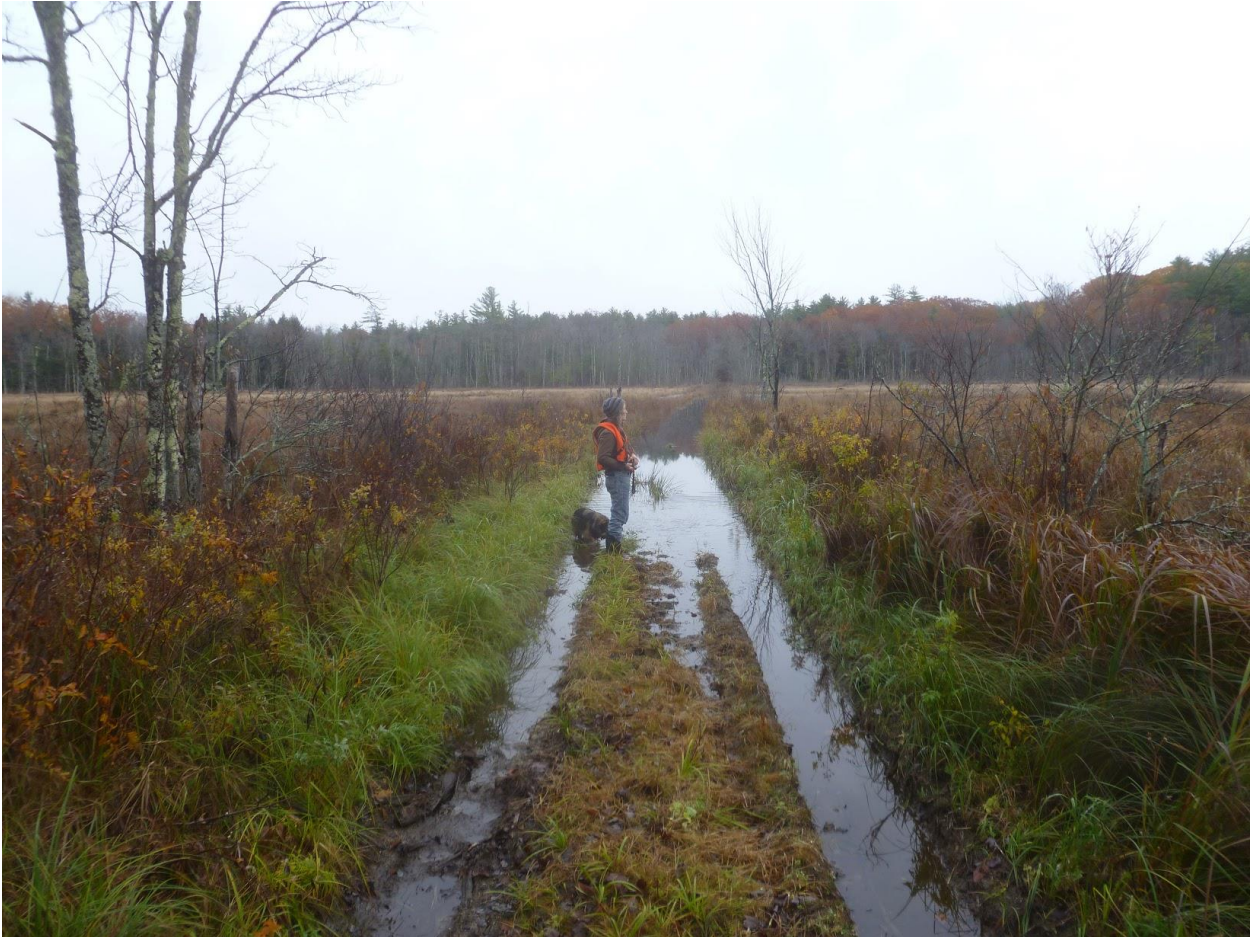
0.25	Up until this point, road is in Good condition with placement of crushed rock. A small building is encountered on the left side of the road which appeared to be occupied in the past. Numerous junk piles and cars/trucks along-side of the road.
0.75	Road surface is Fair to Good, reasonably flat, but with significant mud puddles. One culvert juts up from the road surface.
1.0	Road continues to be in Fair to Good condition, but ends in water at approximately 1 mile (see pic).

Obstructions: Standing water in some areas of the road as previously noted.

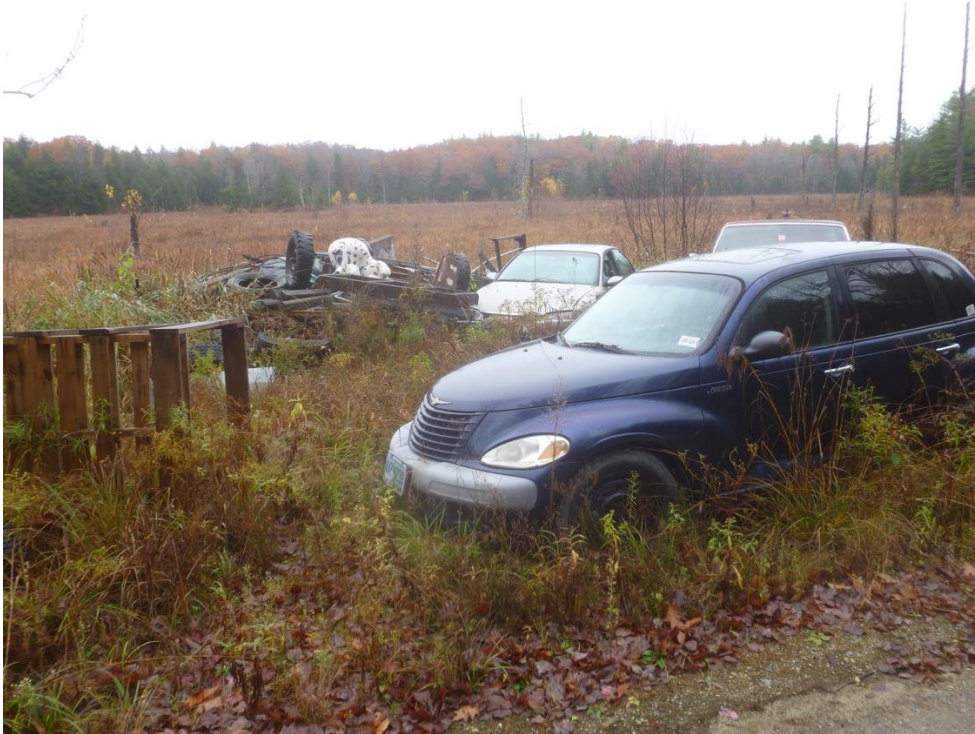
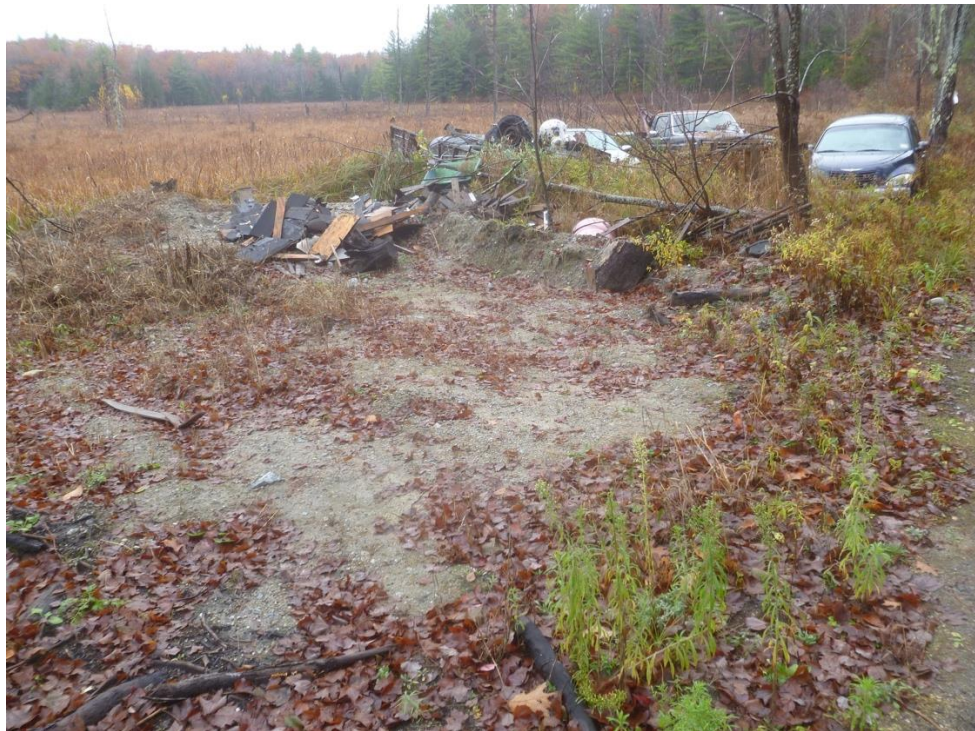
Trash/Dumping: The junk and trash piles looked the similar to the report of Fall 2019. One pile may be somewhat lower than before.

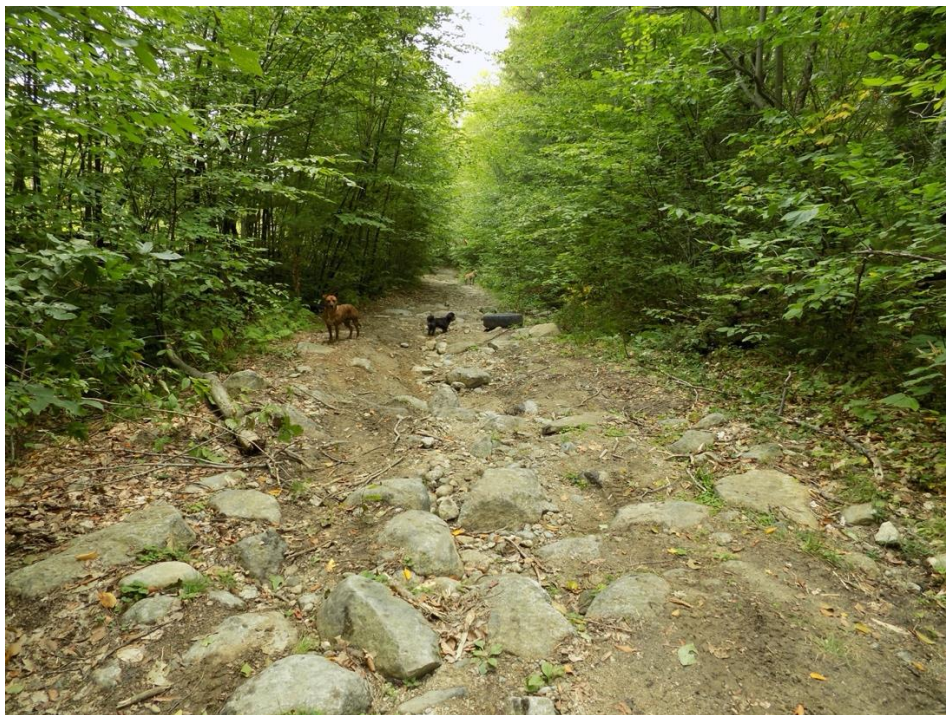
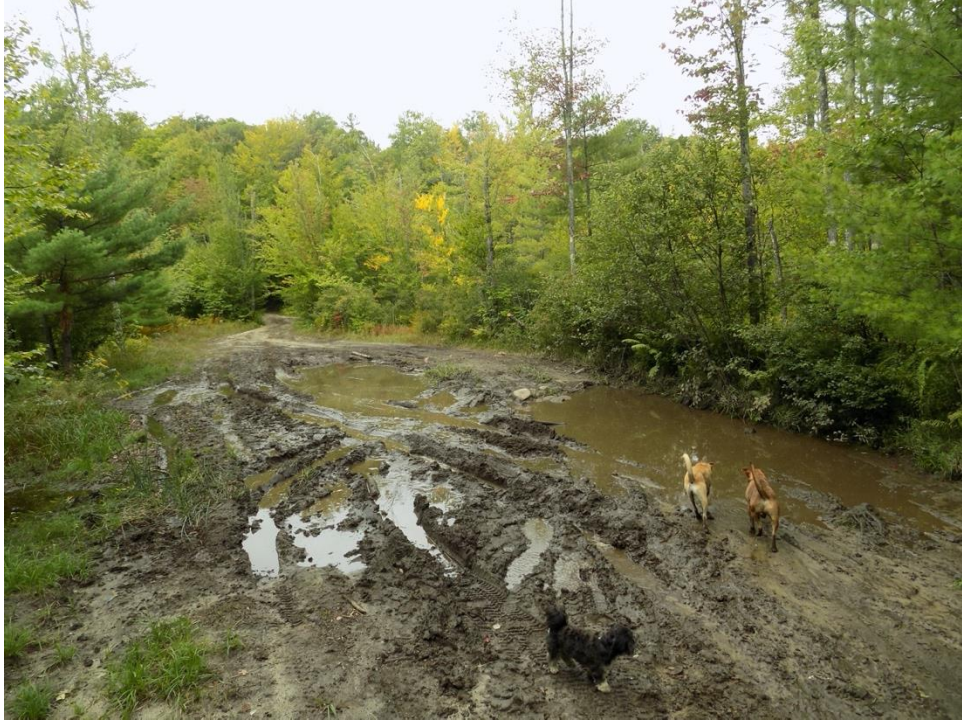
Obstructions: One low lying area has roughly 6 inches to 2 feet of muddy water, perhaps 50ft by 30ft (see picture). \*Update\* Mud hole hasn't seemed to increase in size, but another bypass has been cut through the low-lying forest to allow ATVs to pass. The cut section is too small for Jeep's.

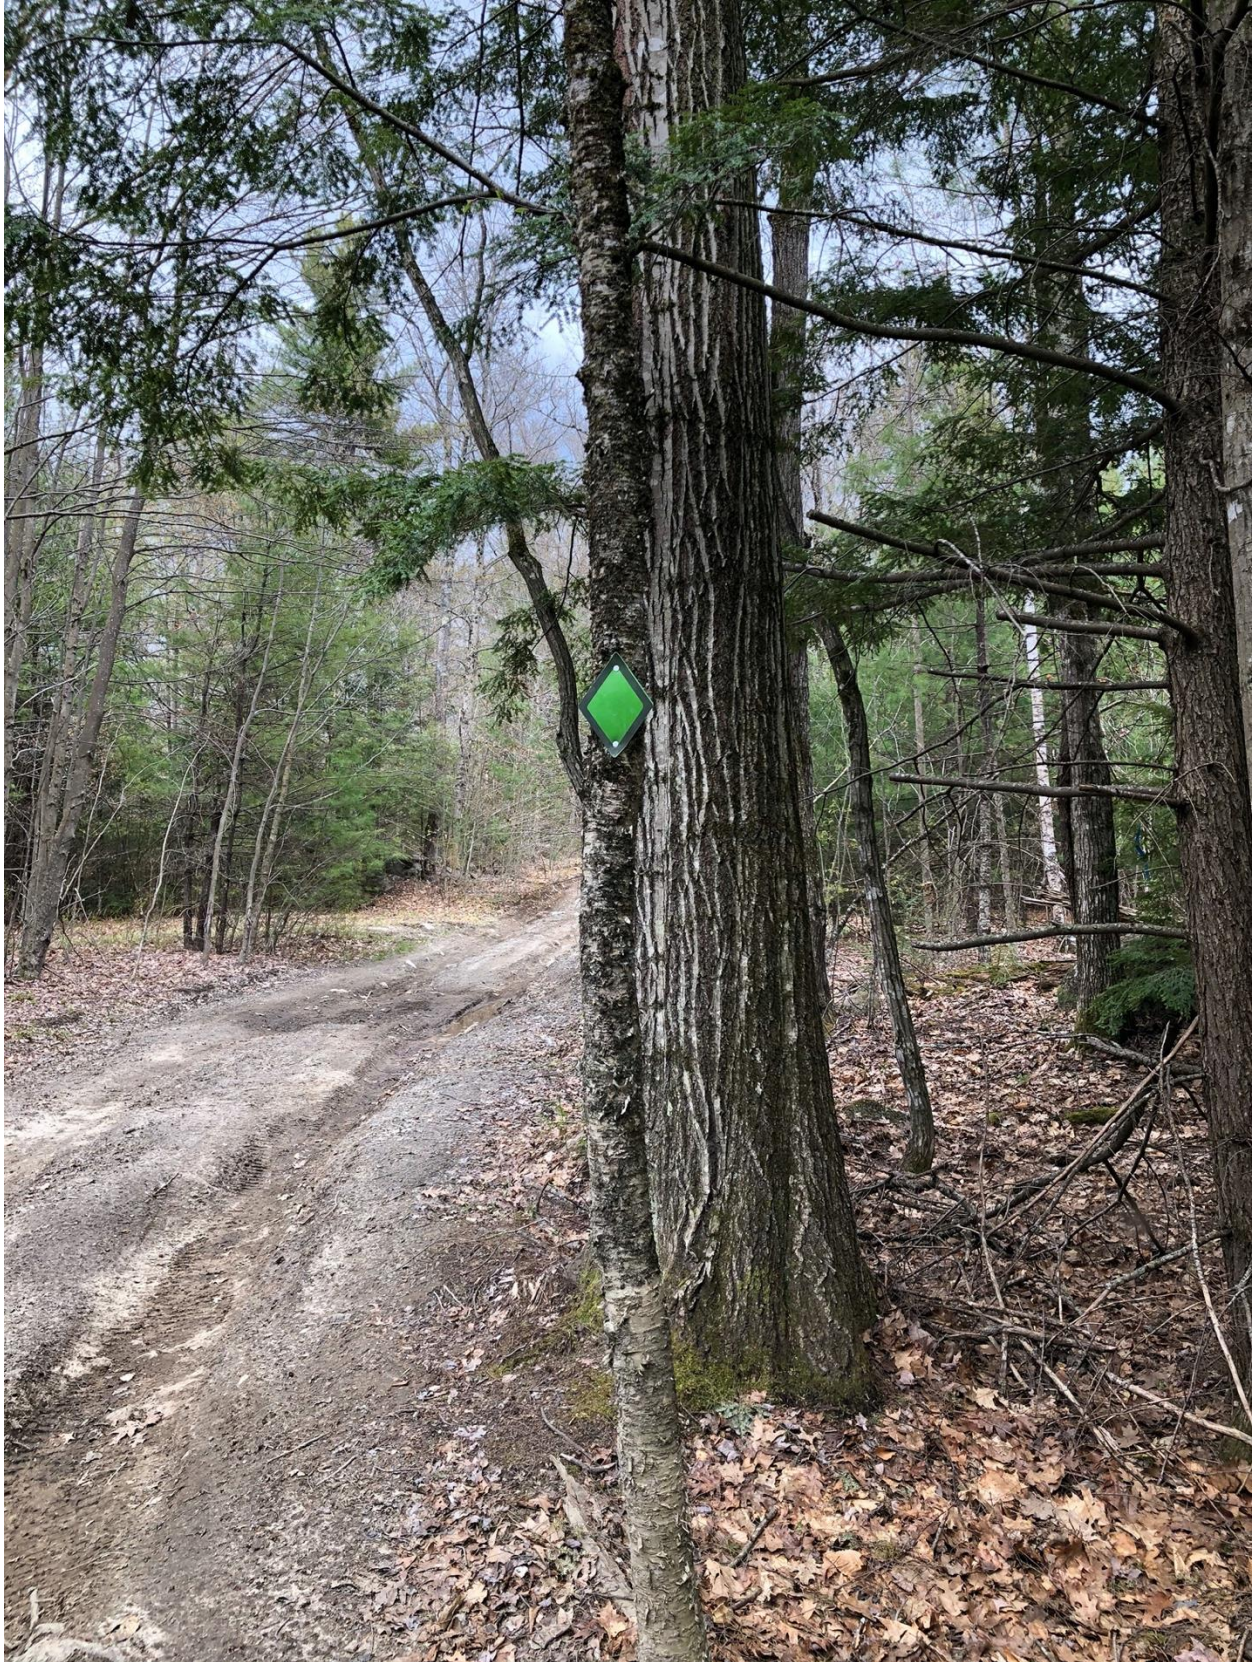
Recreational Vehicle Trail Signage: There are "No ATVs/Dirt Bikes" signs placed at the junction of Day Pond Road and Liberty Road. End of ATV trail sign previously installed at the Bradford/Henniker town line is again missing. Jennifer McCourt at the Contoocook Valley ATV Club has been contacted regarding a replacement. Also, noted was a green diamond shaped sign (see picture 1) which appears to be new, located about 50 feet on the Bradford side of the town line.

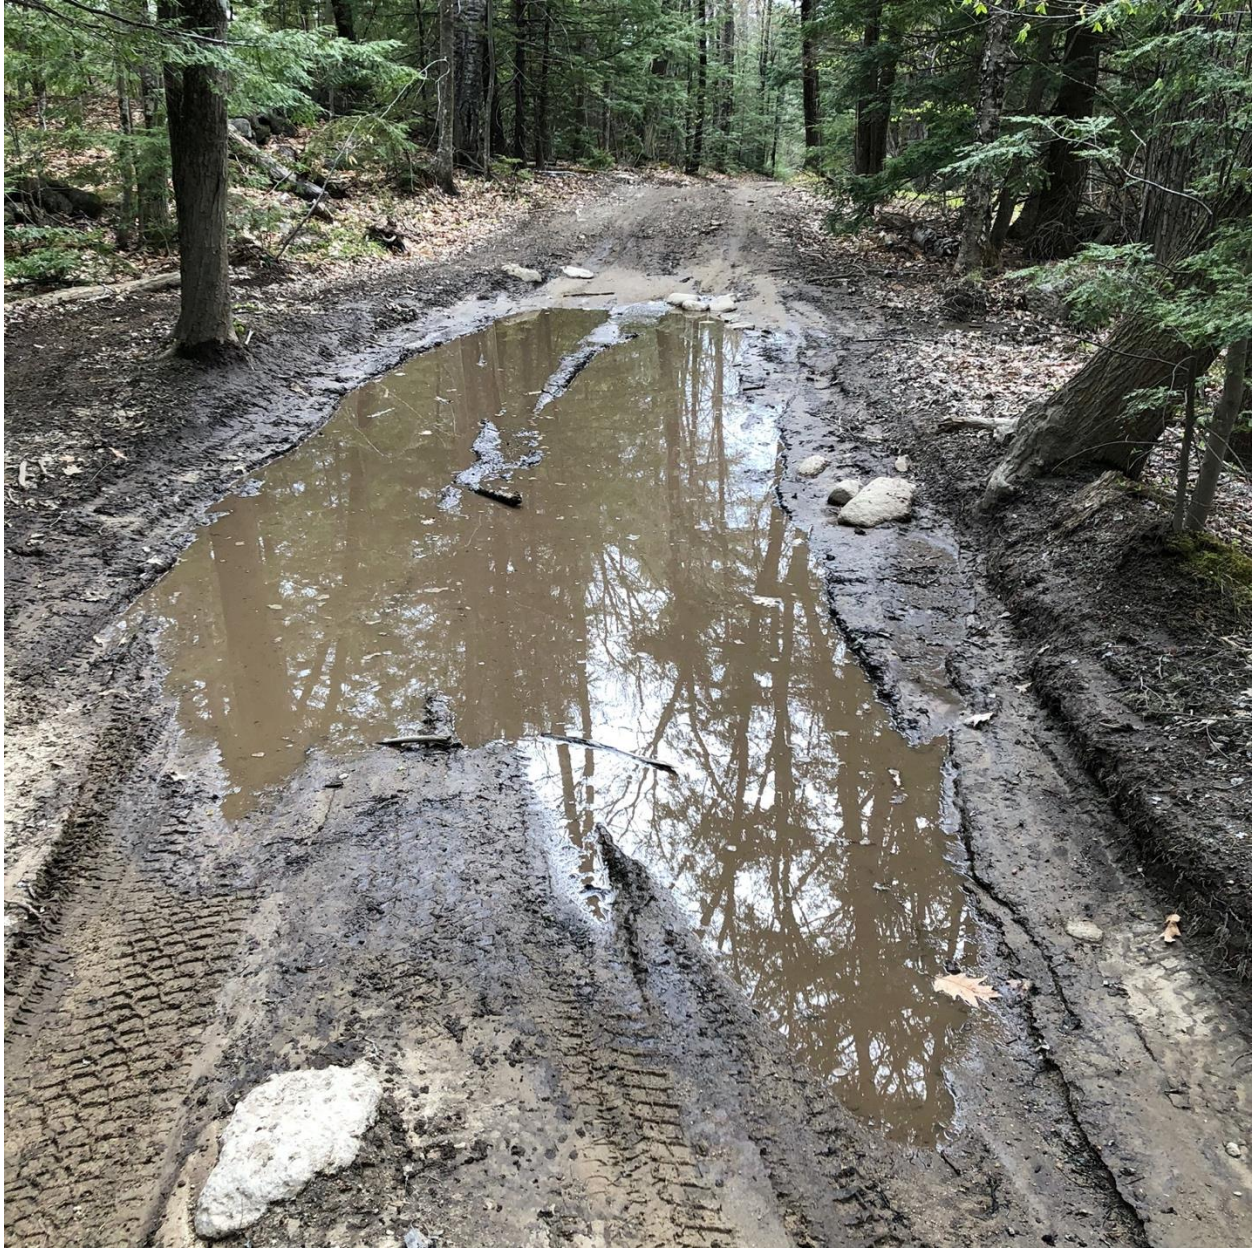
Erosion: Section closest to Henniker has significant erosion. Multiple large mud puddles encountered with vehicle tracks extending the road on both sides (see picture 2). Crushed rock placed on Bradford end makes road a more stable.

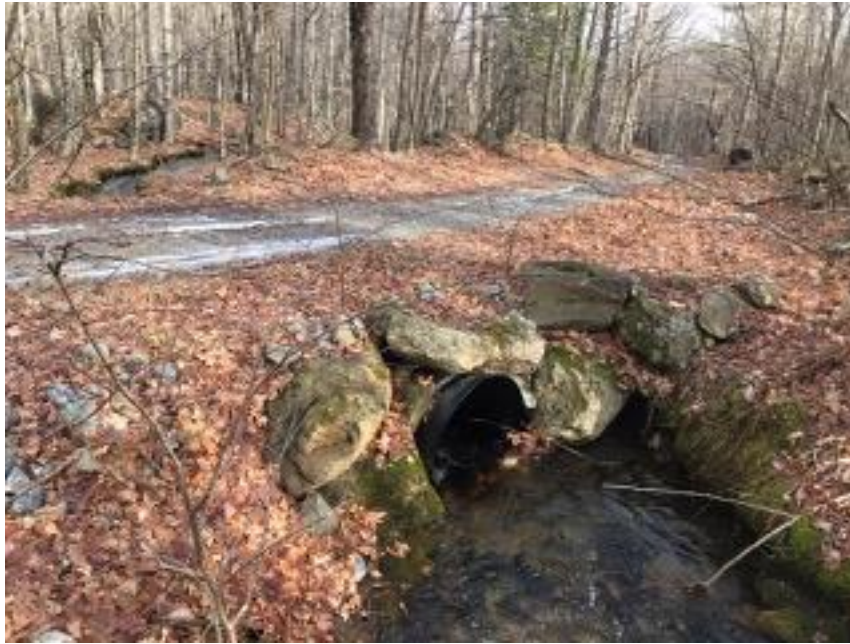
3' culvert at top of first hill – Mile 0.6

Mile 0.4 to 0.6 - The road crosses the brook and climbs a steep hill to another stream crossing. This section of road has washed out and subsequently rebuilt by abutters at least three times in the last thirty years, to provide access for forest management. It is currently in "GOOD" condition — the three-foot culvert now at the top is holding, but water bars on the hill are starting to fill and some erosion has started.

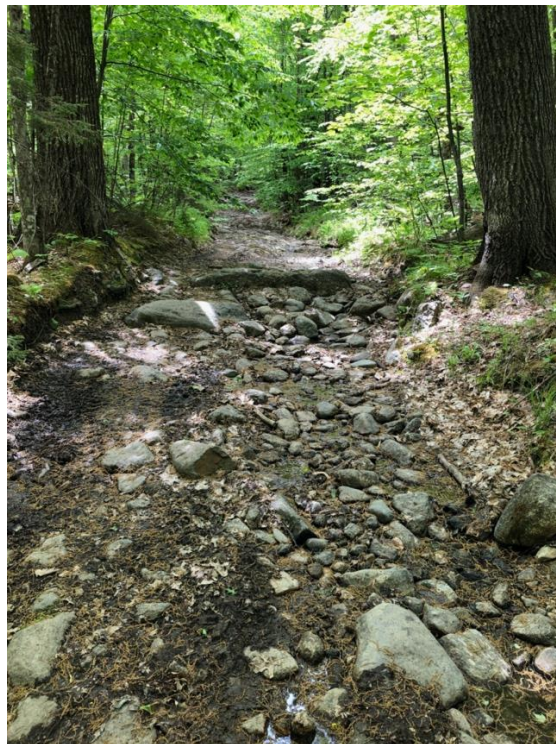
Looking west from Mile 0.9 (after Butler camp)

Mile 0.9 to 1.2 - From the Butler driveway to the Washington town line, the road is in "POOR" condition. The roadway has become a stream bed flowing for much of the year, and it has eroded to boulders, rocks and cobbles.
