Adopt a Road

Bradford Conservation Commission
Summer 2023 Report

July 15, 2023

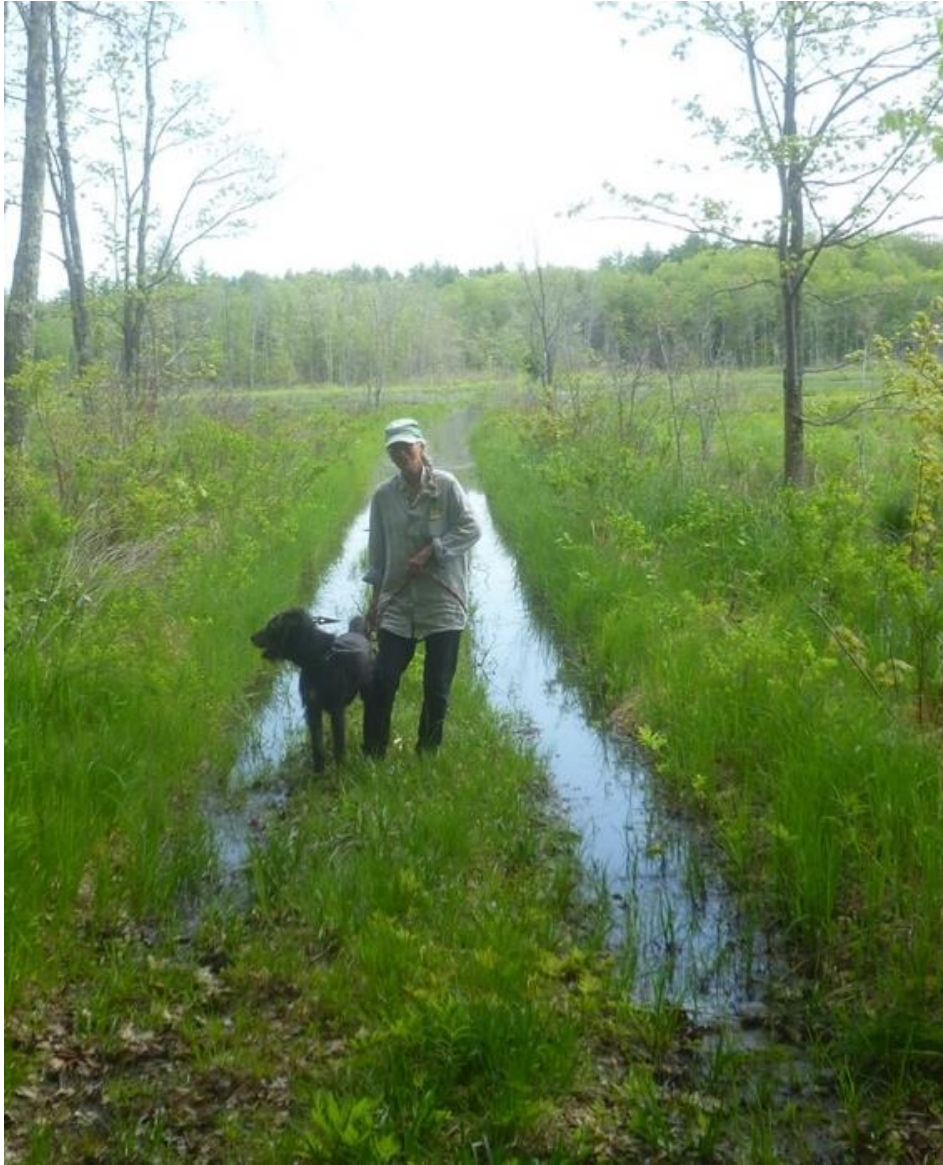
0.25	Up until this point, road is in Good condition with placement of crushed rock. A small building is encountered on the left side of the road which appeared to be occupied in the past. Numerous junk piles and cars/trucks along-side of the road.
0.75	Road surface is Fair to Good, reasonably flat, but with significant mud puddles. One culvert juts up from the road surface.
1.0	Road continues to be in Fair to Good condition, but ends in water at approximately 1 mile (see pic).

0.1 miles	Road is reasonably flat and in Fair to Good condition with mud puddles. Road ends in water as was the case from the entrance via East Washington Road.
Erosion:	Modest amount of erosion as the road surface and surrounding land are relatively flat. However, there are numerous mud puddles. No significant changes to the road condition from 2022.

Obstructions: Standing water in some areas of the road as previously noted.

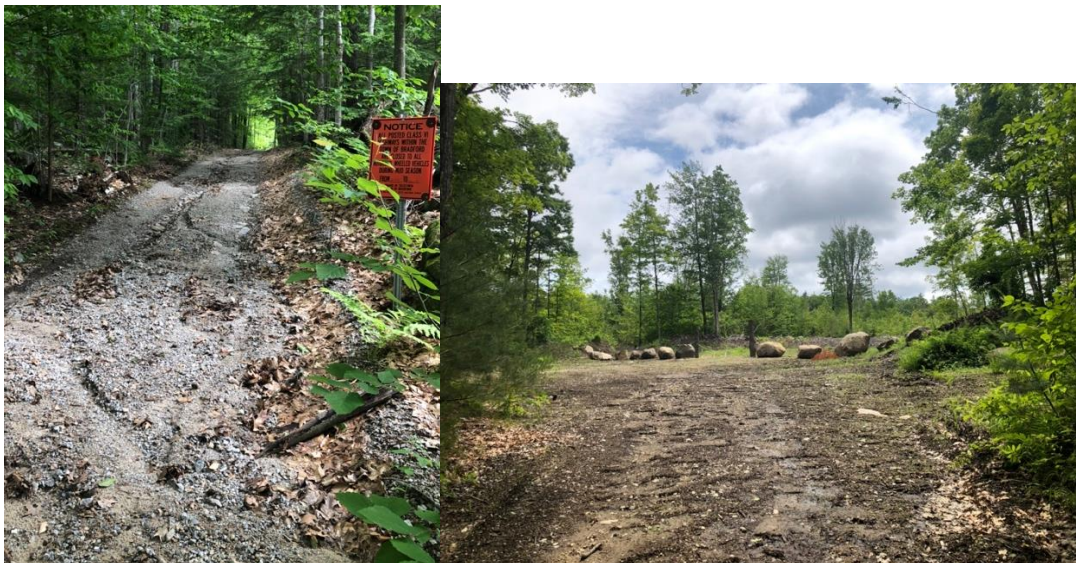
The Class VI section of Blaisdell Hill Road appears to begin just after the Conforti-Adams house and runs along the Bradford/Warner town line for approximately 0.2 miles. It is in FAIR to GOOD condition. There is a Town of Bradford Mud Season sign present at beginning. No evidence of where the Bradford/Warner town line crosses the road was found, making the length of Bradford's section approximate.

Erosion: First .1 miles has had gravel upgrade, but erosion already noted. Significant logging has been done in the past year. Multiple mud holes/puddles seen in various places.

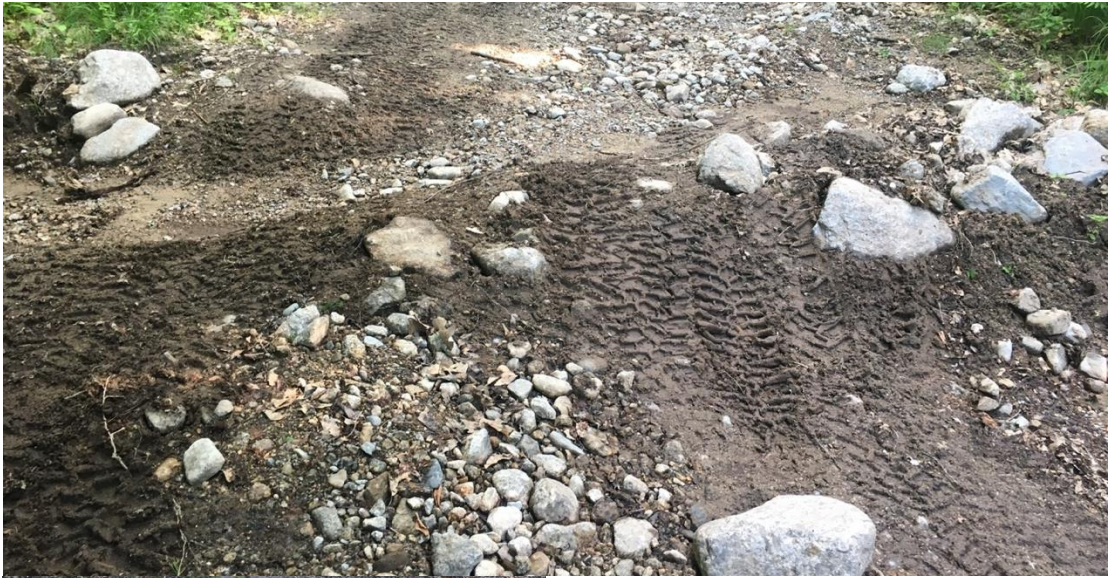
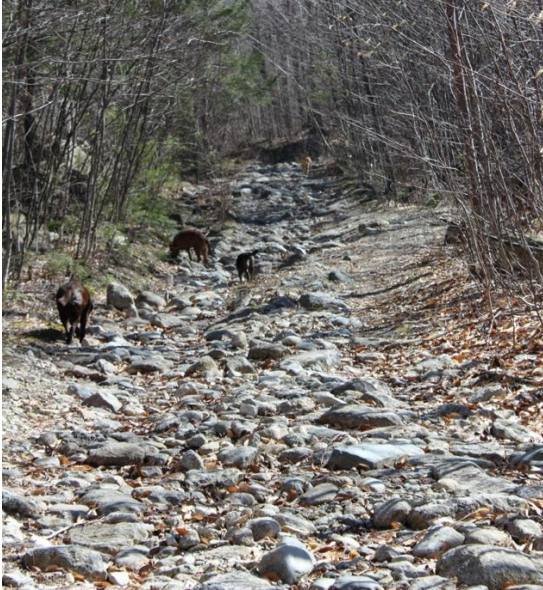
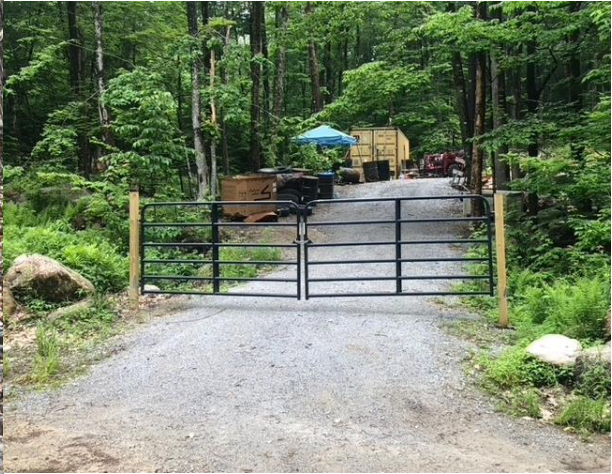
0.55 - 0.6 miles: Large, moderately deep mud wallow, ~2' deep, about 30' x 50' in diameter.

Erosion: Significant erosion from beginning to Hillsborough town line. Some sections essentially impassable except by articulated suspension. Some small bypasses have been cut into the adjacent woods to circumvent the worst sections. Overall, relatively unchanged since 2022 with the exception that someone has made a water barre across the road approximately 30 to 40 yards in from Massasecum Ave.

Obstructions: One low lying area has roughly 6 inches to 2 feet of muddy water, perhaps 50ft by 30ft (see picture). Mud hole hasn't seemed to increase in size, but another bypass has been cut through the low-lying forest to allow ATVs to pass. The cut section is too small for Jeep's.

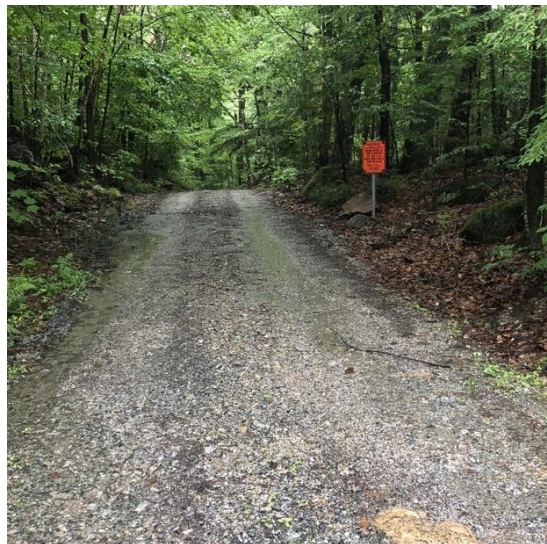
Erosion: As in previous years the first section of the road is well cared for by the residents on that section, beyond the homes the road is starting to wash on the hill. Not horrible yet, but that's how it starts. I did a little water bar work, but the first four-wheeler through will possibly negate that, and more should be done to complete the work.

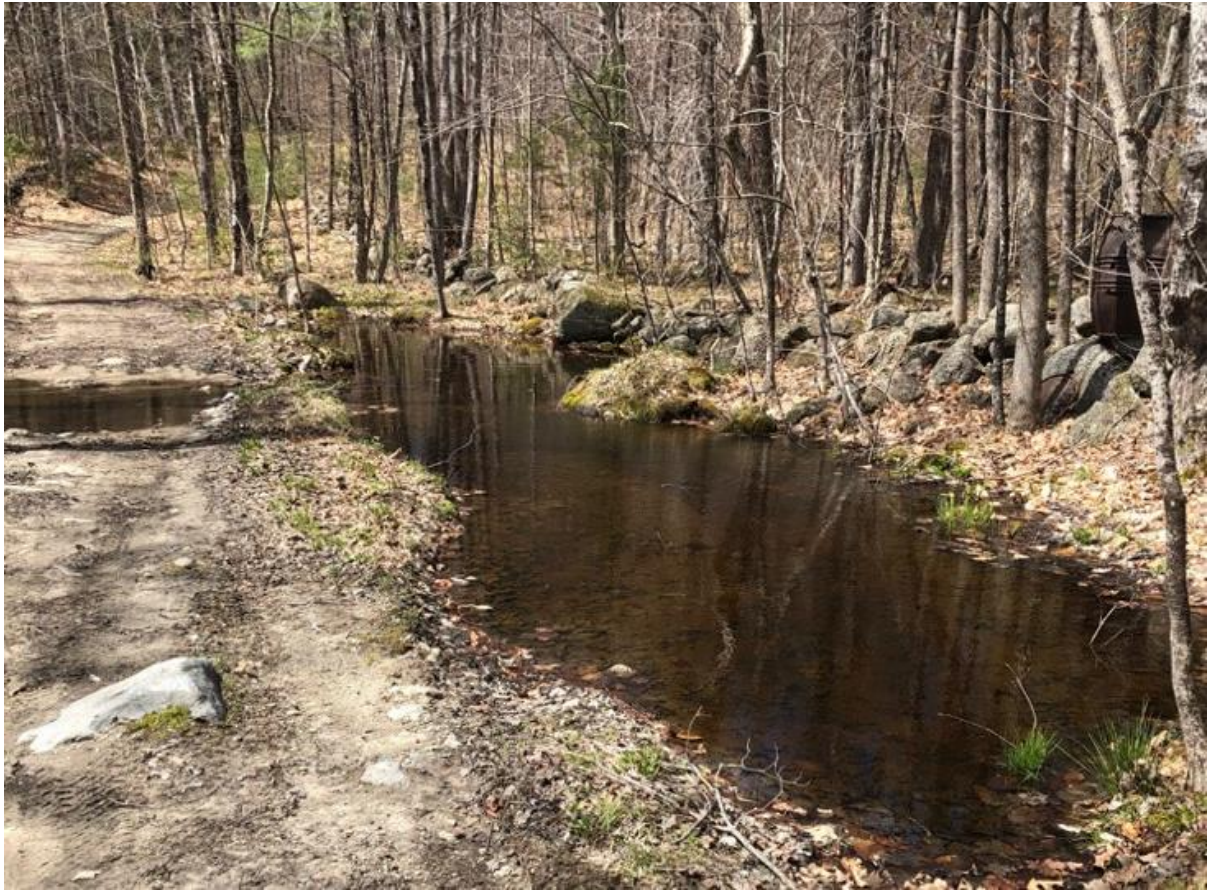
Erosion: Section closest to Rowe Mountain Road has significant erosion and rocks appear to be getting higher. Riprap placed on Liberty Hill end makes road a bit more stable, though erosion continues. Evidence of previous off-road ATV "mudding" on North side of road appears to be returning to more natural condition (see pic).

Motorized/Non-motorized Activities: Old off-road embankment damaged as noted above. No current activity directly observed.

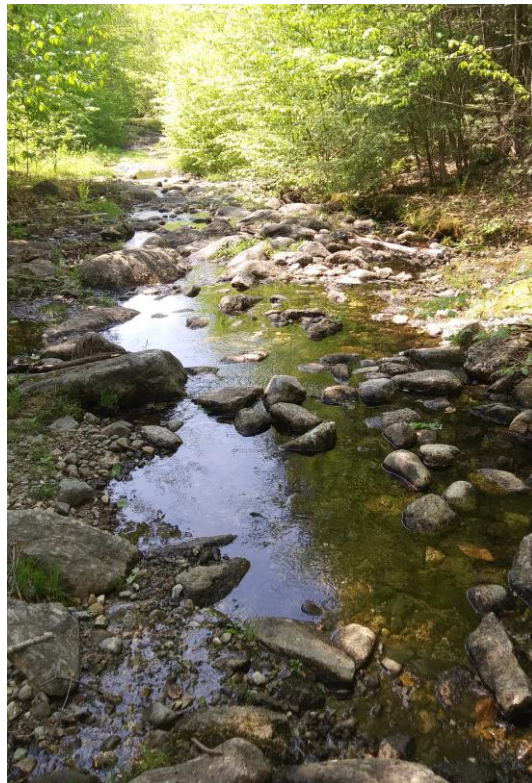
Erosion: Erosion continues in two sections of the road where the stream bed is the road. Most sections dry this year due to recent dry weather. No noticeable changes from last year. Road mostly Fair with two Poor sections.

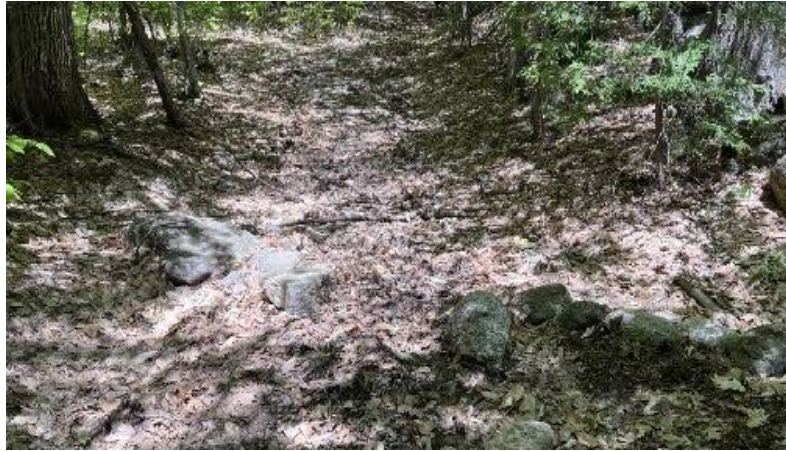
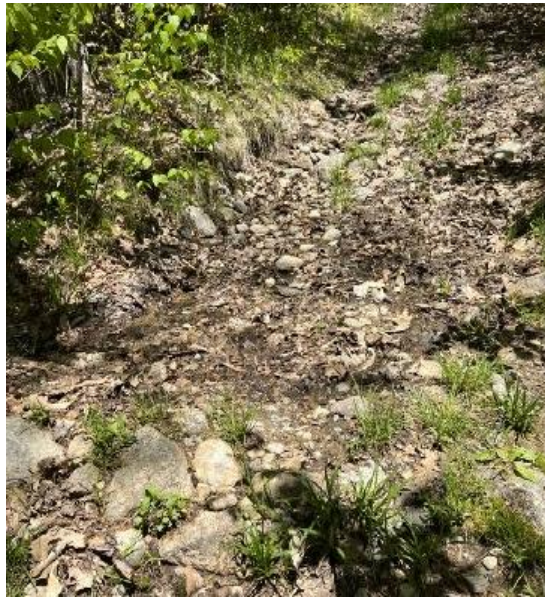
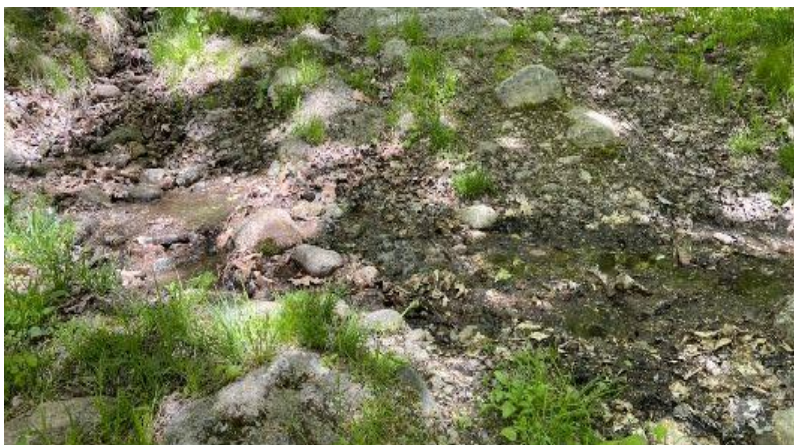
0.89 Roads starts heading downhill; condition moves back to Fair due to erosion. There is a path where water had run down the road, moving leaves out of its way, but road was not damaged by runoff. Photo below.

0.93 Road condition deteriorates to Poor with extensive washouts and large rocks.

Obstructions: Extensive and significant erosion on the Eastern section makes road essentially unpassable. None noted on the Western section.

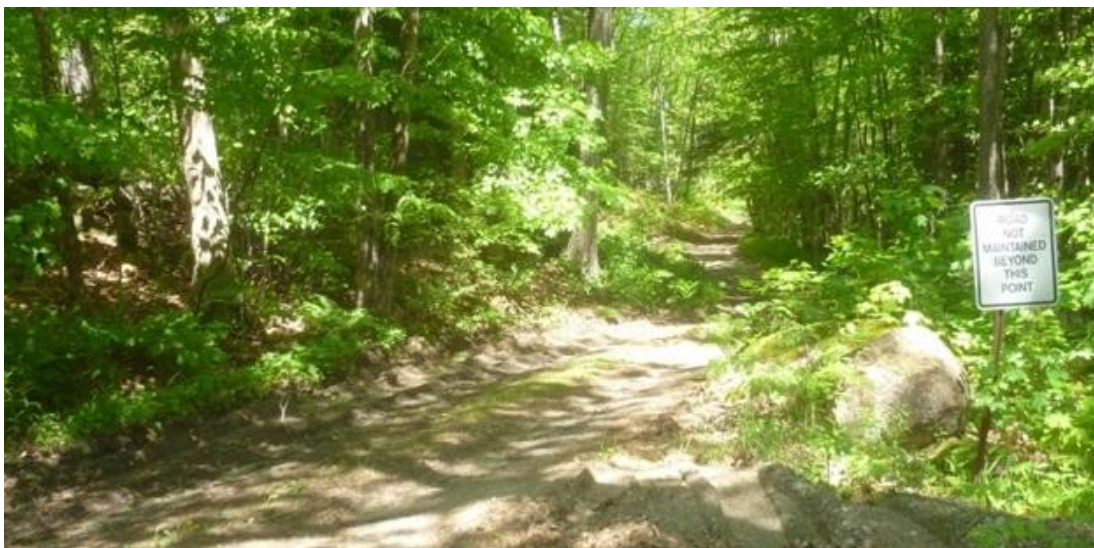
Erosion: Yes, in multiple places, notably around the driveway to 243. Overall, the road is Good with the exception of these mud holes. May 2023 monitoring noted that Jackson Road is unchanged except for a recent small wash out opposite the Thyng's house, but it is still passable.

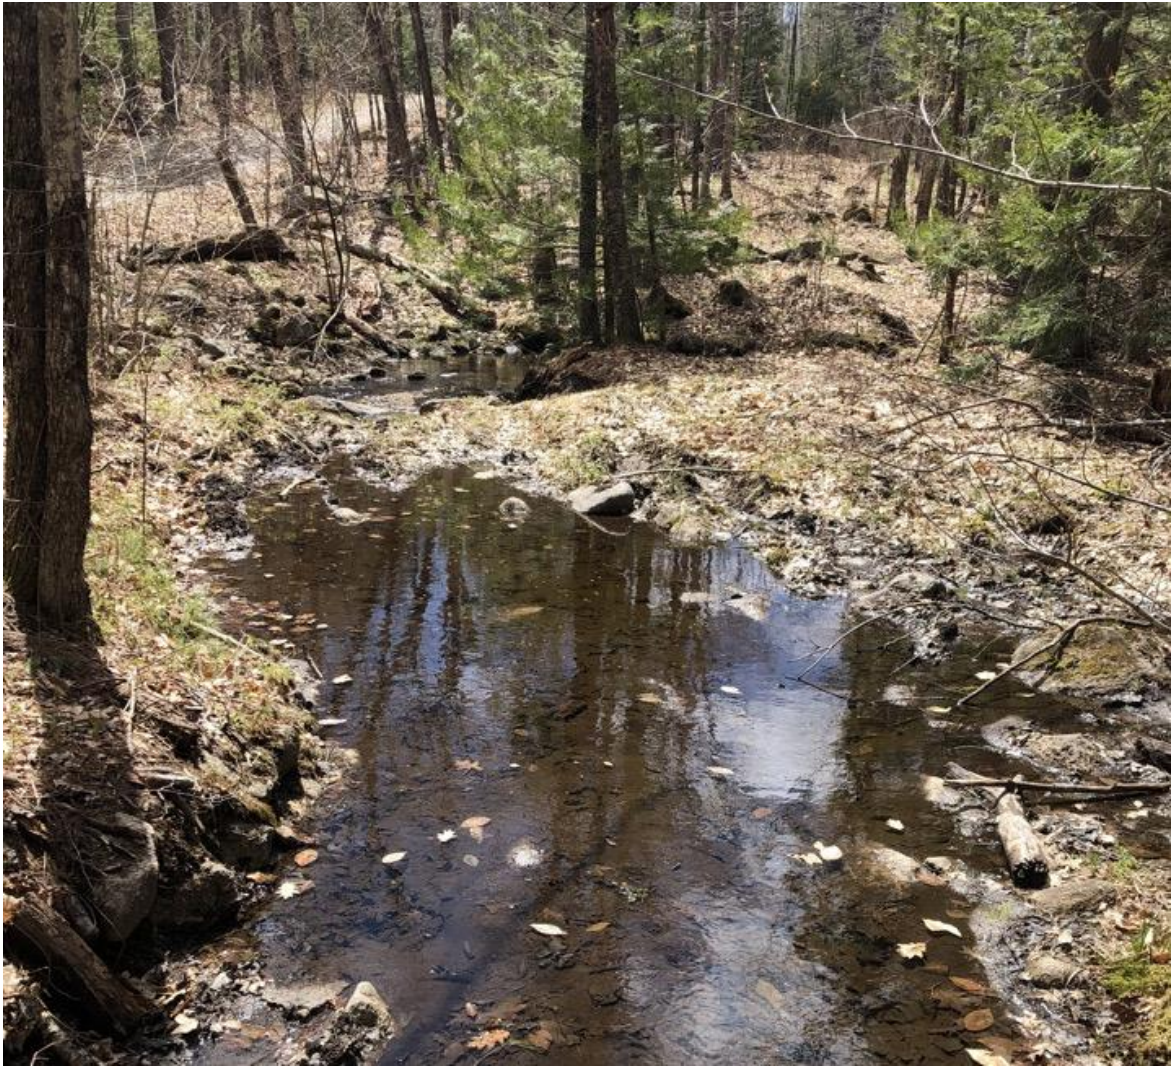
- 0.00 Road in Fair condition with frequent pools of water and rocks 4-8 inches high.
- 0.14 Rip-rap appears to have been placed secondary to a logging operation. Road is Fair to Good from this point forward.
- 0.2 Previous off-road damage to embankment on West side of a bridge over a small stream appears to be filling in and regrowing.
- 0.5 LHR ends at 4-way junction with Day Pond Road (both ways) and a private road.

Erosion: Section closest to Henniker has significant erosion. Multiple large mud puddles encountered with vehicle tracks extending the road on both sides. Crushed rock placed on Bradford end makes a more stable surface for the road. Off-road damage next to bridge appears to be healing with no sign of recent ATV "mudding".

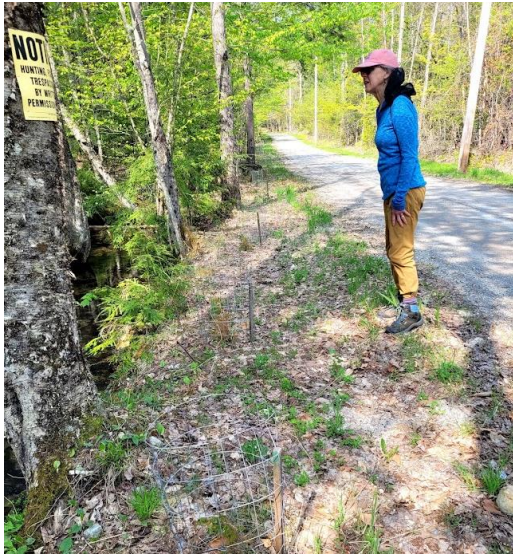
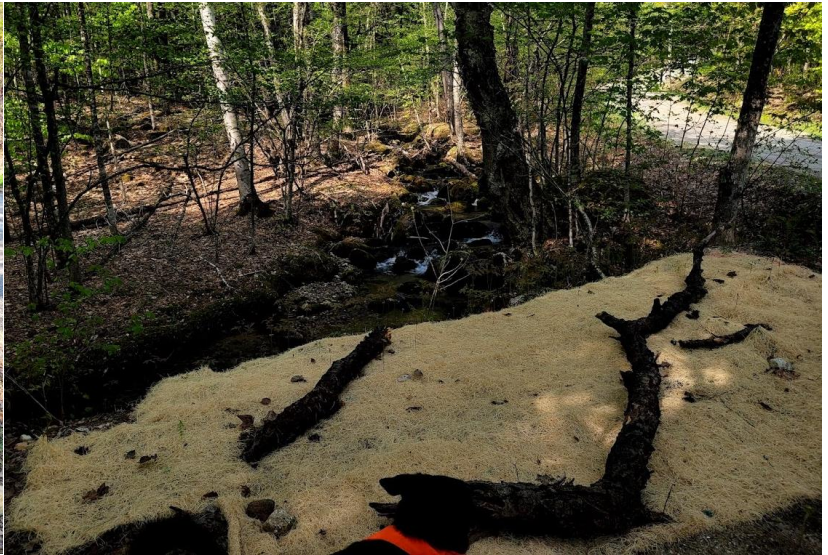
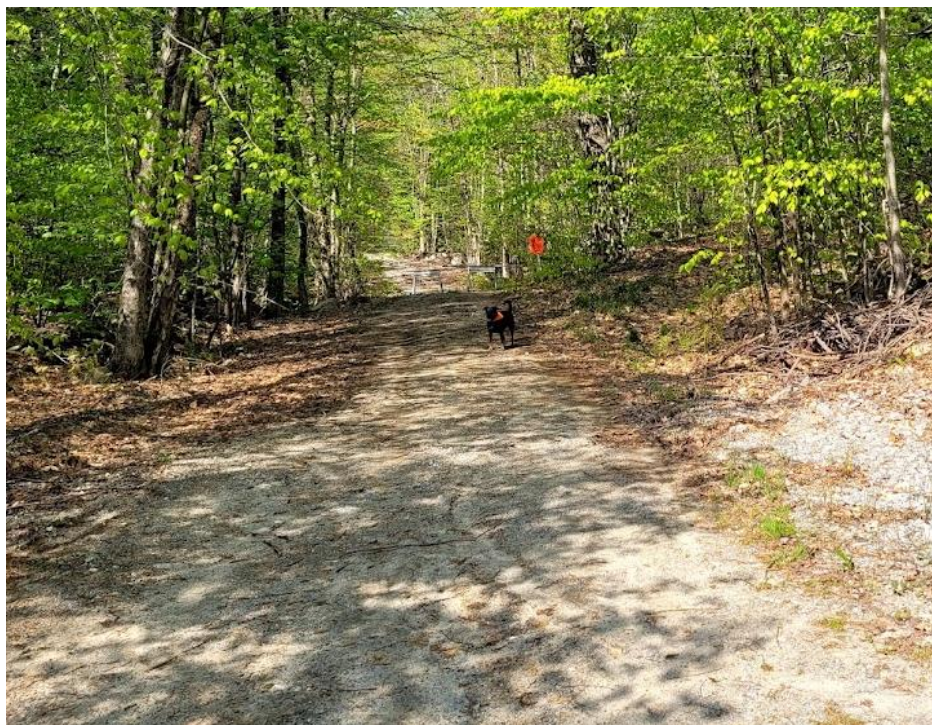
Mile 0.4 to 0.6 - The road crosses the brook and climbs a steep hill to another stream crossing. This section of road has washed out and subsequently rebuilt by abutters at least three times in the last thirty years, to provide access for forest management. It is currently in "GOOD" condition — the three-foot culvert now at the top is holding, but water bars on the hill are starting to fill and some erosion has started.

Mile 0.6 to 0.9 - This section is relatively flat and has been maintained by abutters to the driveway to the Butler camp. It is in Fair to Good condition, with some wet sections where water ponds, and with fords across seasonal streams.

Mile 0.9 to 1.2 - From the Butler driveway to the Washington town line, the road is in "POOR" condition. The roadway has become a stream bed flowing for much of the year, and it has eroded to boulders, rocks and cobbles. The road is not posted at the Town Line.

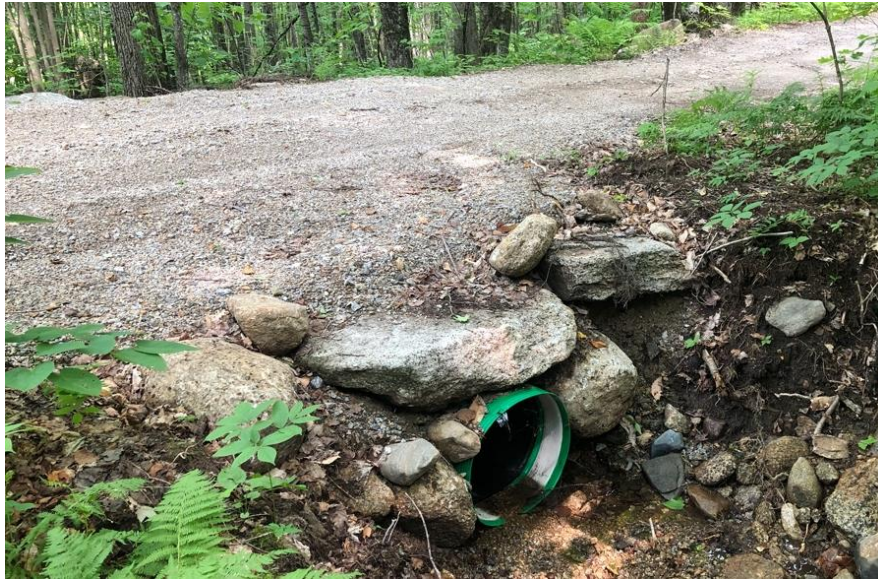
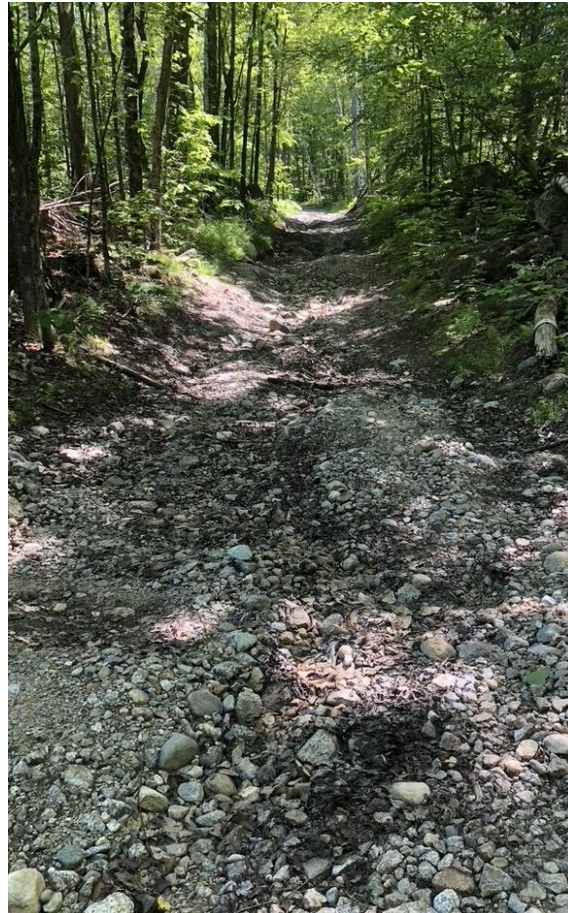
- 0.0 Road initially level and then climbs up a significant hill. At 150 feet there is a new culvert installed in 2022 by the Sunapee Snowmobile Club (see pic). Snowmobile trail off Southard property enters at about 0.15 miles. Overall road condition in the first 0.1 miles is initially "GOOD" due to crushed rock being laid associated with a timbering operation. Unfortunately, significant washout remains from the July 2021 rainstorm just after the 0.15 mile point. From 0.2 miles to 0.75 miles the road appears only "FAIR" as the crushed rock is minimal compared to the first section and there are frequent rock outcrops.

Erosion: Entire road suffers from erosion, however, the section from 0.75 to 0.94 miles is extremely eroded. Rocks/ledge drops of 1-2 feet are frequent in this section. Significant erosion in first 0.25 mile is new since July 2021.

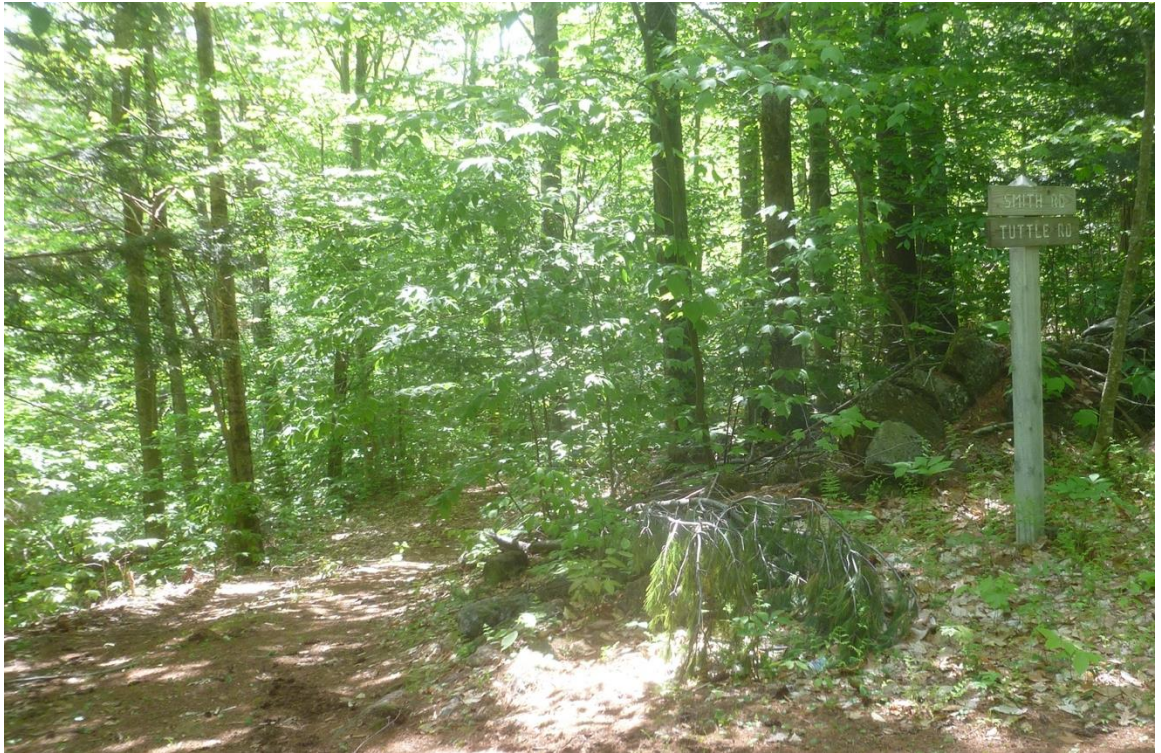
Erosion: Starting on Forest St the lower end of Smith Rd was improved for logging truck access and is in very good shape as far as the Smith cellar hole. Beyond the Smith cellar hole is a plugged culvert (mud and leaves) which has caused a small wash out across the road. One other change is that the Tuttle Rd sign was repositioned ninety degrees. The last hill up to Rowe Mt Rd is the best it's ever been as the sediments have filled in between all the trap rock.
