Adopt a Road

Bradford Conservation Commission

Spring/Summer 2019 Report

Alder Plains Road

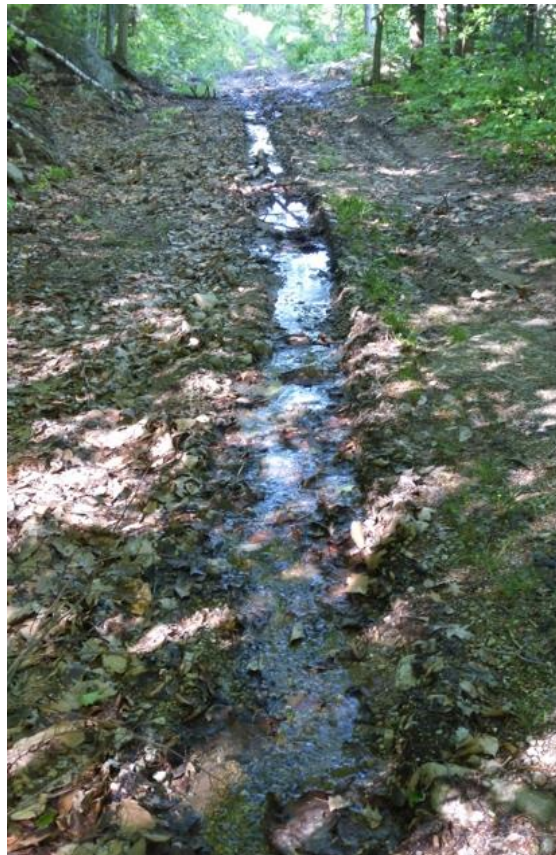
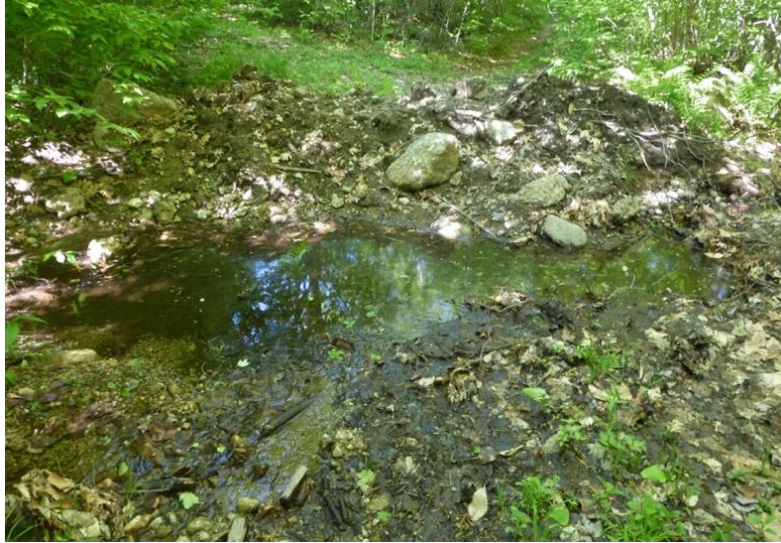
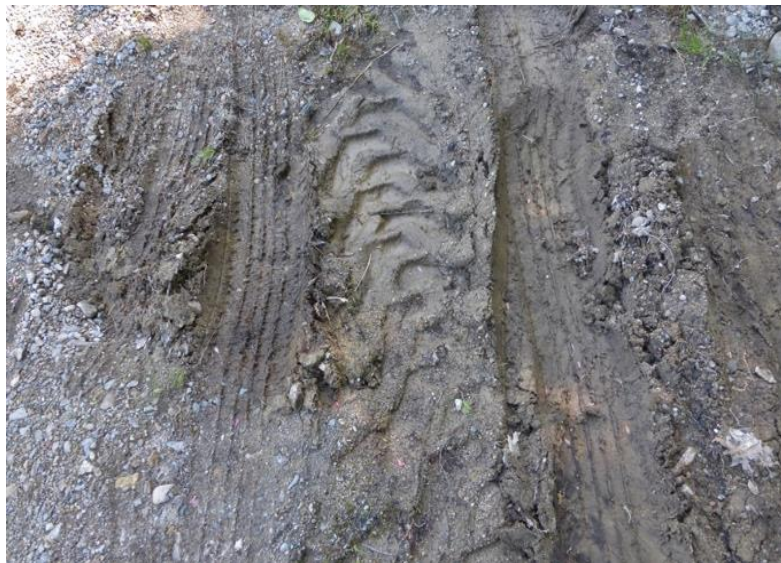
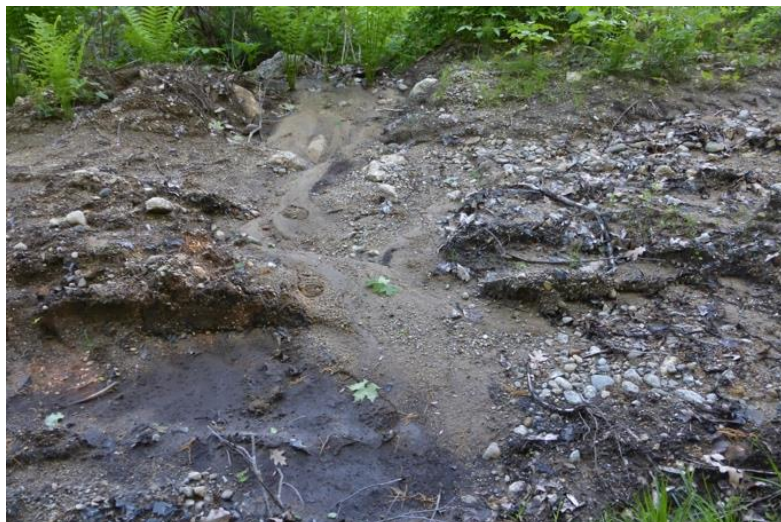
The east side of Alder Plains Rd is severely eroded. (Far worse than it was in the spring of 2018.) There are impassable dirt/stone piles. There are very deep and extensive ruts. There are pools of water and a flowing stream running down a section of the road (see examples below).

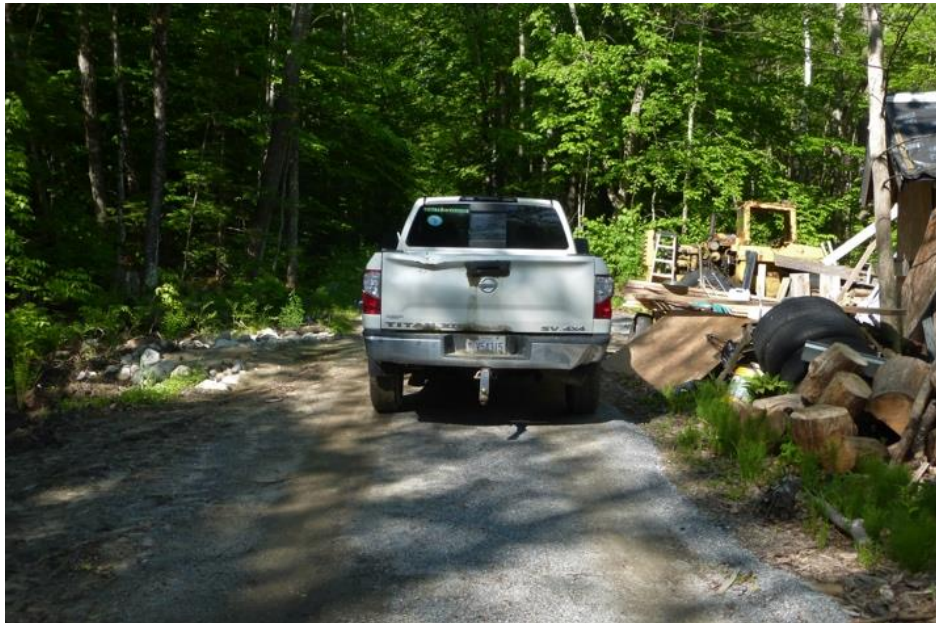
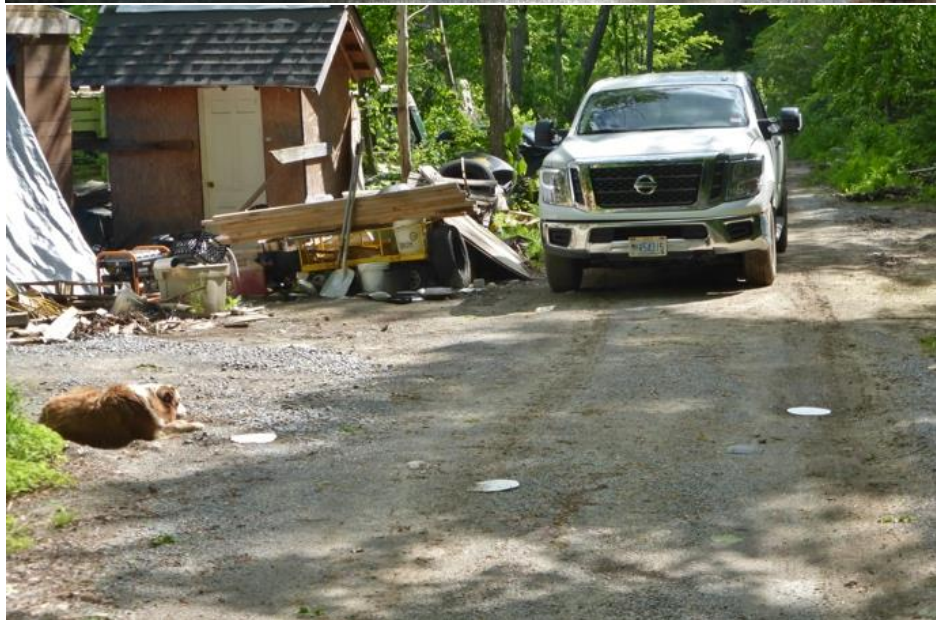
The resident parks a truck in the middle of the road, obstructing other vehicles at that point (see below).

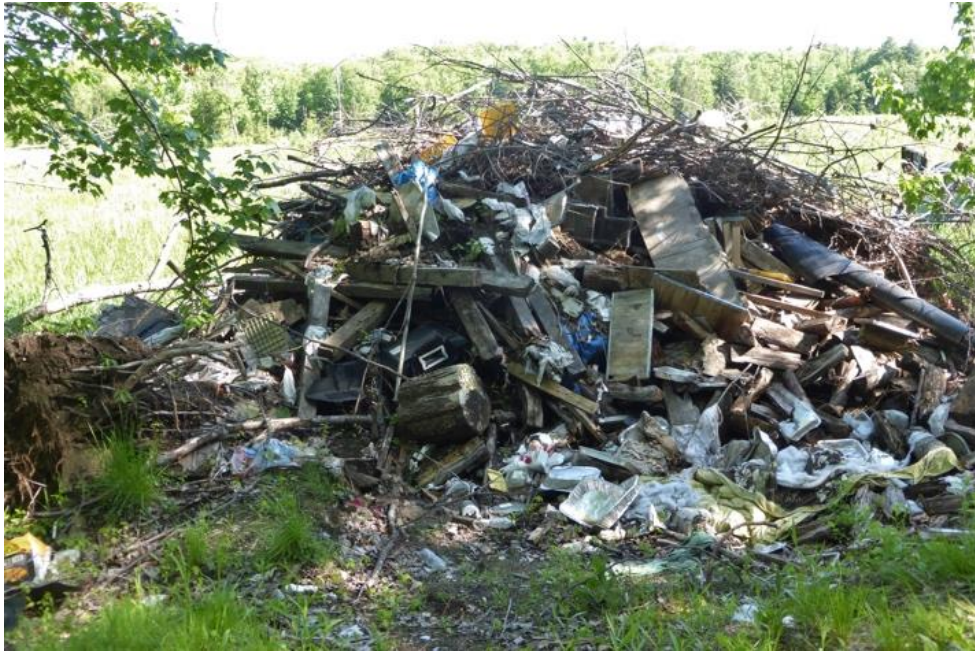
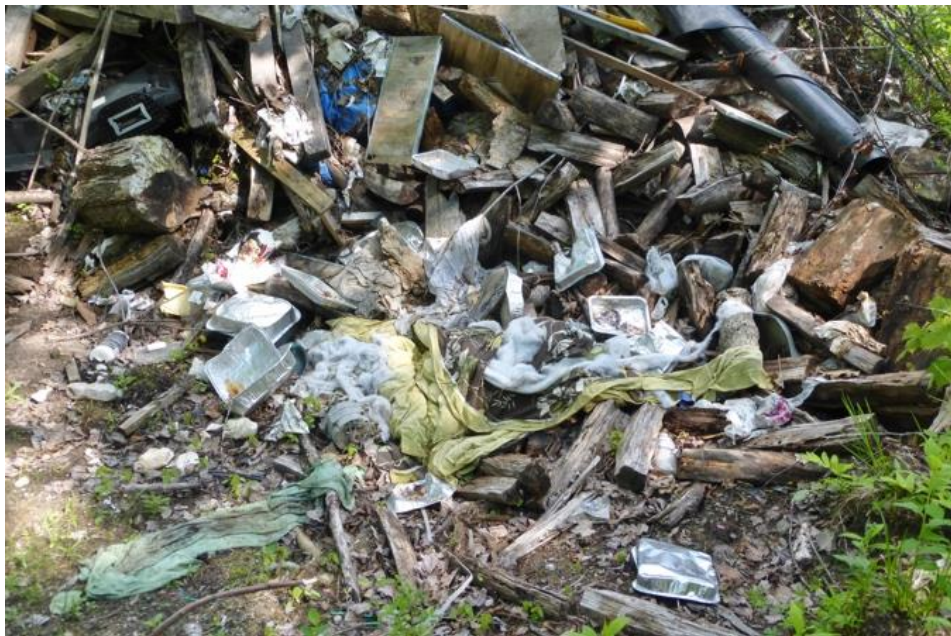
Trash/Dumping? Y Comments: Litter strewn throughout. A few huge trash piles and junk pile. **Update: There are also several enormous, unsightly junk piles (some containing food waste) along the road. Some of the junk piles are so large they encroach on the adjacent wetlands (examples below).**

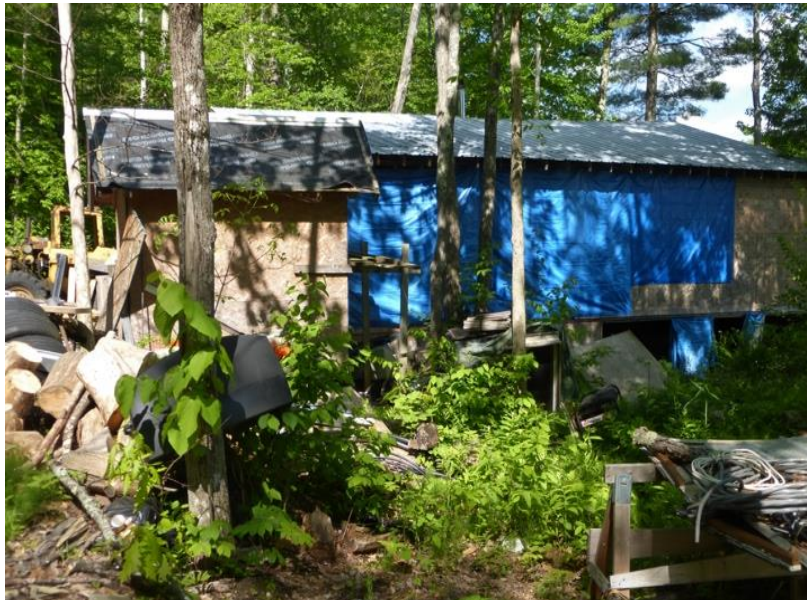
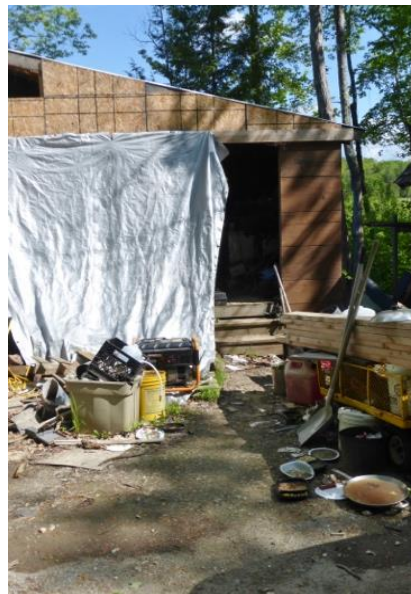
Other Conditions? Comments: **Update: There appears to be an occupied camp under
development at 260 Adler Plains Road (map9, lot 15).**

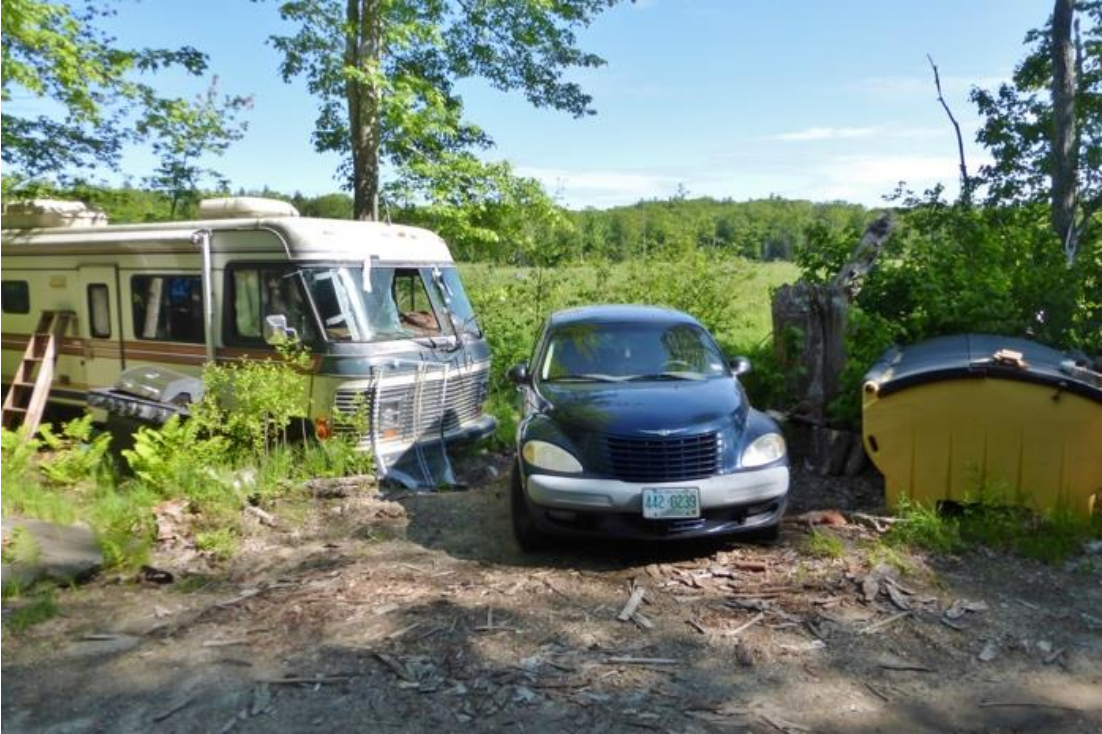
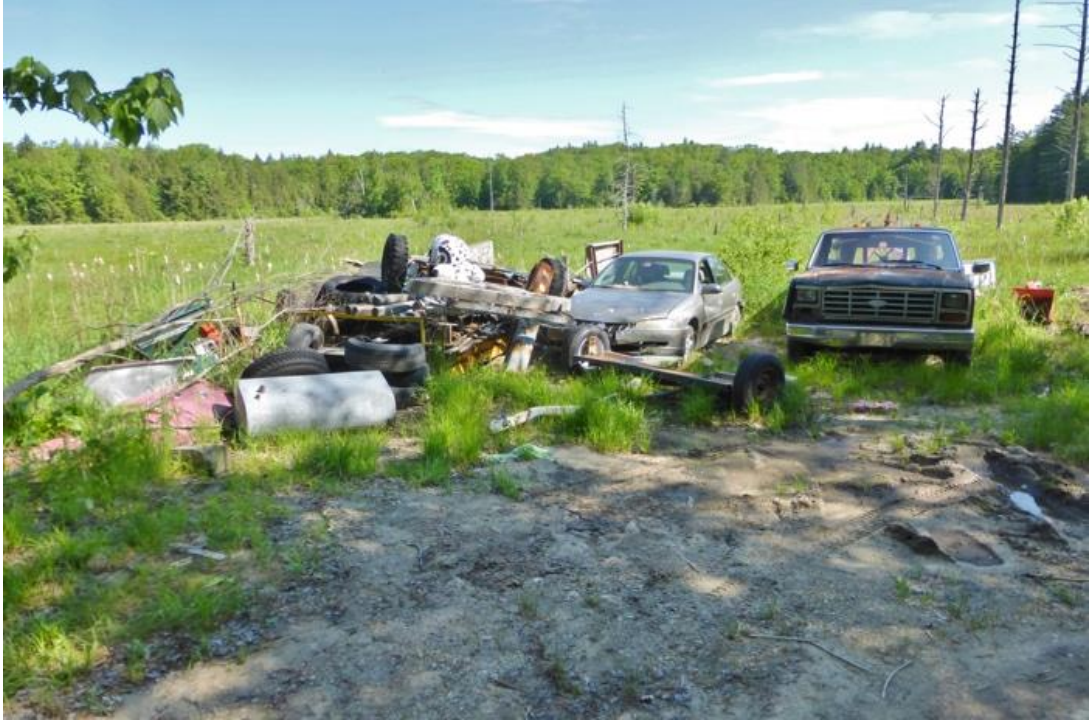
There are also a number of vehicles on the property without current registration (see examples below).

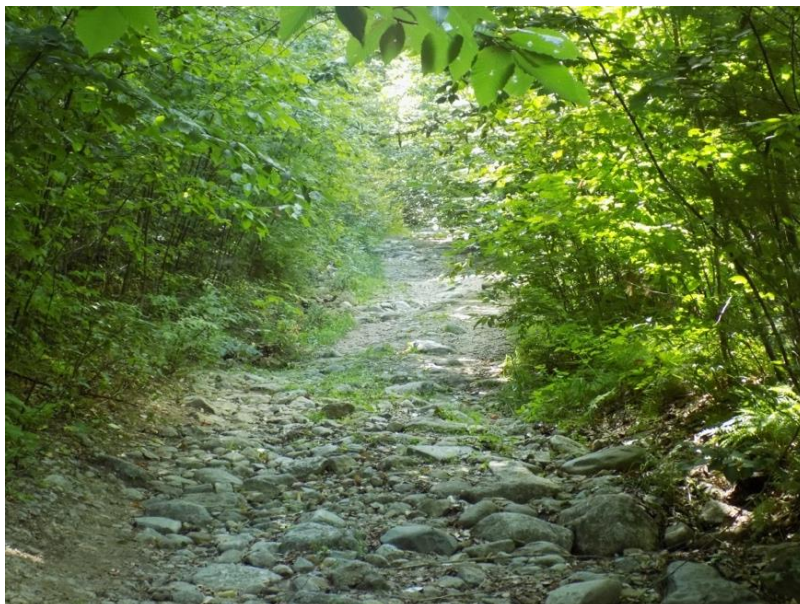
Other Conditions? Yes. Comments: Road primarily consists of large stones, with small sections of sand or gravel interspersed. Likely impassable by smaller ATVs.

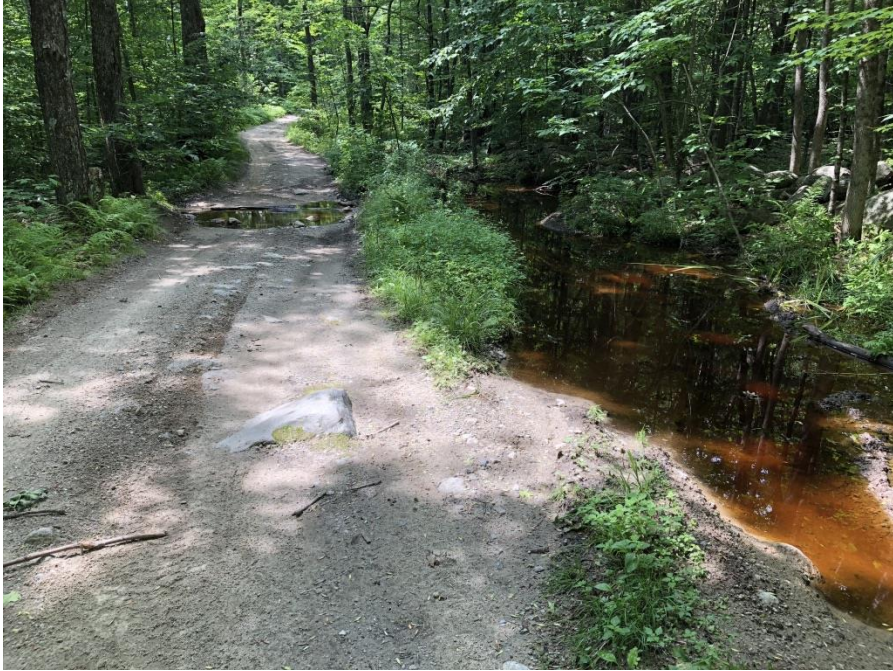
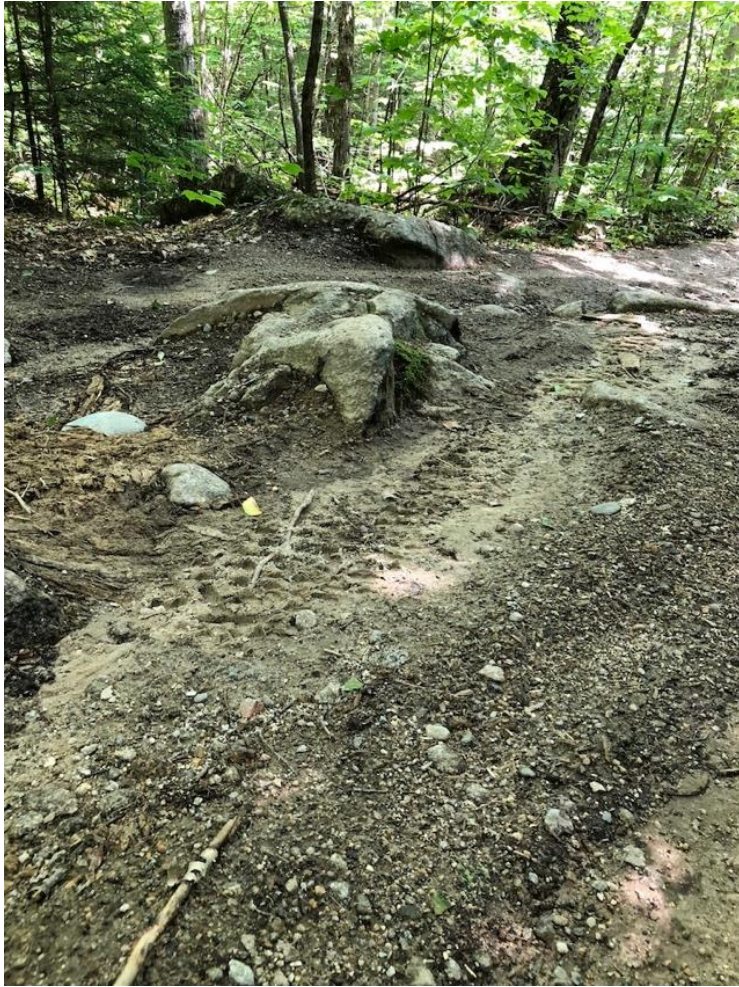
Erosion? Yes Comments: Section closest to Rowe Mountain Road has significant erosion. Rip-rap placed on Liberty Hill end makes road a bit more stable. **Update: No significant changes as of June 14, 2019.**

Other Conditions? Comments: Trail sign needs to be labeled "Snowmobile".

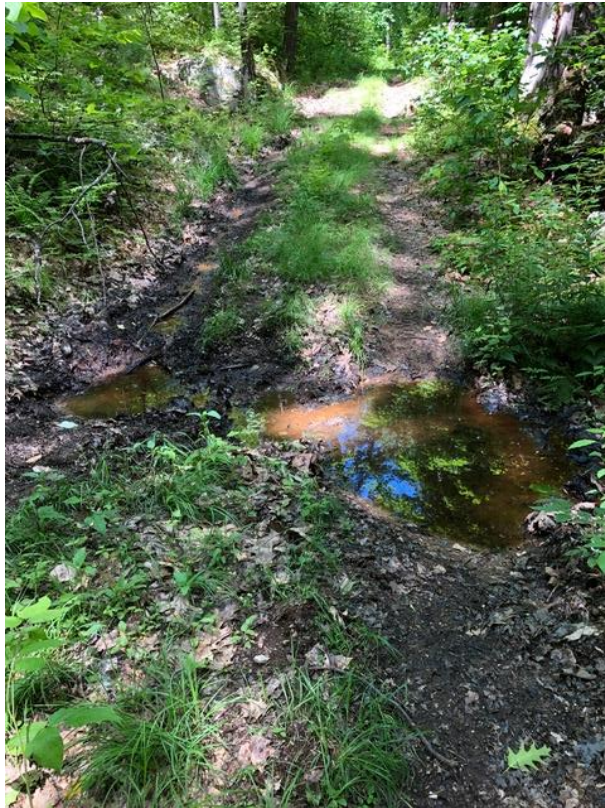
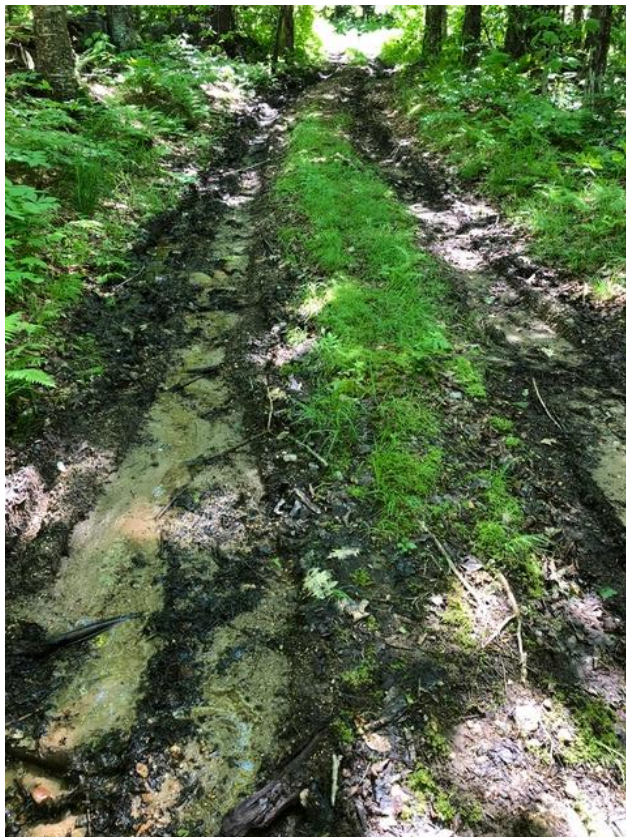
Erosion? No Comments: West end of road some sign of rain water running down the road, but not washed out. "Water bars" are doing their job well. East end washed out.

Update: With all the rain this year, there were more places with water running across the road and where vehicles had driven, more ruts. Not washed out.

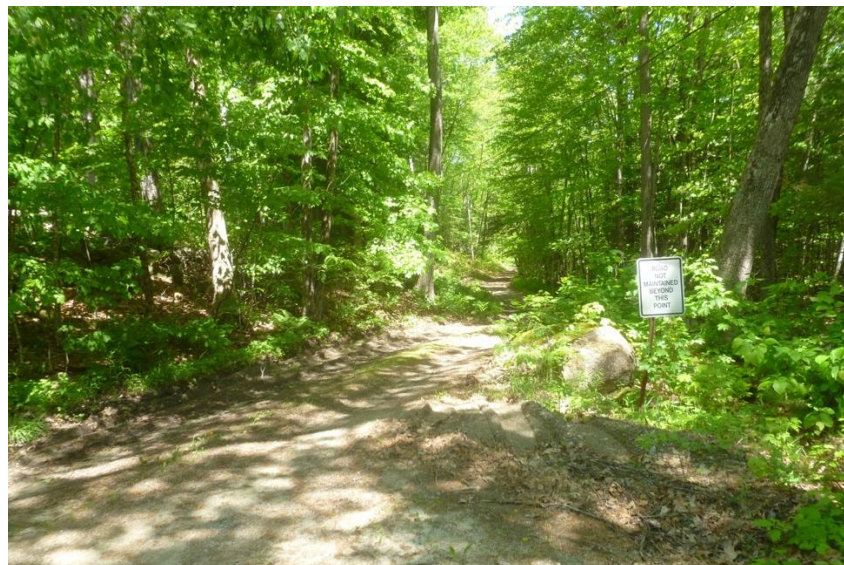
Erosion? Y Comments: from 2-inch downpour on 7/28. **Update: On June 3, 2019 the condition of Jackson Rd is slightly better than last fall. This pic is looking north down Jackson at the Forest St junction**

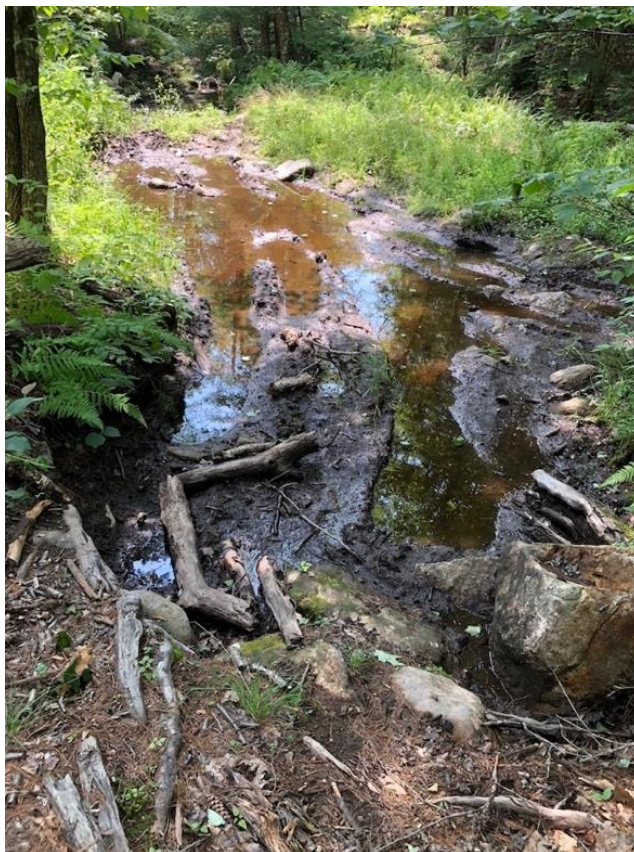
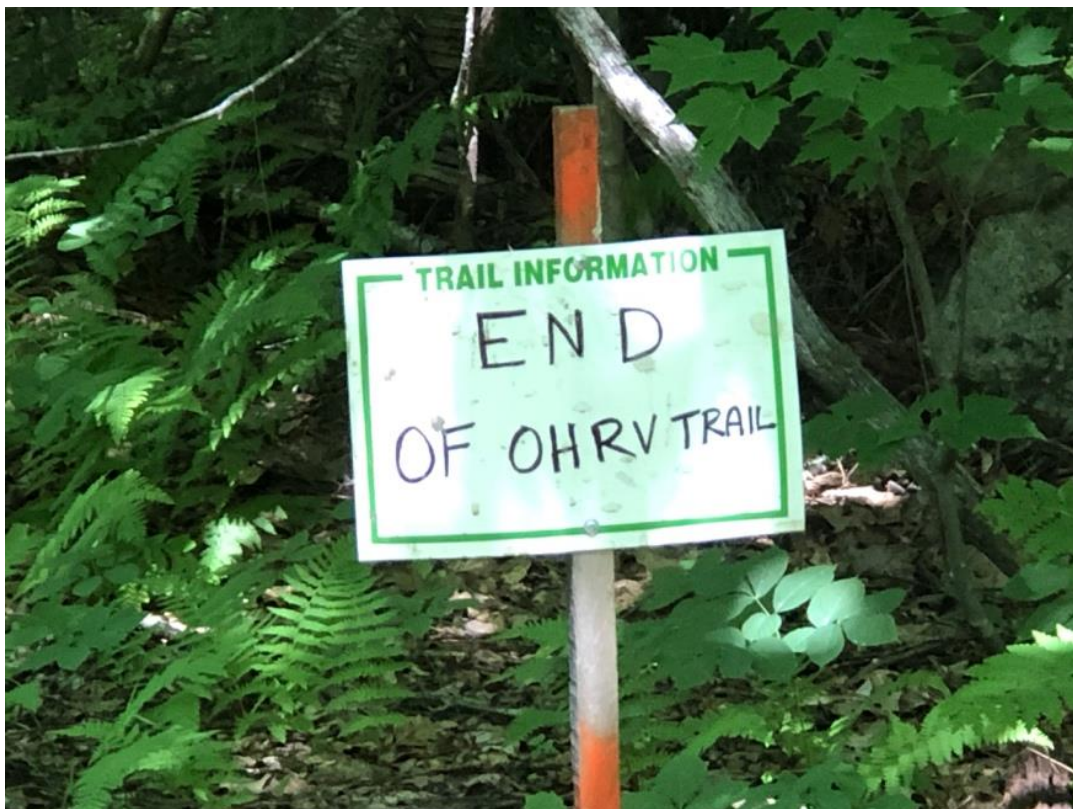
- 0.00 Road in "FAIR" condition with frequent pools of water and rocks 4-8 inches. ATV signs formerly present have been removed. An "End of Contoocook Valley ATV Trail System" sign is now present as one heads into Bradford along LHR. (see pic)
- 0.14 Rip-rap appears to have been placed secondary to a logging operation. Road is close to "GOOD" from this point forward.
- 0.2 Substantial off-road damage has been done to embankment on West side of a bridge over a small stream. (see pic)
- 0.5 LHR ends at 4-way junction with Day Pond Road (both ways) and a private road.

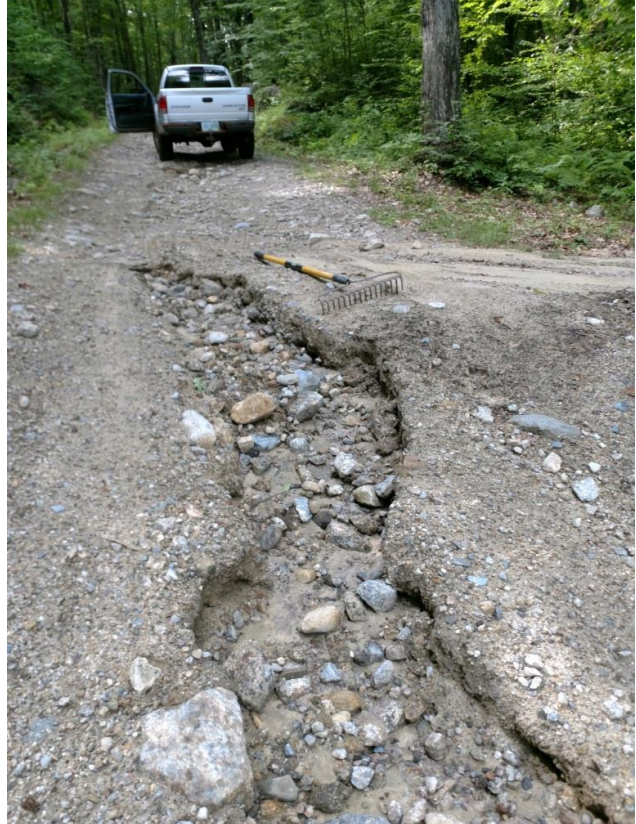
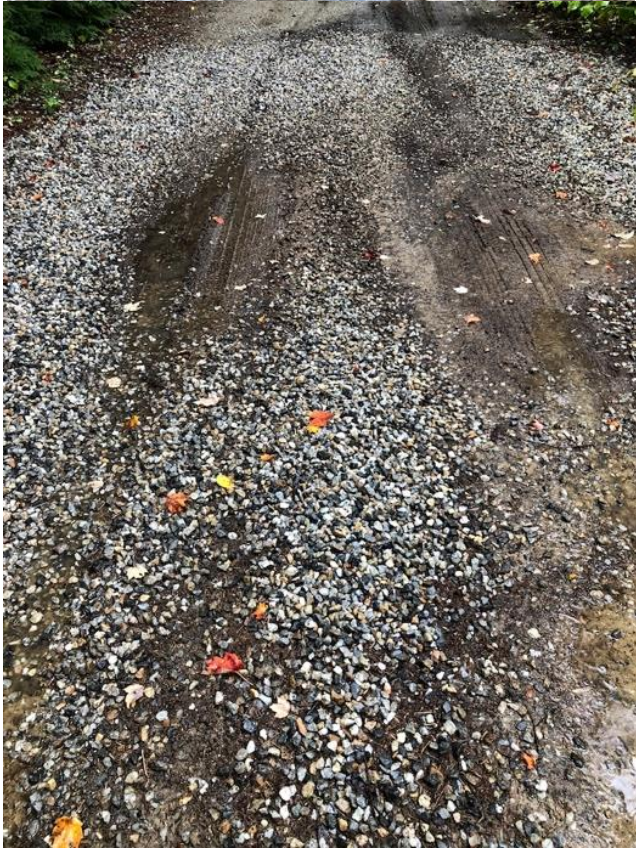
Erosion? Modest Comments: Road in generally "GOOD" condition with isolated rocks and water bars. Several areas appear to have had small rock fill in the low points.

Obstructions? N Comments: **Update: Road was still rutted and wet from spring but passable.**

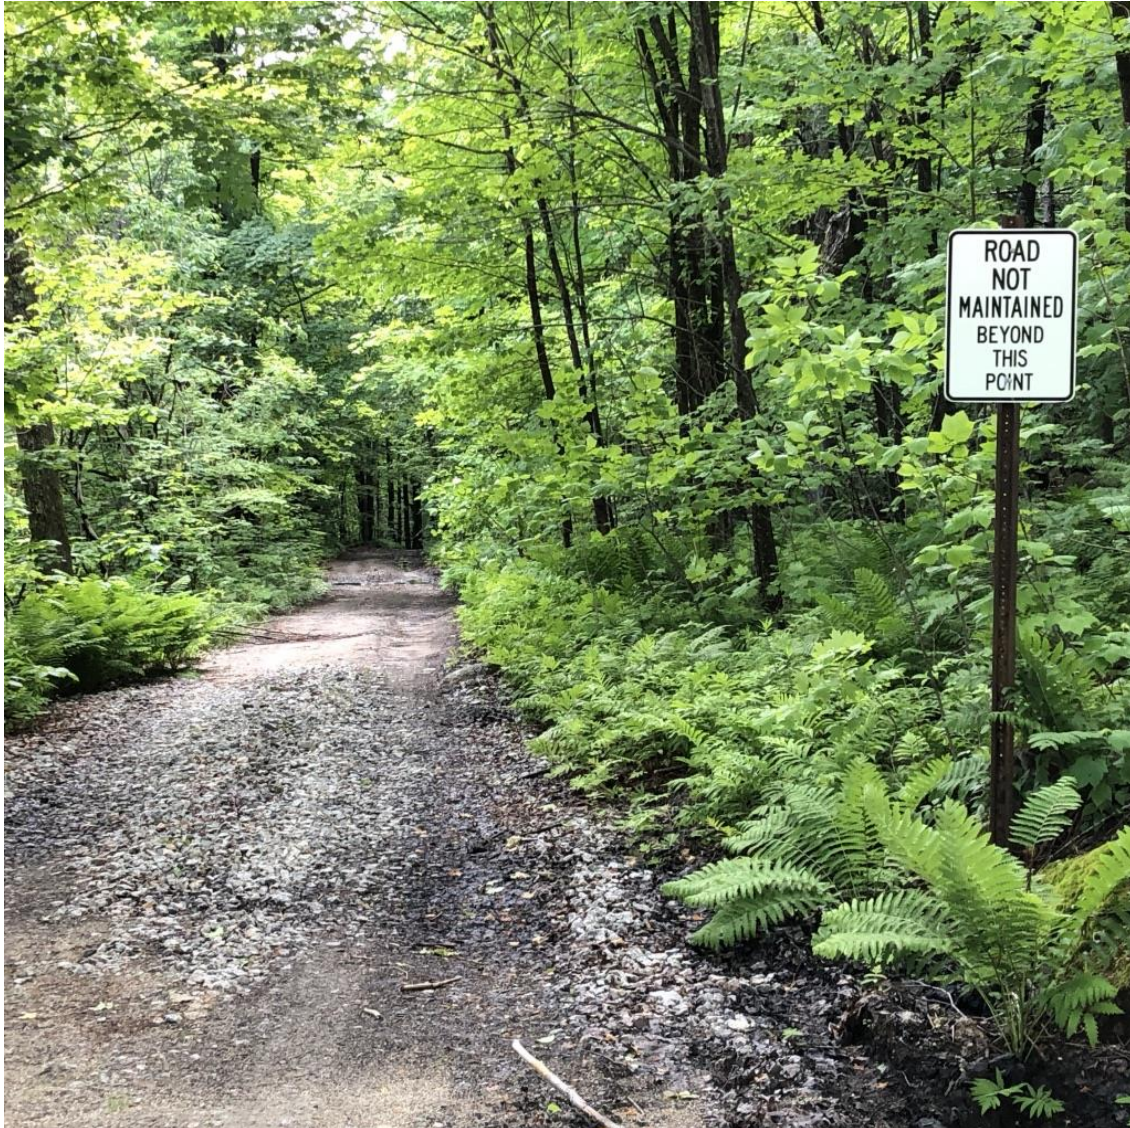
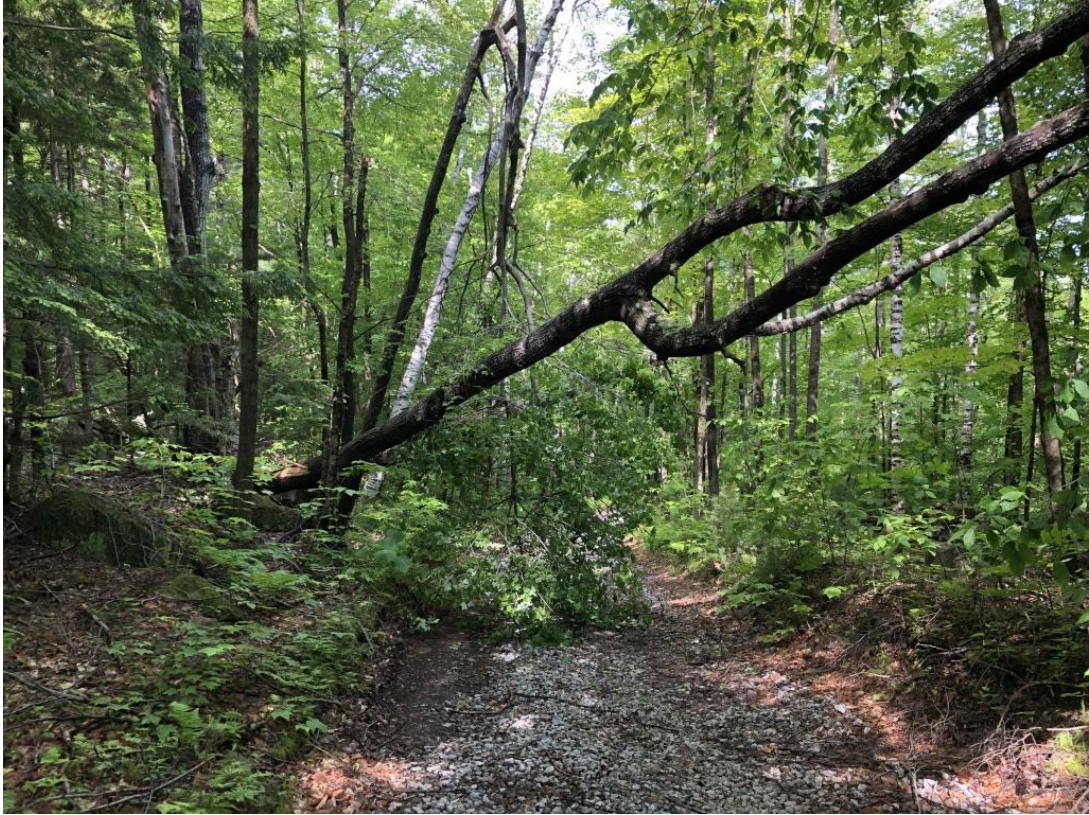
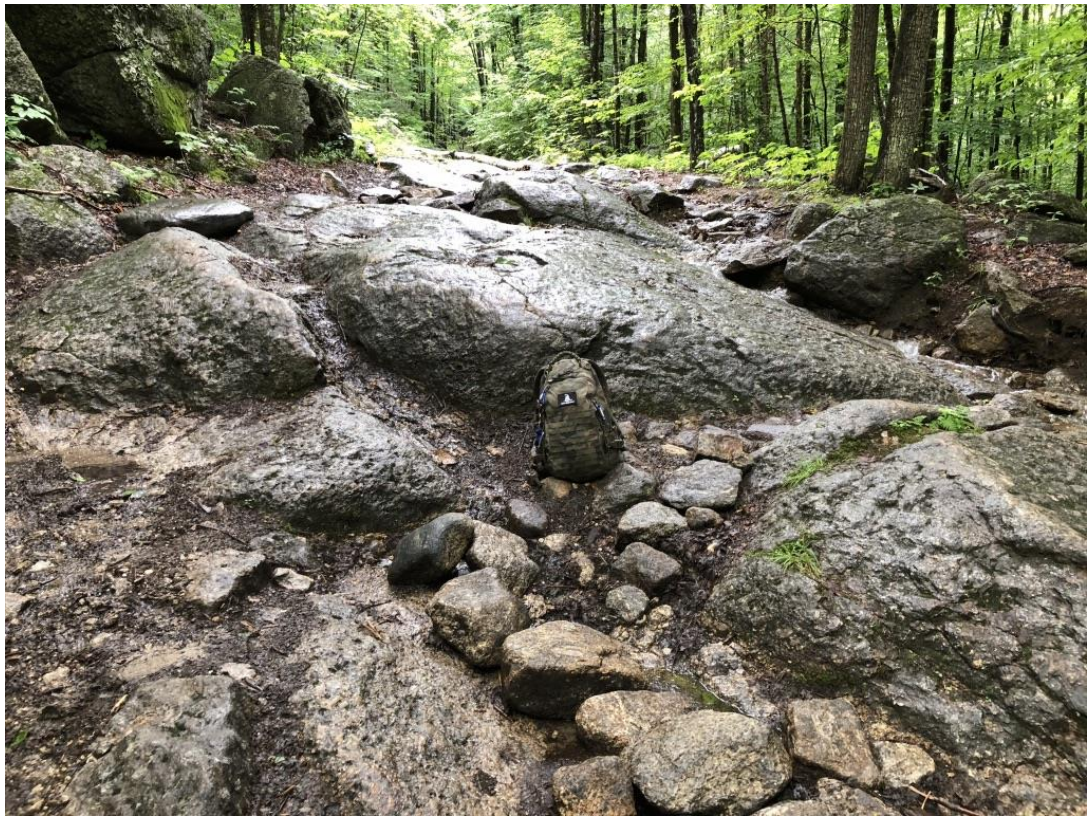
0.75 Road conditions deteriorate substantially. Gentle downslope with significant rock outcropping, ledge and general erosion. Road condition is "POOR". See pictures.

Obstructions? No Comments: No significant obstructions, however, erosion is so significant, it could be considered an obstruction as noted above. **Update: Significant obstructions are imminent as several large trees are about to impact the road at about the 0.25 mile point (see pic).**

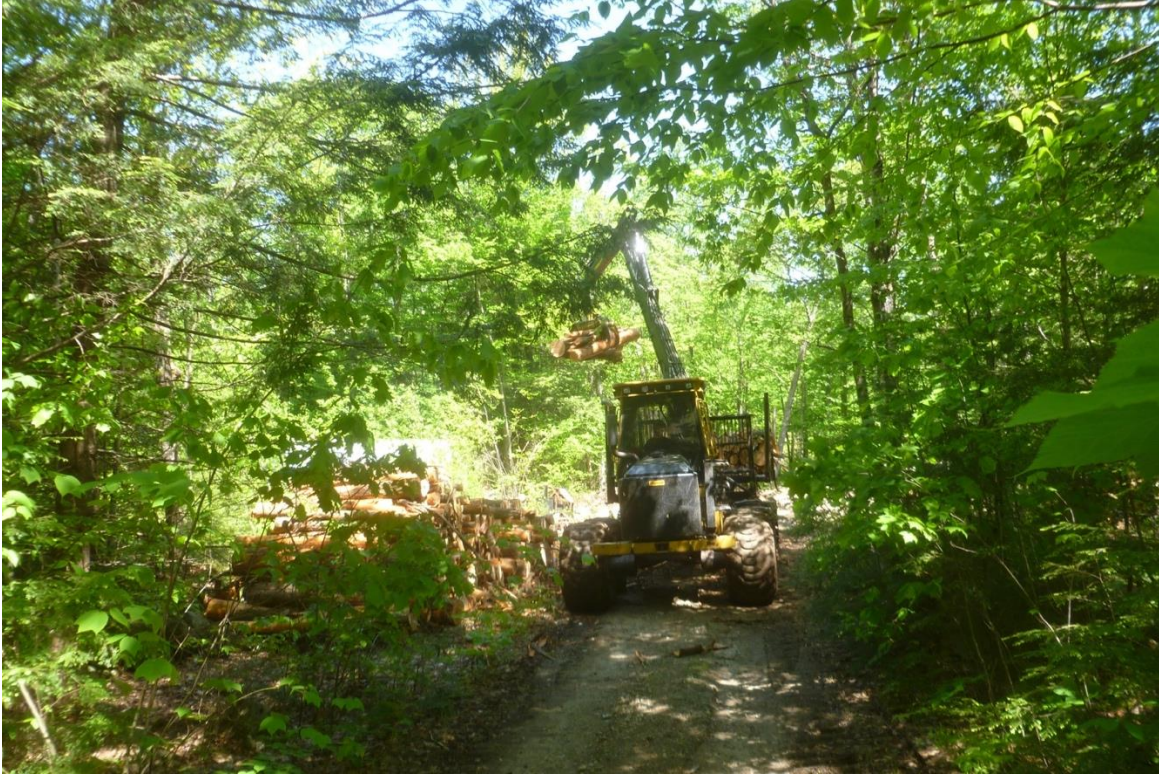
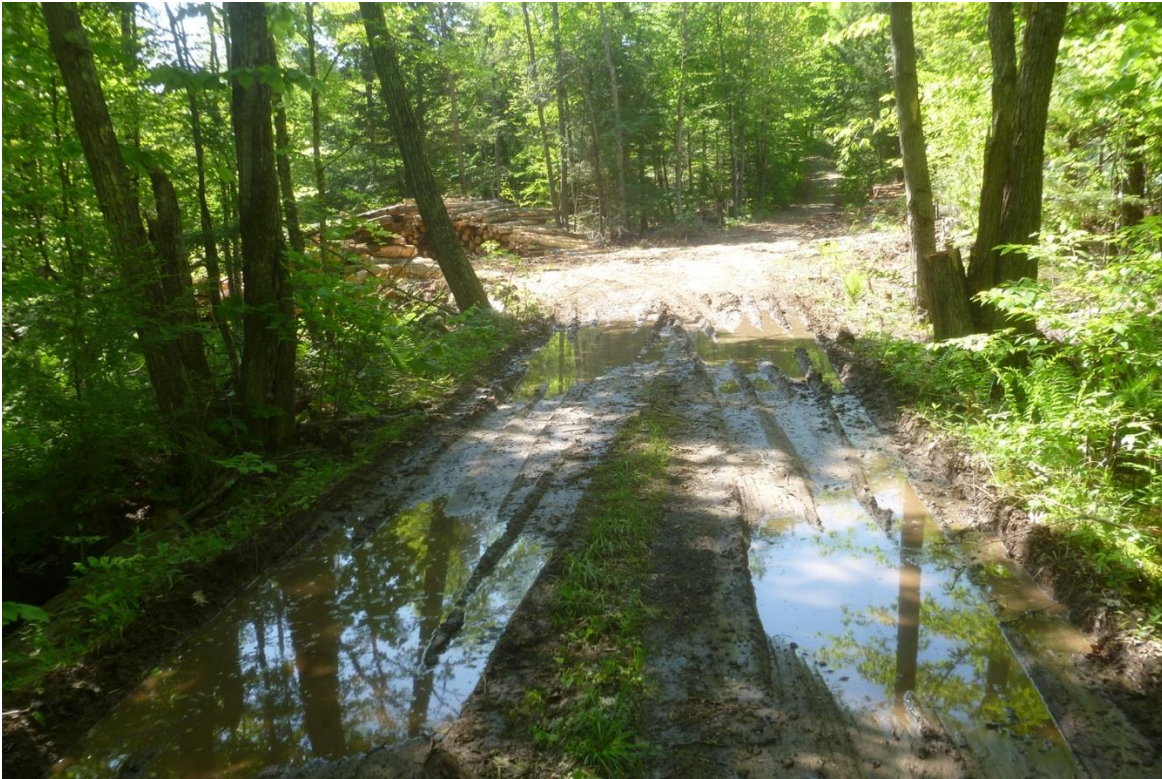
Motorized/Non-motorized Activities? Y Comments: occasional OHRV. **Update: Logging is in progress on Kincaid property and the road has been impacted. A closer log landing is being used which is roughly 1/4 mile from Forest St and has created a muddy area in that area of the road. Crushed stone /gravel has been placed at the Forest St junction and a few other places to help out log truck access. The condition now has worsened from last fall's inspection due to current logging and vehicle usage during wet conditions.**
