Adopt a Road

Bradford Conservation Commission

Spring 2021 Report

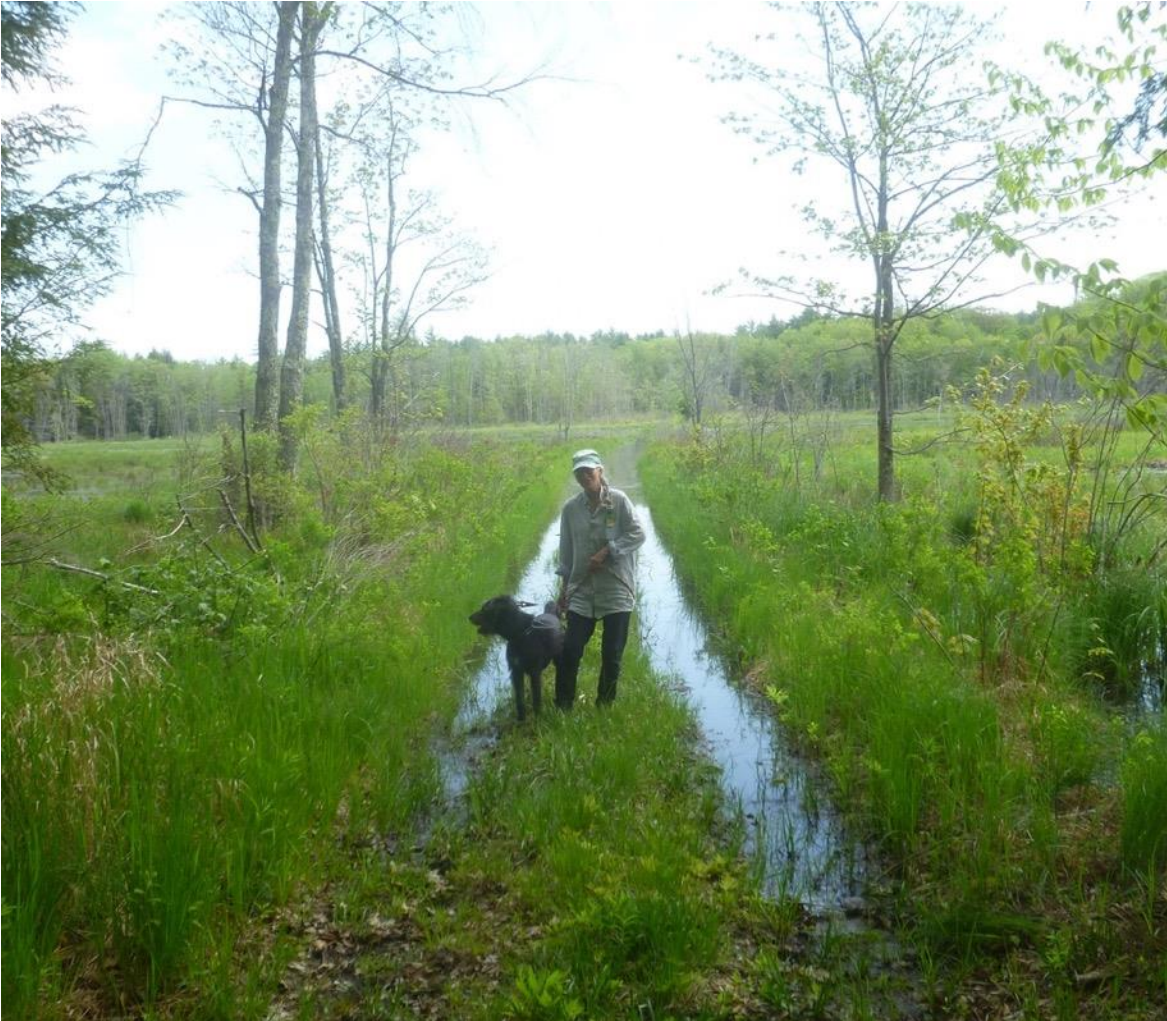
0.25	Up until this point, road is in Good condition with placement of crushed rock. A small building is encountered on the left side of the road which appeared to be occupied in the past. Numerous junk piles and cars/trucks along-side of the road.
0.75	Road surface is Fair to Good, reasonably flat, but with significant mud puddles. One culvert juts up from the road surface.
1.0	Road continues to be in Fair to Good condition, but ends in water at approximately 1 mile (see pic).

0.1 miles	Road is reasonably flat and in Fair to Good condition with mud puddles. Road ends in water as was the case from the entrance via East Washington Road.
-----------	--

Obstructions: Standing water in some areas of the road as previously noted.

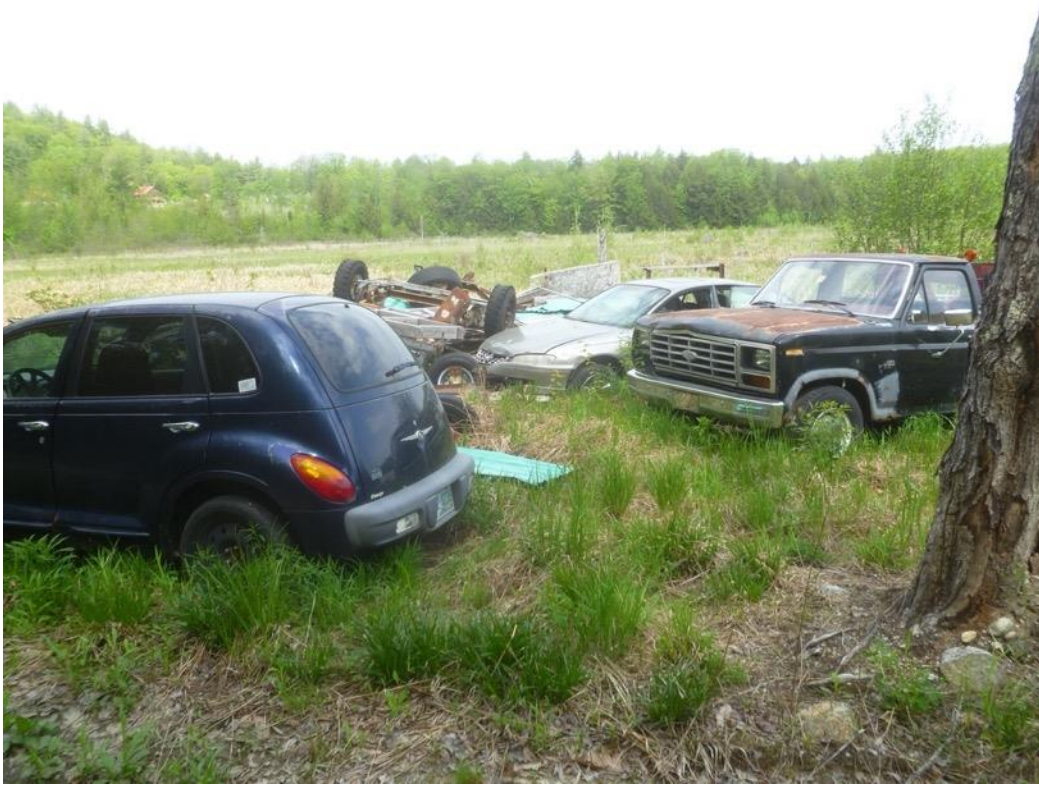
Trash/Dumping: The junk and trash piles looked similar to the report of Fall 2019.

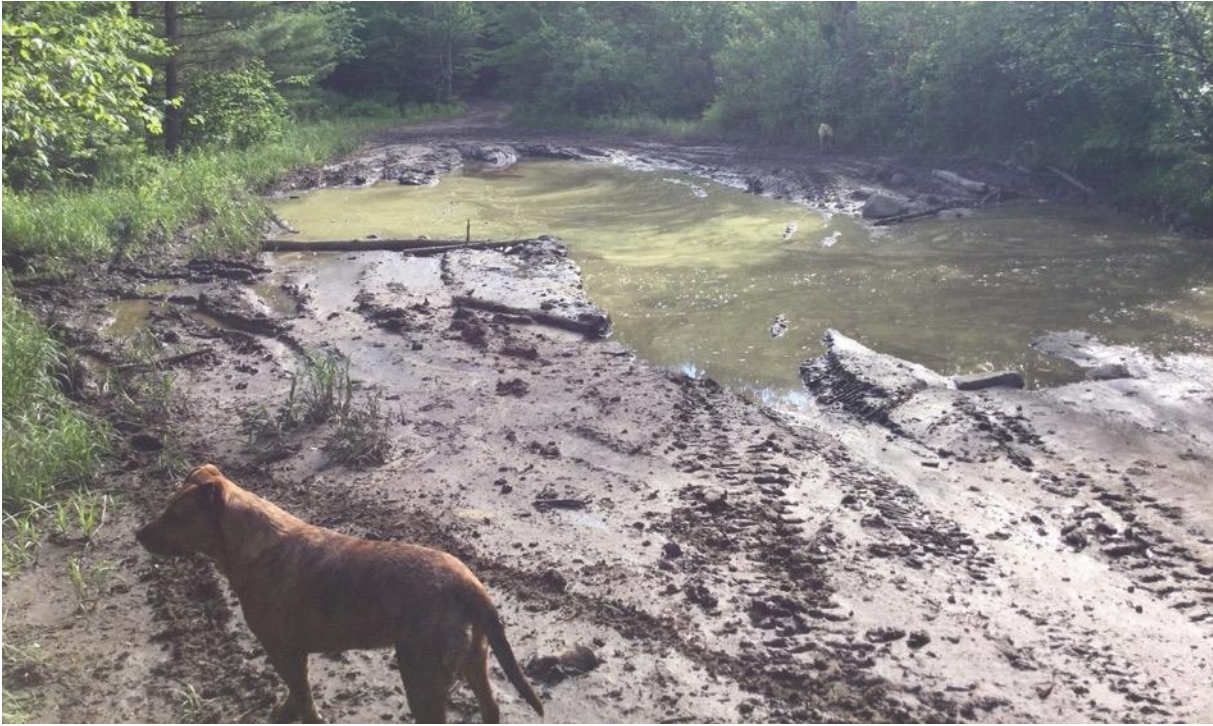
0.55 - 0.6 miles: Large, moderately deep mud wallow, ~2' deep, about 30' x 50' in diameter.

Obstructions: One low lying area has roughly 6 inches to 2 feet of muddy water, perhaps 50ft by 30ft (see picture). Mud hole hasn't seemed to increase in size, but another bypass has been cut through the low-lying forest to allow ATVs to pass. The cut section is too small for Jeep's.

Trash/Dumping: Some trash. A small residual campfire with beer cans is located by the flooded section.

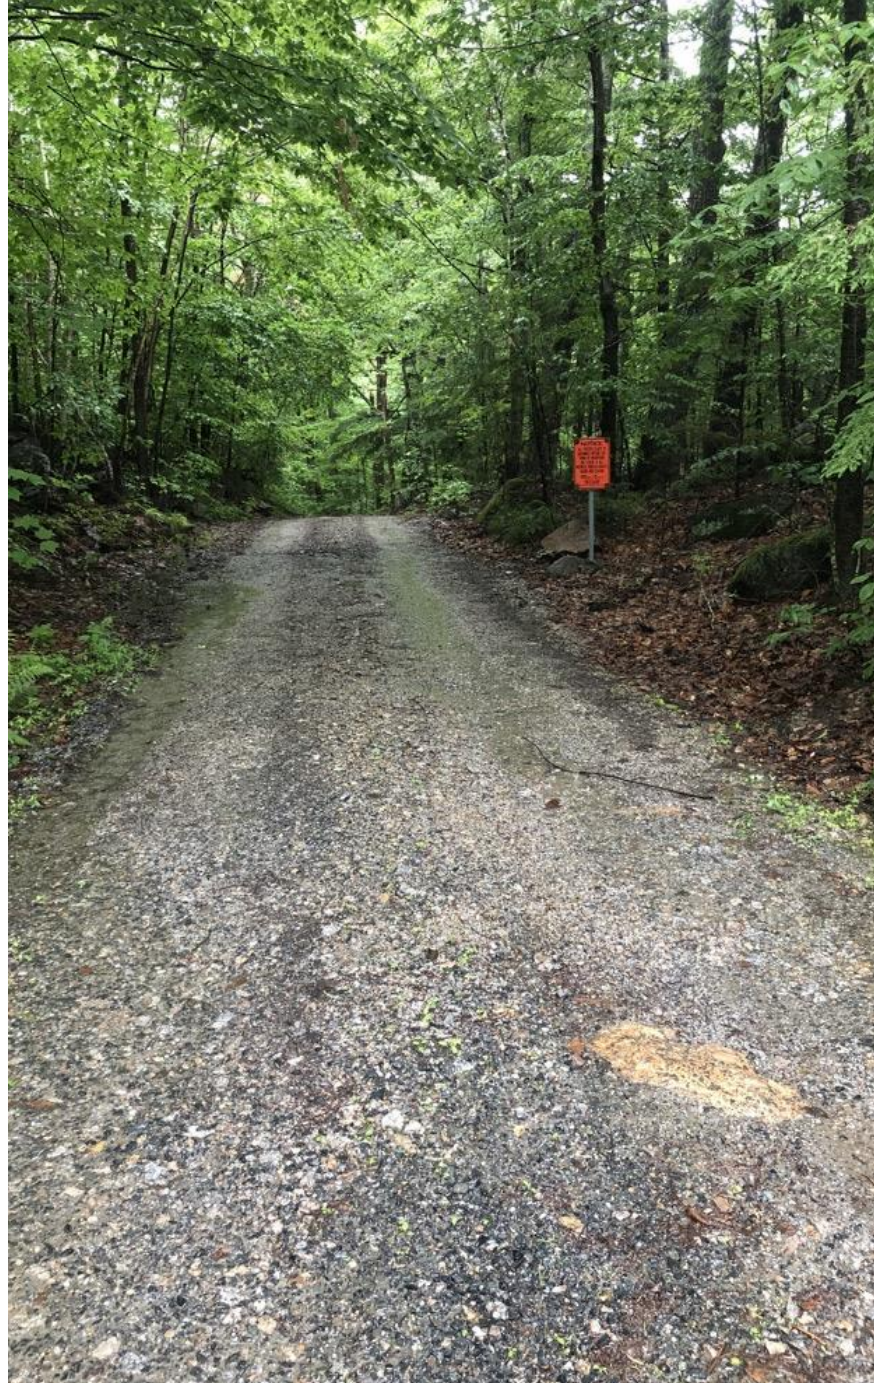
Erosion: The State of NH logged out past the Bradford line. They upgraded the short section that was past the last habitation to get their log work done. Making Bradford's section and slightly beyond very drivable. There are, however, several relatively deep water bars that have been installed.

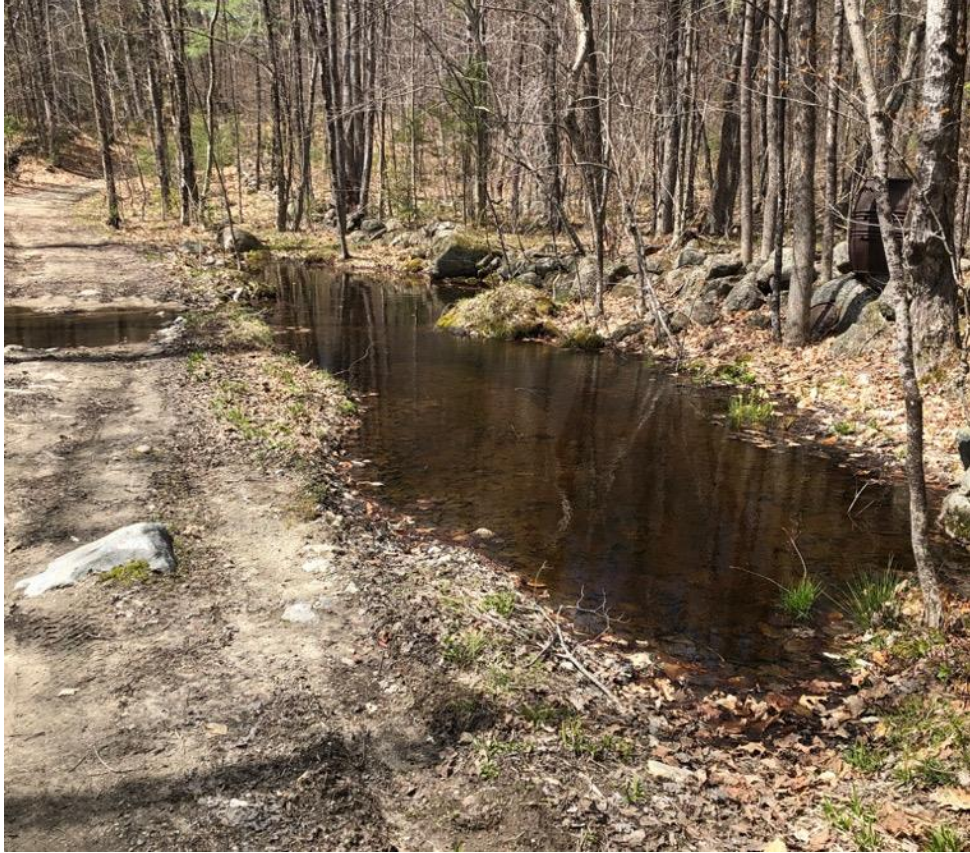
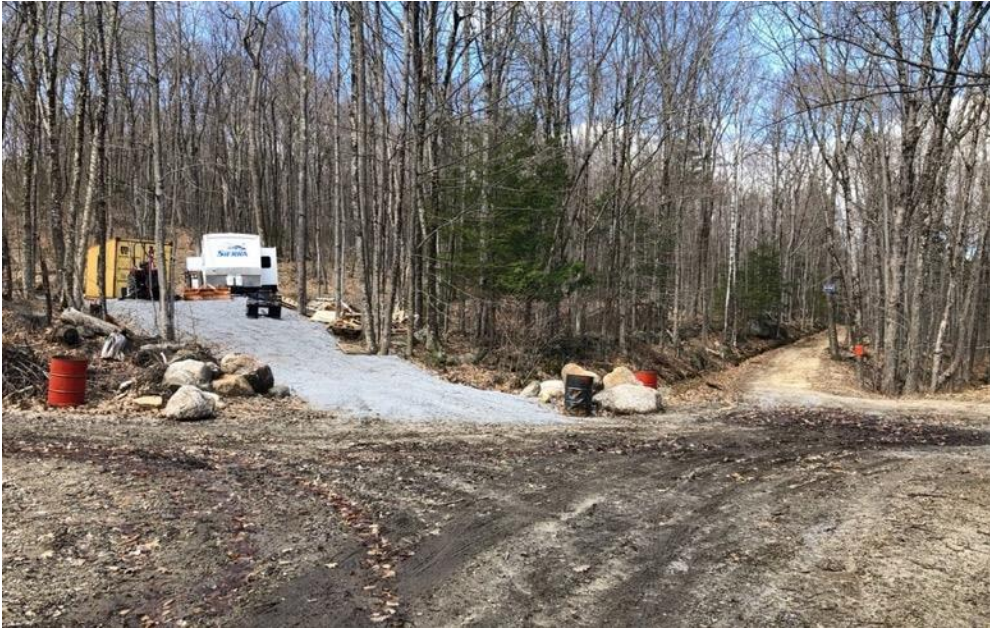
- 0.0 Road generally in "FAIR" condition with some large rocks (8-12 inches) over the first .25 miles.
- 0.37 Appears to be old off-road damage near a water crossing on left (North side).
- 0.96 Road enters 4-way junction with Liberty Hill Road and a private road before continuing on to Rt. 114. The last .25 miles moves from "FAIR" to "GOOD" in sections due to riprap placed after logging operations.

Erosion: Section closest to Rowe Mountain Road has significant erosion. Riprap placed on Liberty Hill end makes road a bit more stable. Evidence of off-road ATV "mudding" on North side of road appears to be returning to more natural condition (see pic).

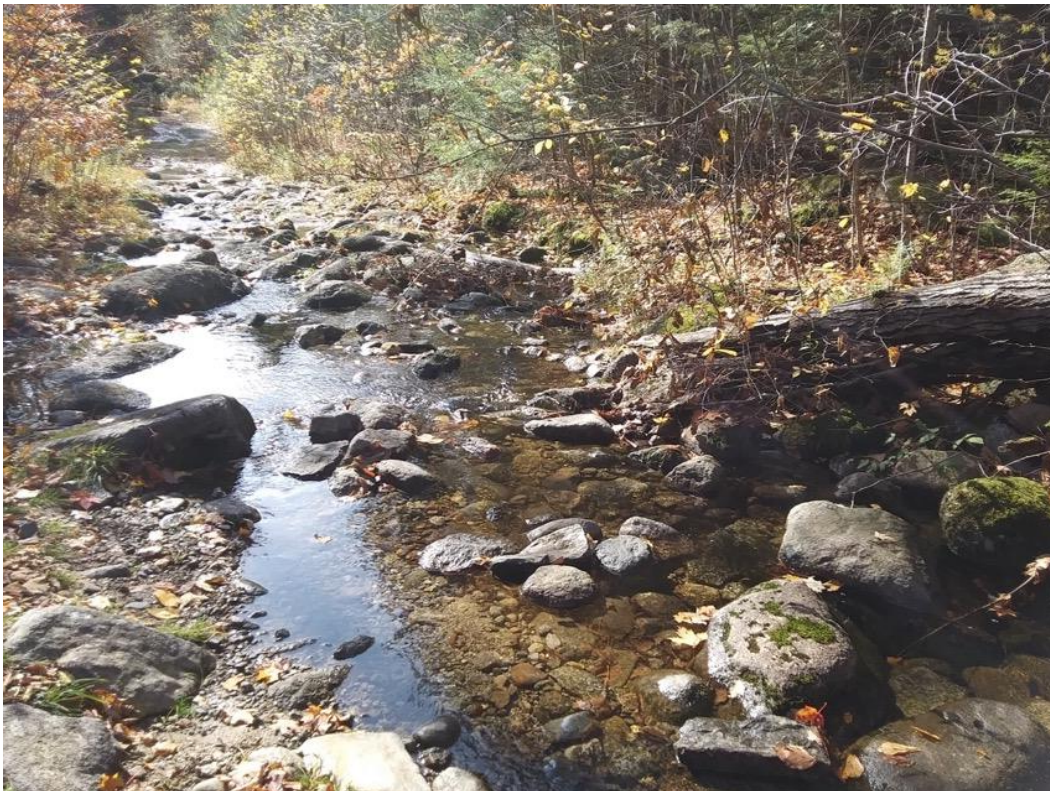
Erosion: Erosion continues in two sections of the road where the stream bed is the road. Road mostly Fair with two Poor sections. Recent usage appears light.

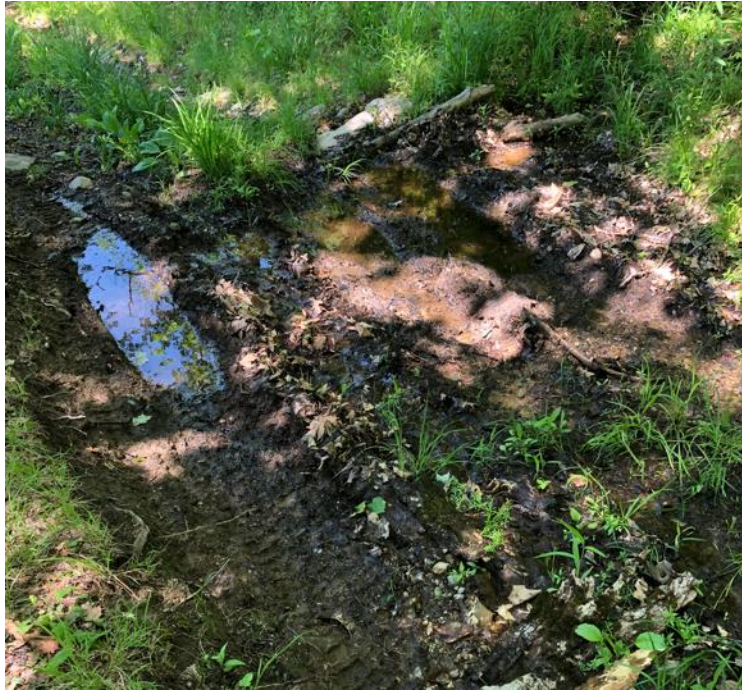
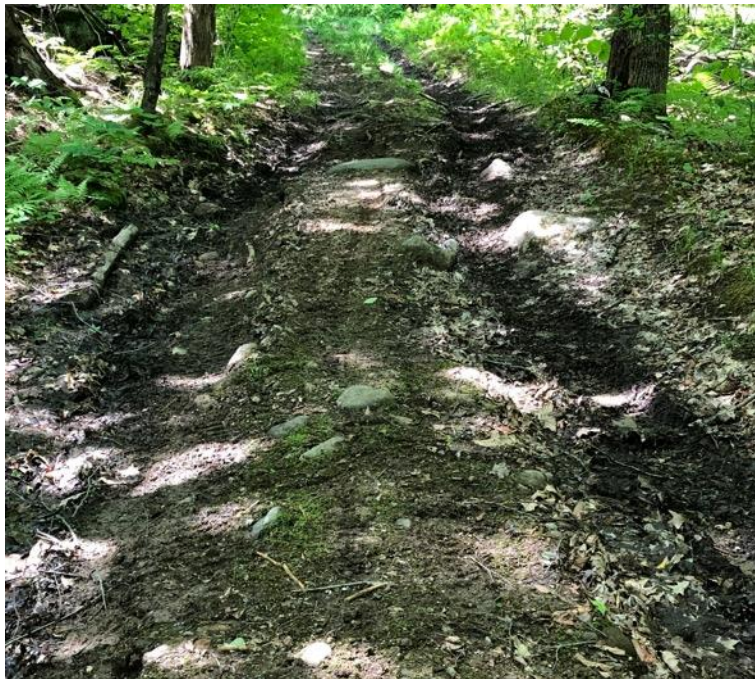
Motorized/Non-motorized Activities: There were tracks of a 4WD vehicle that had gone up the road recently - photos attached. Could have been after the end of May. Also met 5 or 6 ATV's coming up the road as I was returning. They were from Hillsborough and said they take this ride once a year. They seemed respectful of the area. Overall, I see occasional traffic of ATV's, etc., but not excessive. Foot traffic seems to have increased a bit.

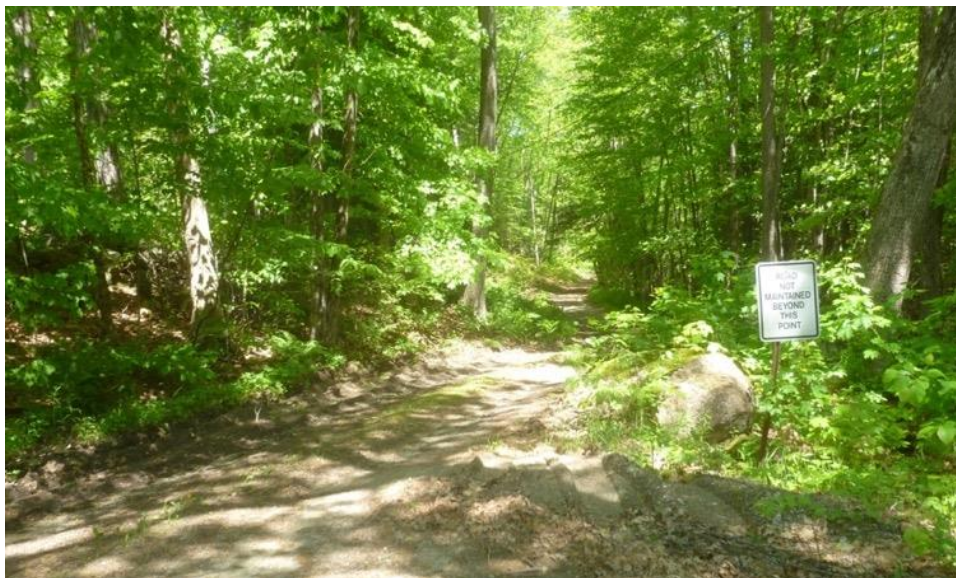
Erosion: Yes, in multiple places, notably around the driveway to 243. Overall, the road is "GOOD" with the exception of these mud holes.

Other Conditions: George Beaton did some grading with this tractor this Spring to fill in some of the mud holes/ruts.

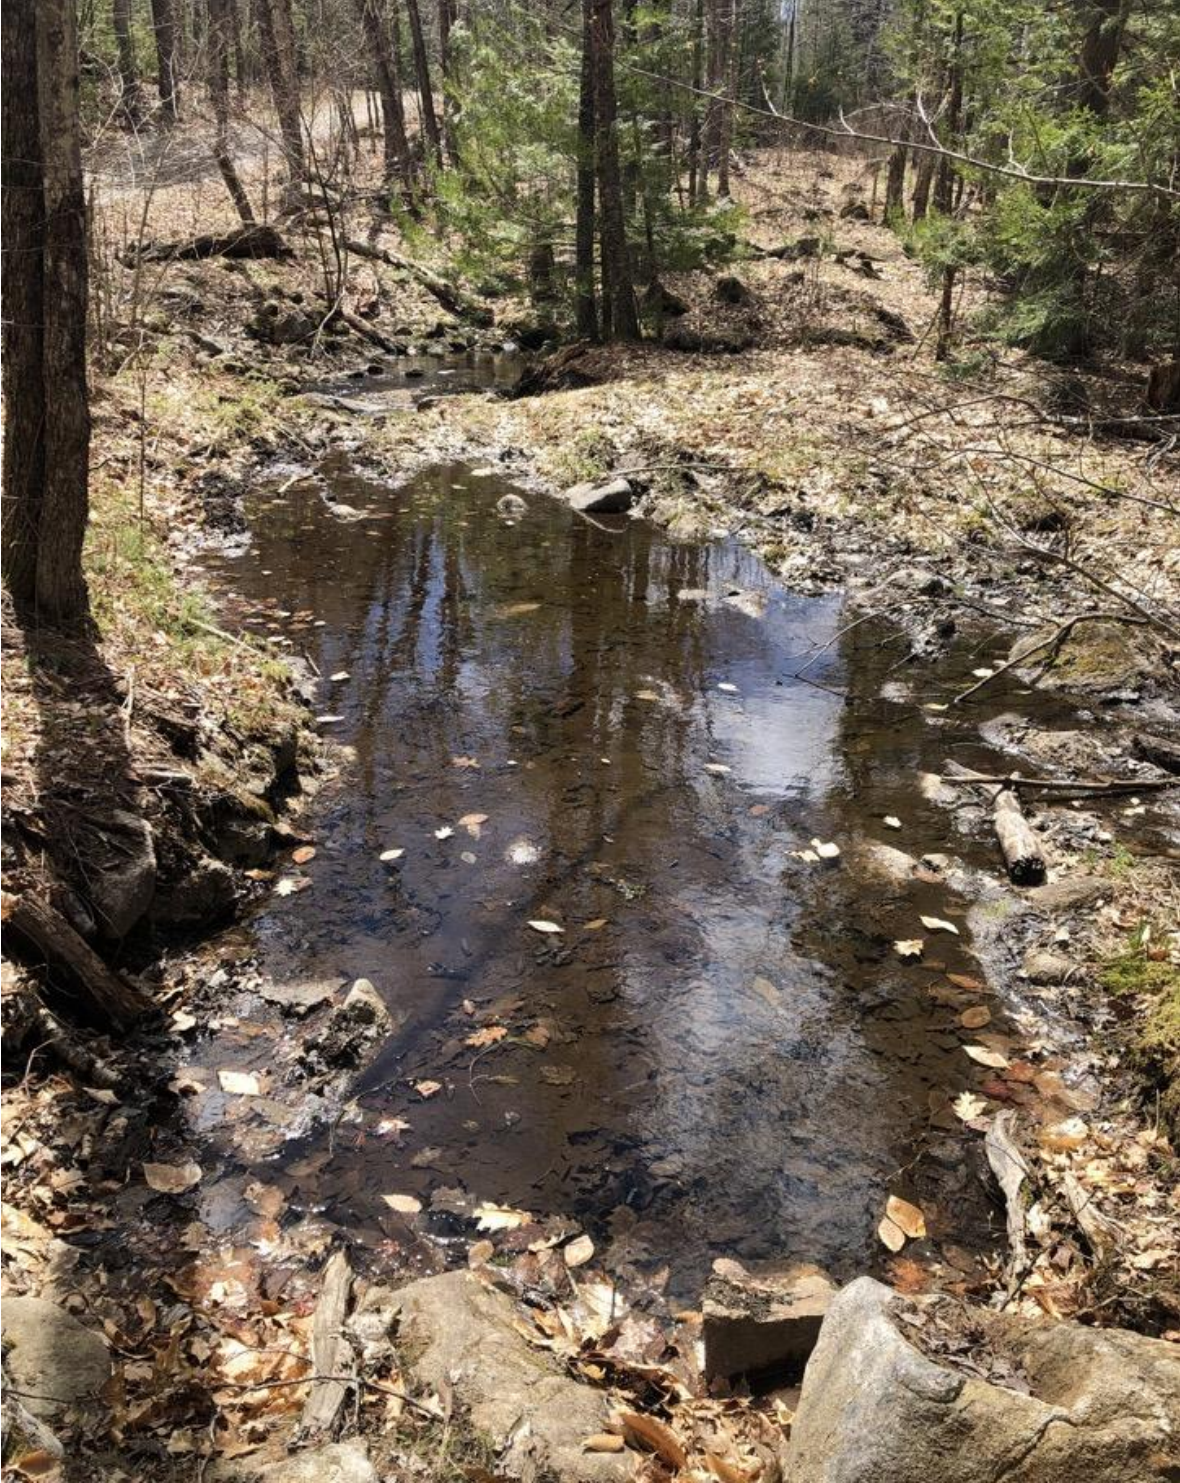
- 0.00 Road in "FAIR" condition with frequent pools of water and rocks 4-8 inches.
- 0.14 Rip-rap appears to have been placed secondary to a logging operation. Road is fair to good from this point forward.
- 0.2 Substantial off-road damage has been done to embankment on West side of a bridge over a small stream.
- 0.5 LHR ends at 4-way junction with Day Pond Road (both ways) and a private road.

Erosion: Section closest to Henniker has significant erosion. Multiple large mud puddles encountered with vehicle tracks extending the road on both sides. Crushed rock placed on Bradford end makes a more stable surface for the road. Off-road damage next to bridge appears to be healing with no sign of recent ATV "mudding".

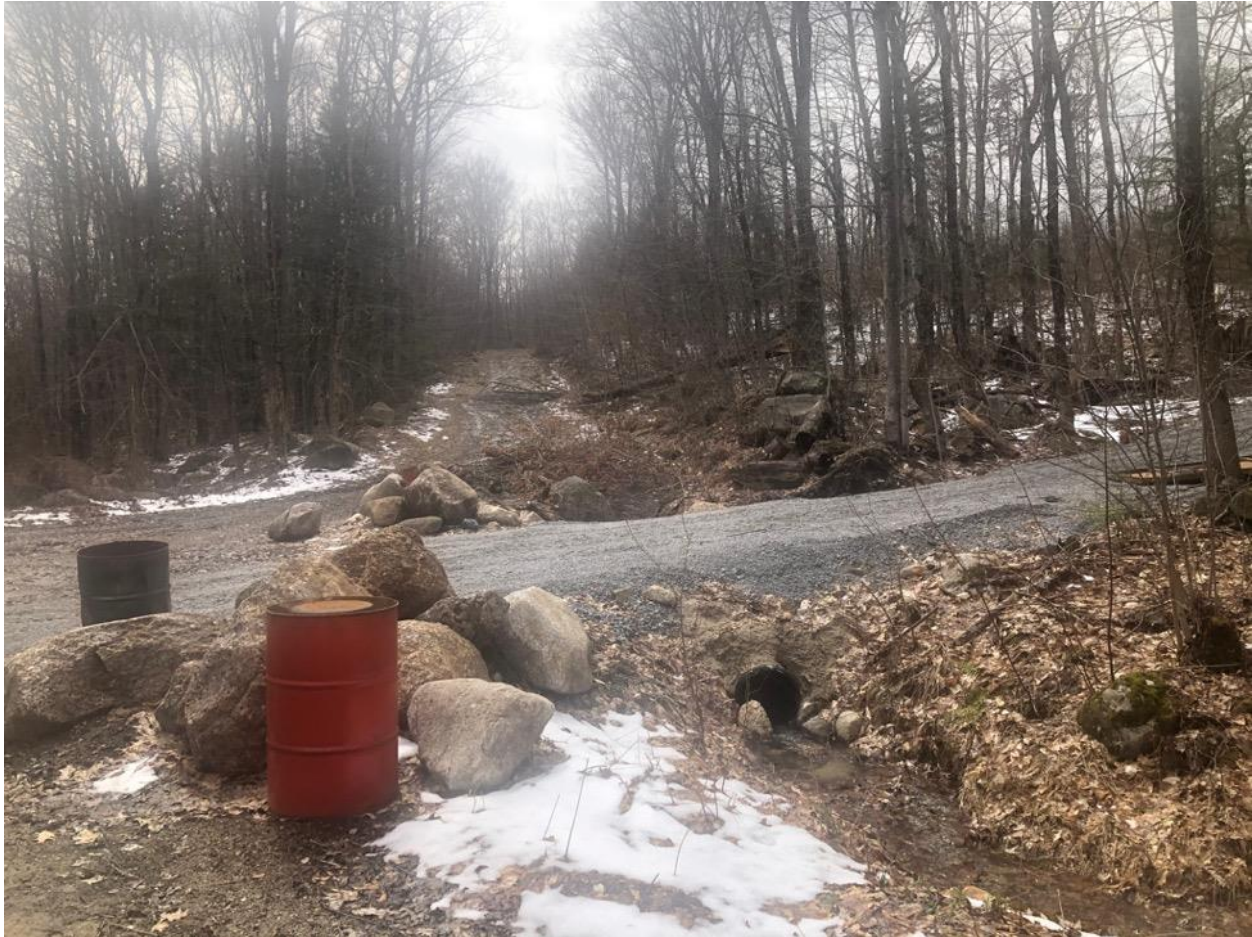
0.8 Road in generally "GOOD" condition with isolated rocks and water bars. Relatively fine gravel has been added in several places. However, traffic has created a washboard effect. In addition, several water bars are quite deep.

Erosion: Washboard surface in places and fairly deep water bars. However, these improvements seem to have limited overall erosion.

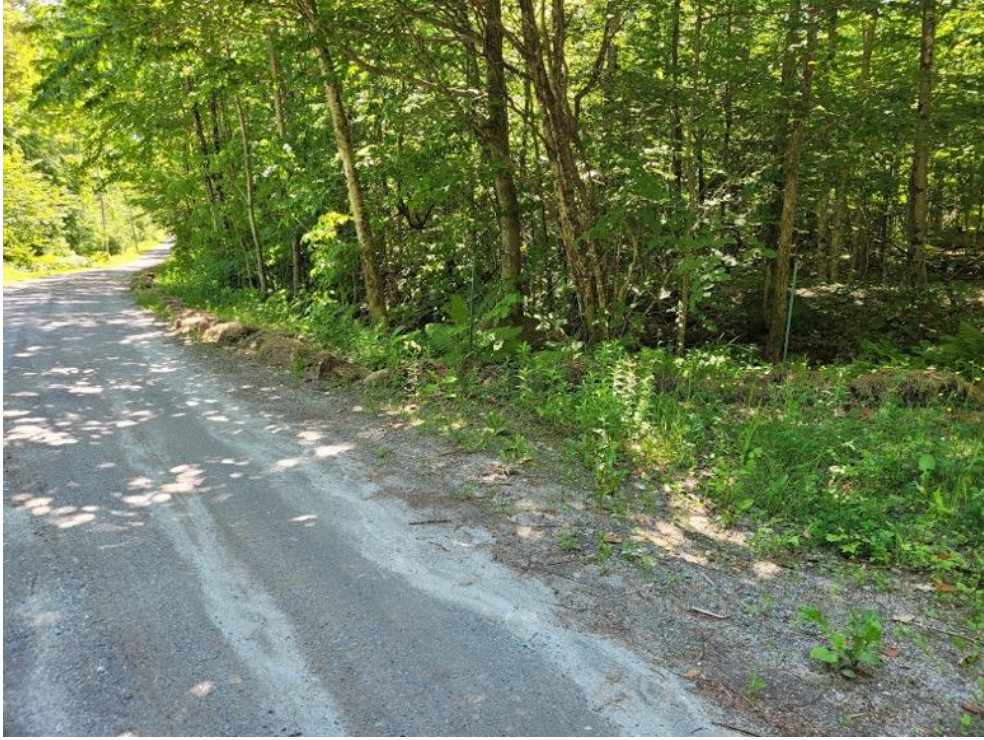
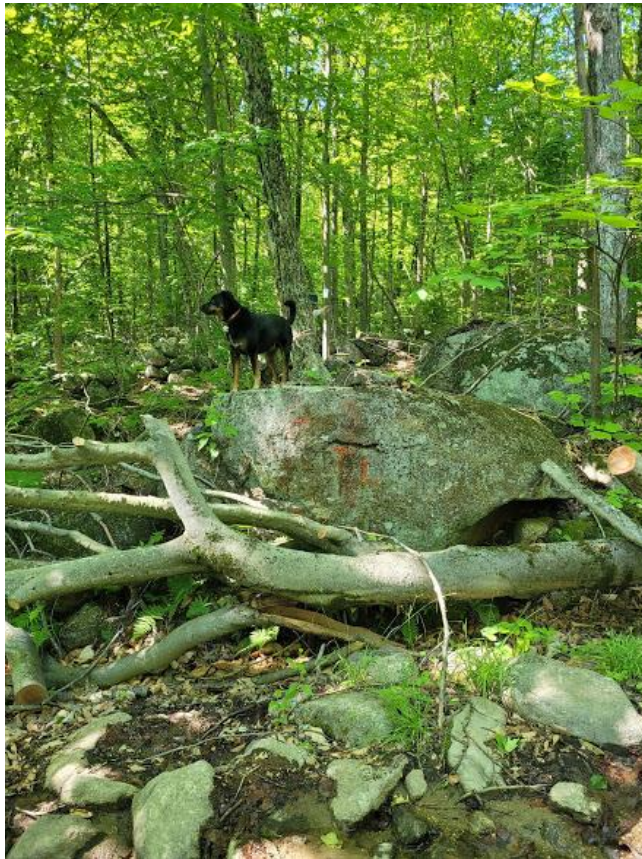
Mile 0.0 to 0.4 - The road is maintained by abutting homeowners. The road surface is currently in "EXCELLENT" condition to Jane Lucas' driveway. There have been problems in the past with road maintenance disturbing the bank of the adjacent stream (Hoyt Brook), and with road material washing into the brook. Monitor update from June 2021 finds that the stream buffer in the first 1/2 mile continues to look good. Haybales were observed to be in place along this section of the brook (see pic). The road is posted at this end.

We found conditions to be significantly the same as the last report. No new issues of concern were identified. Town line located (see pic with dog).
