# *Adopt a Road*

Bradford Conservation Commission

Fall 2020 Report

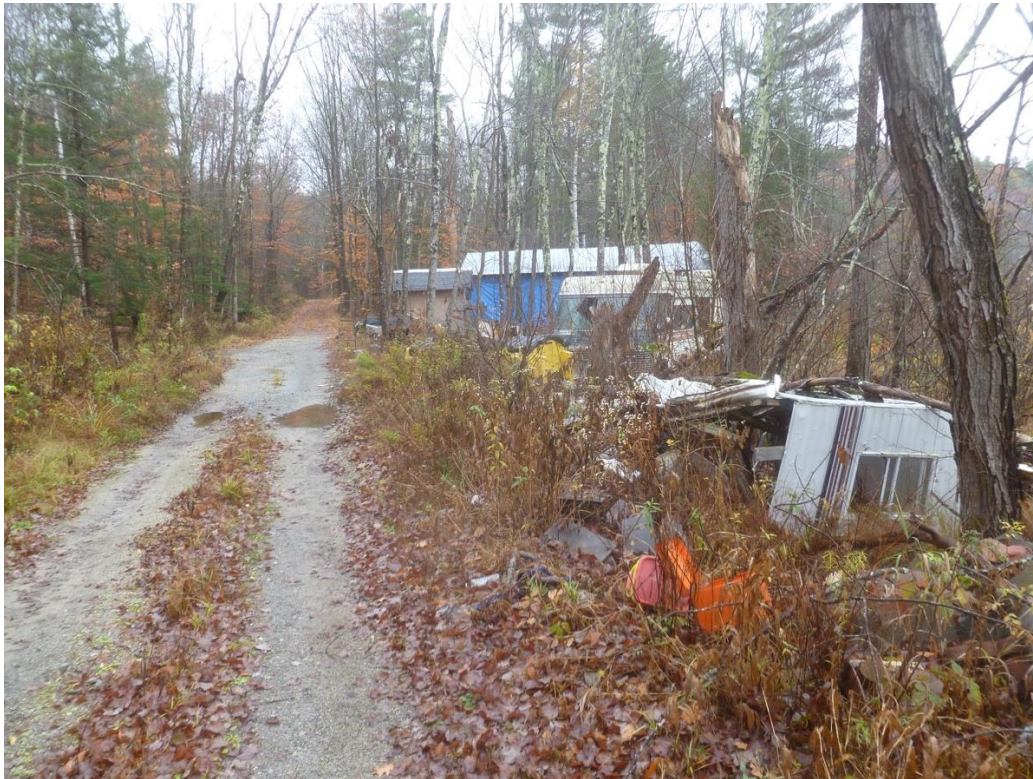
0.25	Up until this point, road is in Good condition with placement of crushed rock. A small building is encountered on the left side of the road which appeared to be occupied in the past. Numerous junk piles and cars/trucks along-side of the road.
0.75	Road surface is Fair to Good, reasonably flat, but with significant mud puddles. One culvert juts up from the road surface.
1.0	Road continues to be in Fair to Good condition, but ends in water at approximately 1 mile (see pic).

Obstructions: Standing water in some areas of the road as previously noted.

Motorized/Non-motorized Activities: Tracks and ruts from very large tires -- earth moving equip or large trucks.

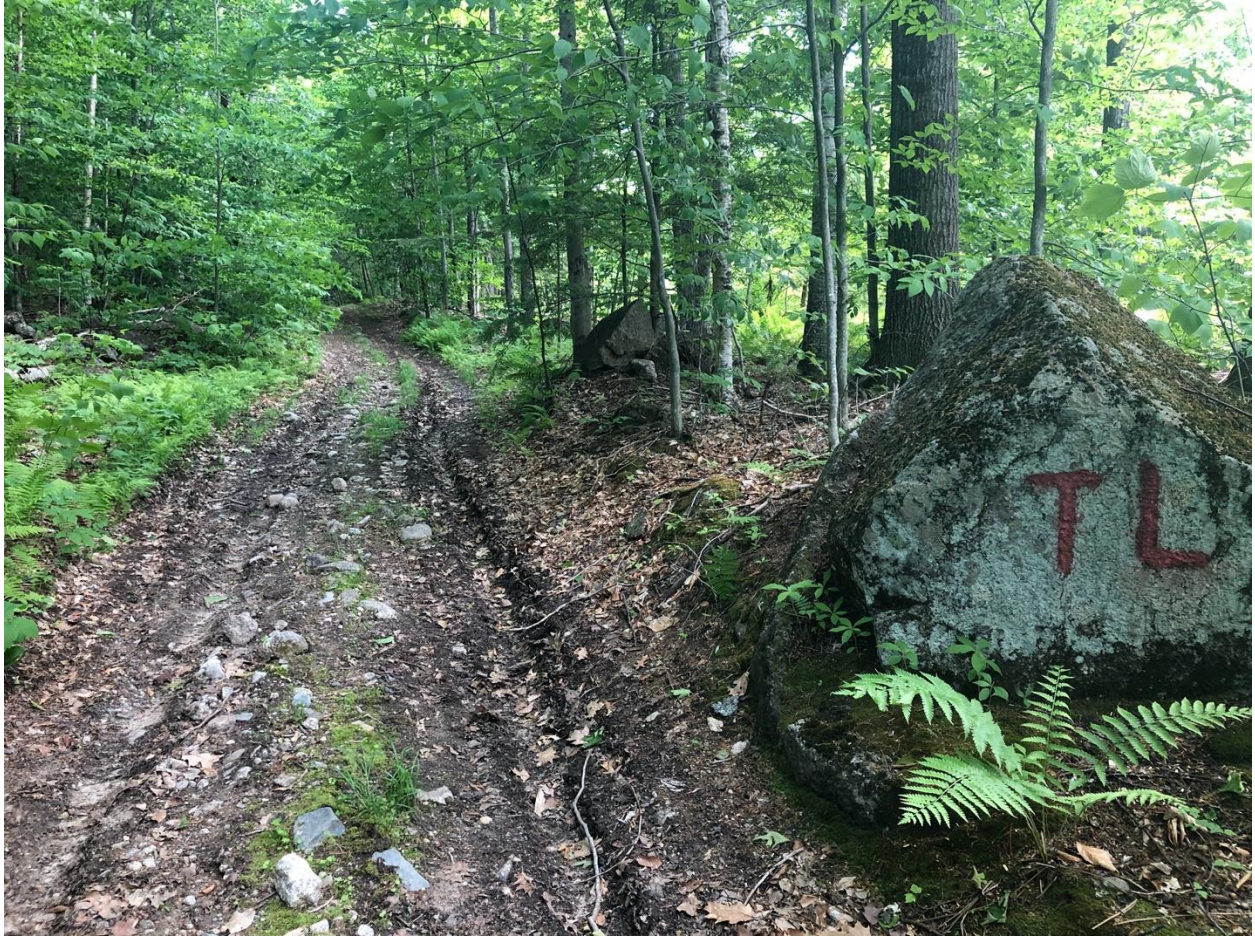
- 0.0 Road maintained by Tom Dunne and is in EXCELLENT condition for a Class VI road.
- 0.3 Road converts to unmaintained and is in FAIR condition.
- 0.45 Warner/Bradford town line (approximately 800 ft from beginning of unmaintained road).
- 0.49 Apparent end of Class VI roadway (approximately 200 feet from town line).

Erosion: Mud/pot holes with some large rocks noted on the Bradford Class VI section.

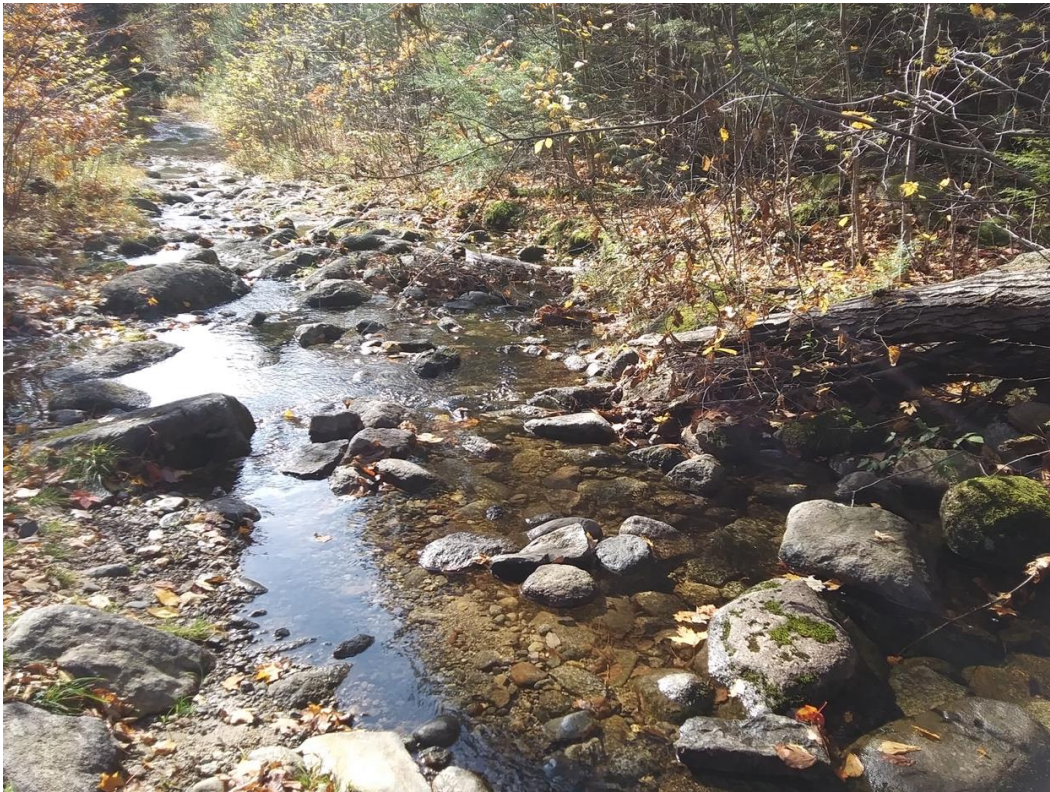
Motorized/Non-motorized Activities: Regular use by dirt bikes, ATVs and 4WD trucks, uptick from previous years. Minimal new damage.

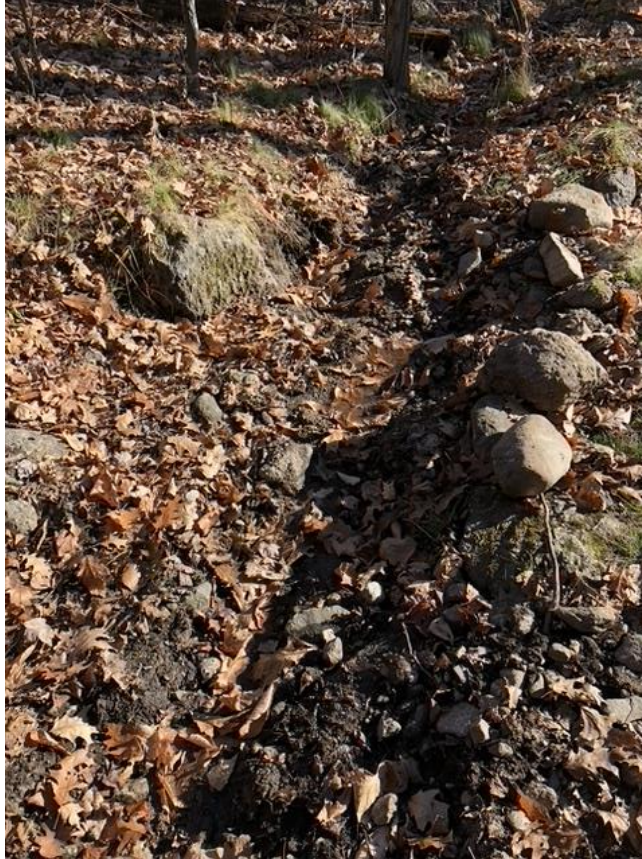
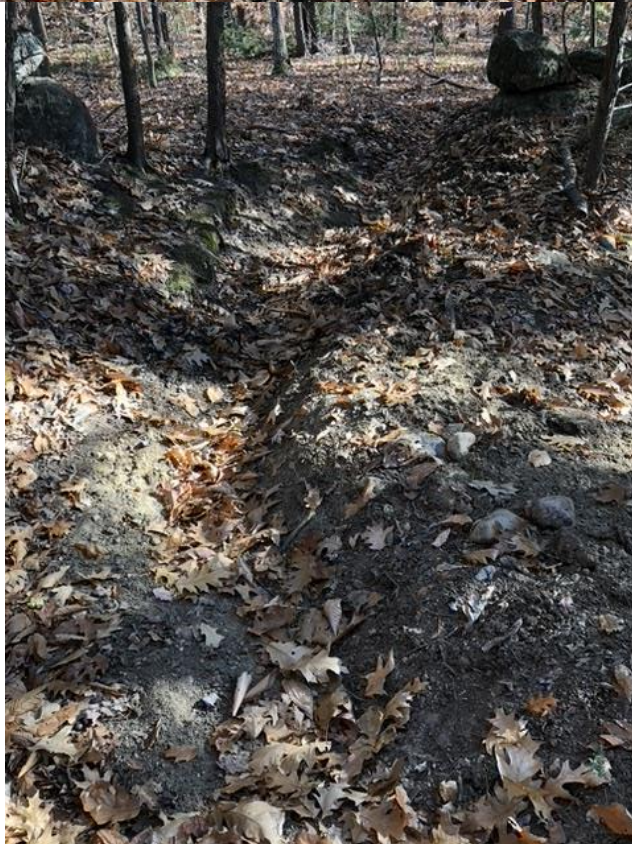
- 0.00 Initial section is Fair with some erosion
- 0.53 Road condition moves from Fair to Good
- 0.6 Top of hill; Harriman and Howlett cellar holes noted
- 0.89 Roads starts heading downhill; condition moves back to Fair due to erosion
- 0.93 Road condition deteriorates to Poor with extensive washouts and large rocks.
- 1.32 Unmaintained section ends

Comments: Overall, the condition of the Western section of the road is Fair to Good; Eastern section is Poor.

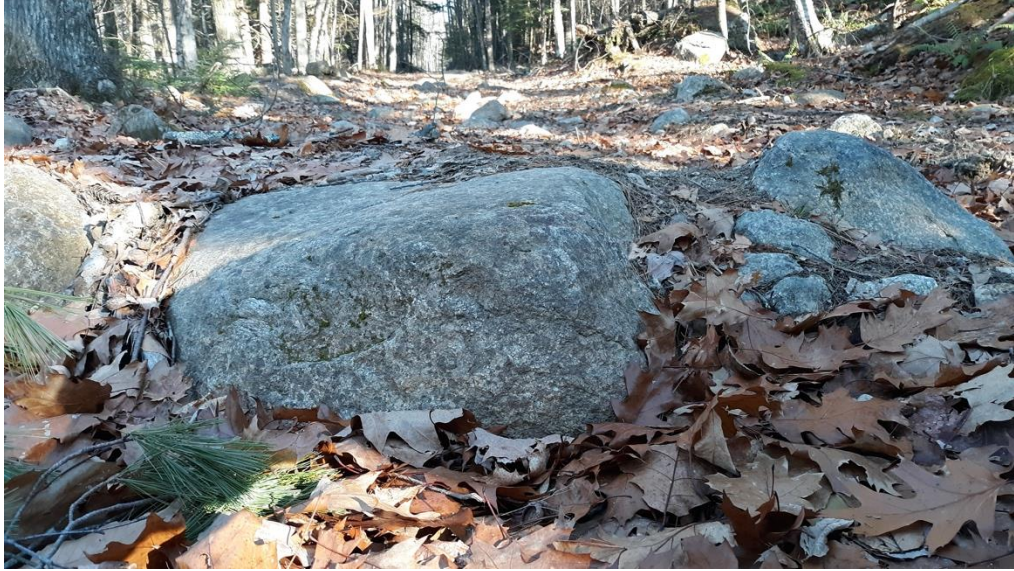
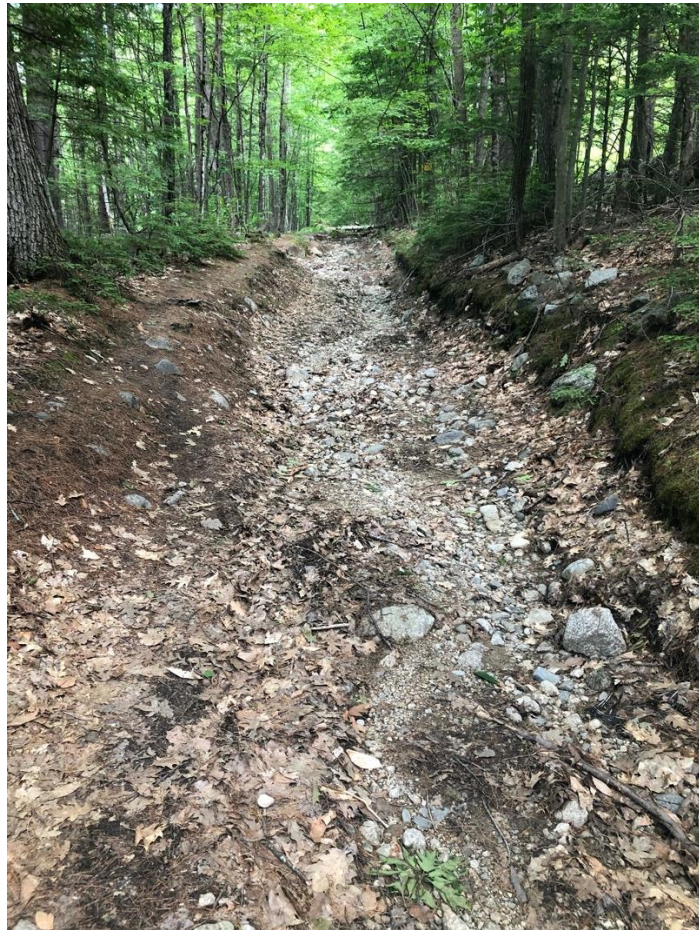
Motorized/Non-motorized Activities: Occasional. This spring we saw a couple of individuals who thought that they owned the road and could do as they pleased with ATV's and heavier four-wheel drives. Much damage was done.
